**Study on Deterioration and Conservation of Brick
Monuments in Polonnaruwa.**

D. Chandrasiri Chithrananda
April, 2010.

Study on Deterioration and Conservation of Brick Monuments in Polonnaruwa

A thesis presented to the University of Moratuwa, for the Master of Science degree in the Architectural conservation of monuments and sites.

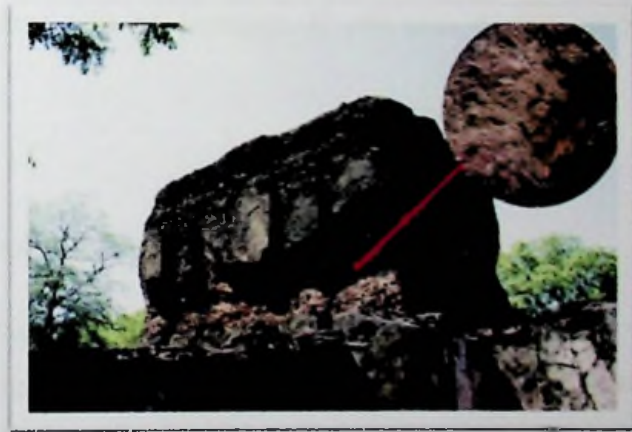
The walls of this building are very thick. Large holes made through these walls can be seen. Once timber beams had been interested into them. Due to wind erosion these holes themselves and the surroundings have immensely been destroyed. Owing to broken erosion and its resultant effect on these large holes made through the wall, the upper part of the wall may collapse. Continuing exposure to rain and excessive absorbency of brick will possibly make this process quicker.

Wind erosion Upper part of the wall in Palace of king Parakramabahu

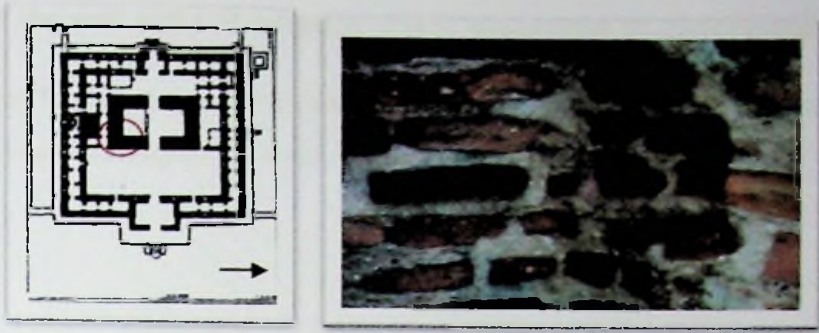
This kind of damage is also in the Parakramabahu palace. It is especially seen on interior of very high walls, i.e. on interior and both exterior surface. In many places the brick have been dissolved but the lime mortar in its entirety survives. But this feature is not wide spread. It is seen only here and there. The following photos show such instances where un burnt (soft) bricks have been dissolved leaving the mortar in its entirety causing damage to the aesthetic value of the monuments. This kind of remains can be found in thick brick walls belonging to the first floor of the interior ground floor. Of the Parakramabahu's palace.

Soft bricks in hard mortar Palace of king Parakramabahu

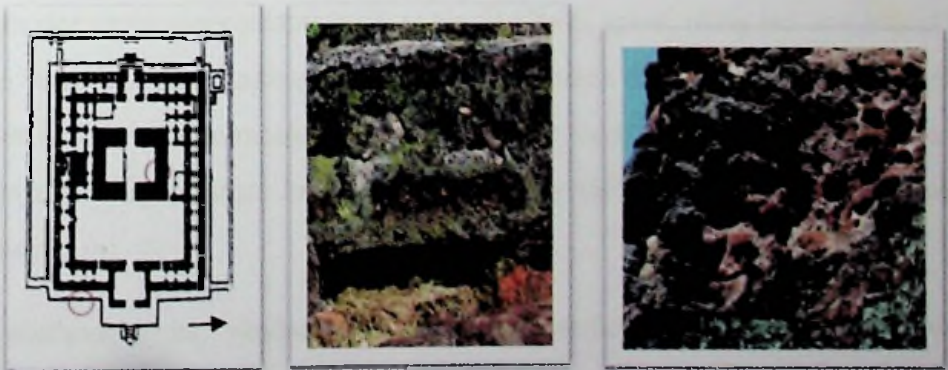
Polonnaruwa palace is a colossal structure built using a countless number of bricks. Fragile and ill-baked bricks in this construction have been dissolved and deformed holes have been formed on walls with the passage of time. These holes are a threat to the strength and aesthetic value of the walls. Furthermore, in these places as humus gathers plants also will probably grow.

Dissolved brick Palace of king Parakramabahu

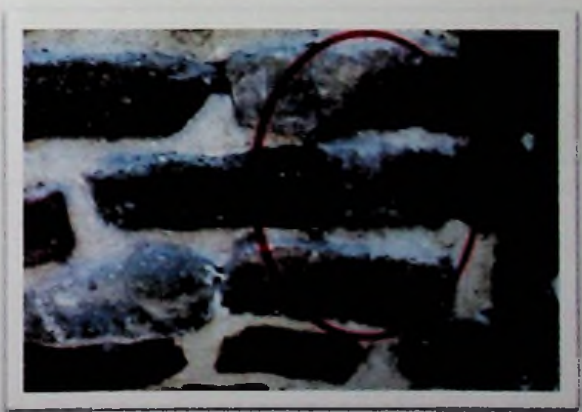
Small cracks on bricks

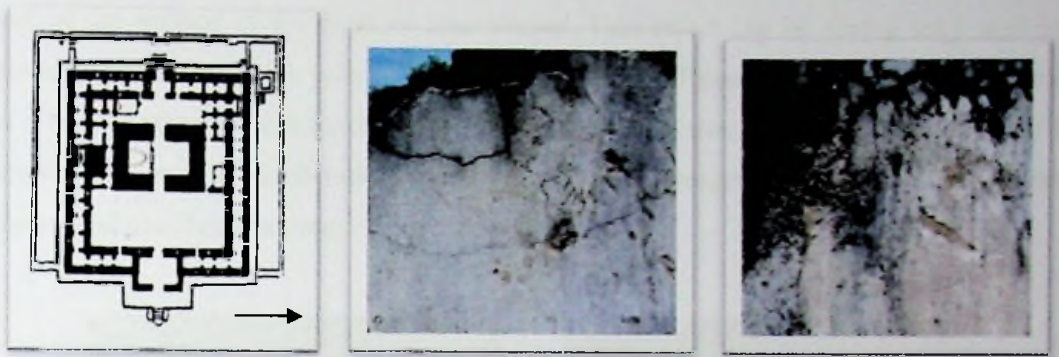
Numerous thermal small cracks can be identified even on lime plaster spread on bricks. Although they are tiny cracks they can cause a considerable and both long-lasting damage to brick monuments.

Small cracks on plaster

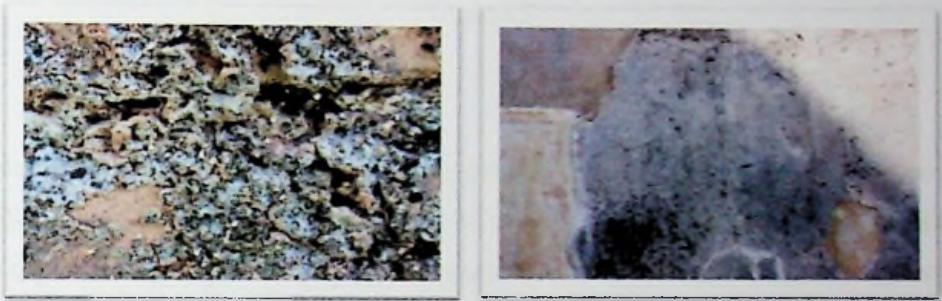
The moss grown on bricks due to excessive sunlight it receives in dry weather peel off also a part of the surface of the brick or lime plaster. This effect can be seen very well on the wall and plaster on Parakramabahu palace. This process of peeling off wears away the brick and in case of a brick surface depicting painting or containing lime plaster accompanying paintings the deterioration will be much more severe. This kind of damage is very often found in lime plaster and masonry erections.

Moss and cracked growth on bricks and lime plaster

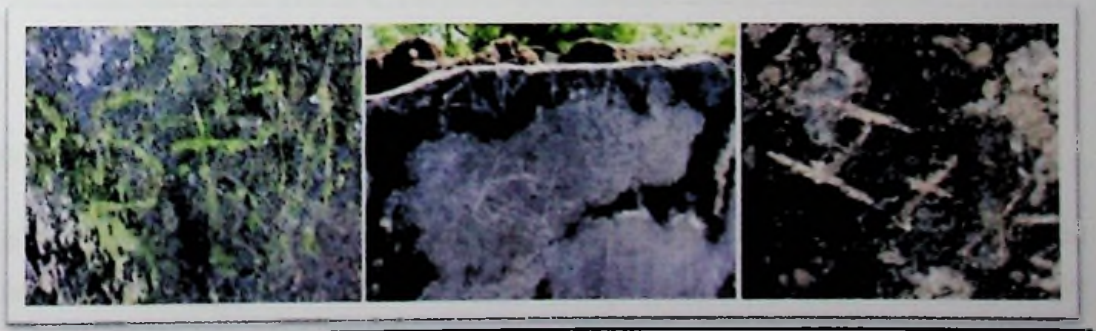
Names of persons and various scribbles have been written on this more than 800 years old yet well preserved lime plaster surface in the small rooms of the back portion of the Parakramabahu palace.

Scribble on lime plaster

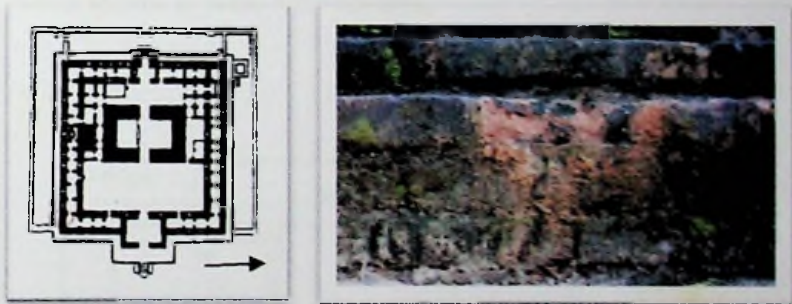
Again with the increase of the rain following soakage clay particles of the brick are disintegrated and this process can be seen on the right foundation brick wall. Ceaseless wearing away or finding away is a great harm not only to its beauty.

Wearing a way of brick

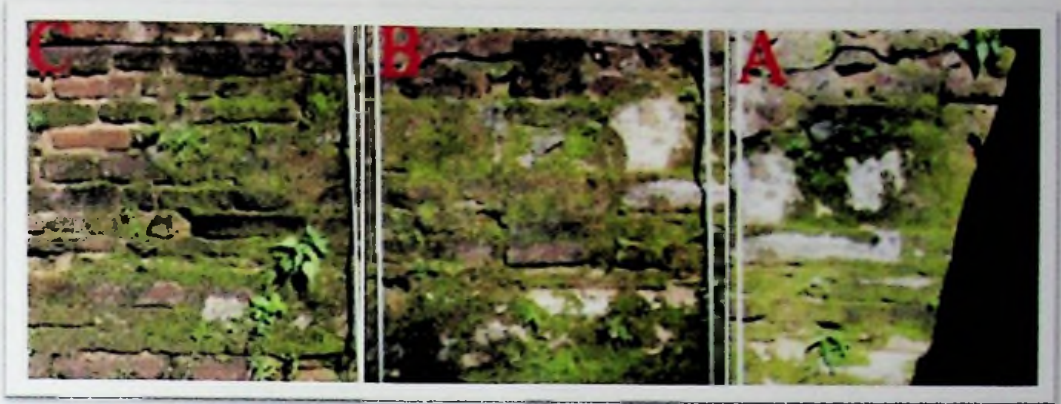
The whole monument is covered with large and small plants. Therefore with a view to making a thorough study we studied plants to within $1 \times 1 \text{ m}$ squares and other deteriorating factors. What the photo shows is three squares $1 \times 1 \text{ m}$ high.

Botanical damages in foundation

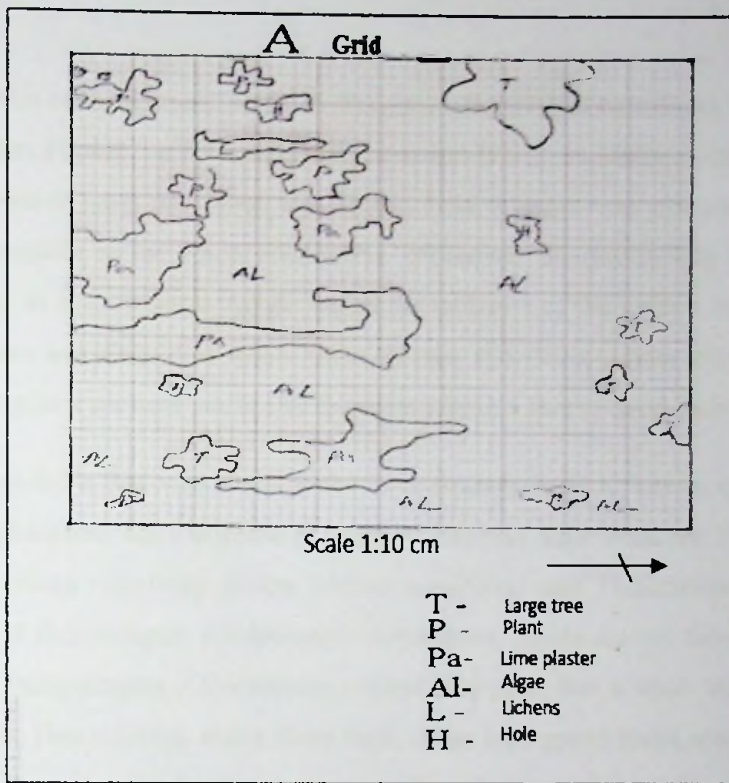
We obtained all this information according to a plan drawn on a scale and we calculated percentages of deteriorating factors found within the 1x1m square.

Botanical damages in foundation – squares-A

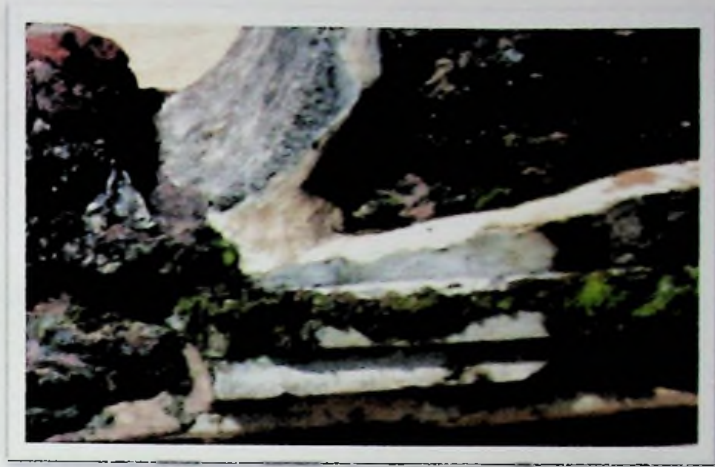
One can see how these moss and algae deteriorate the lime plaster bands. At the back of the Parakramabahu palace which belongs to a period dating back to some 800 years. (Polonnaruwa period).

Moss and algae on lime plaster

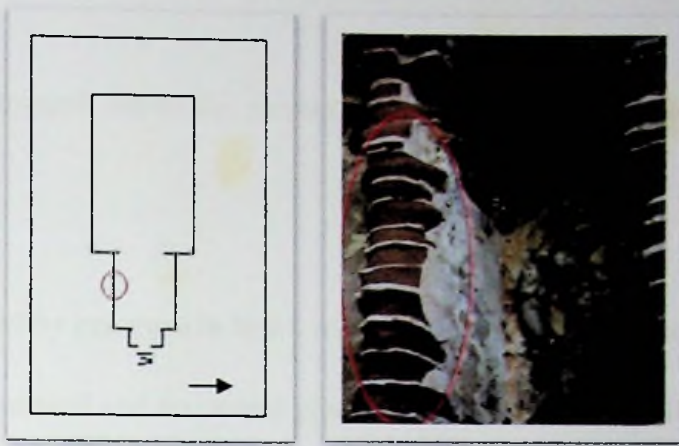
While plaster remains the soft bricks disappear this kind of plaster which is stronger than the brick tend to preserve it in the presence of erosion factors while the latter is eroded.

Deterioration of soft brick and preserve stronger plaster

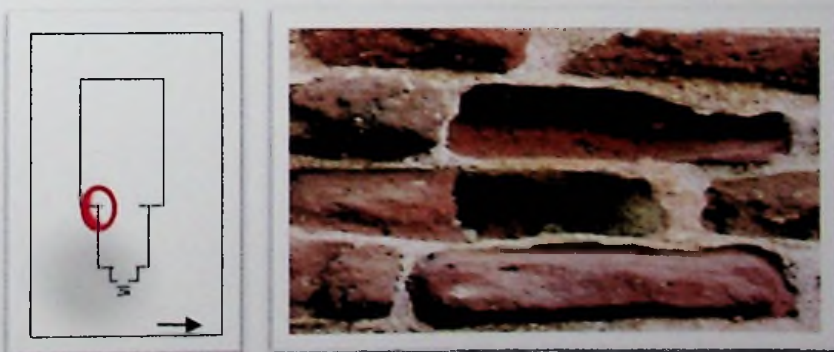
In the construction of Thivanka Image House some bricks of inferior quality below standard had been used and such bricks unlike others rapidly deteriorate and as a consequence they made holes among the bricks wall. It is a threat to the strength of the wall. It damages aesthetic values in monuments.

Dissolving bricks in bricks wall

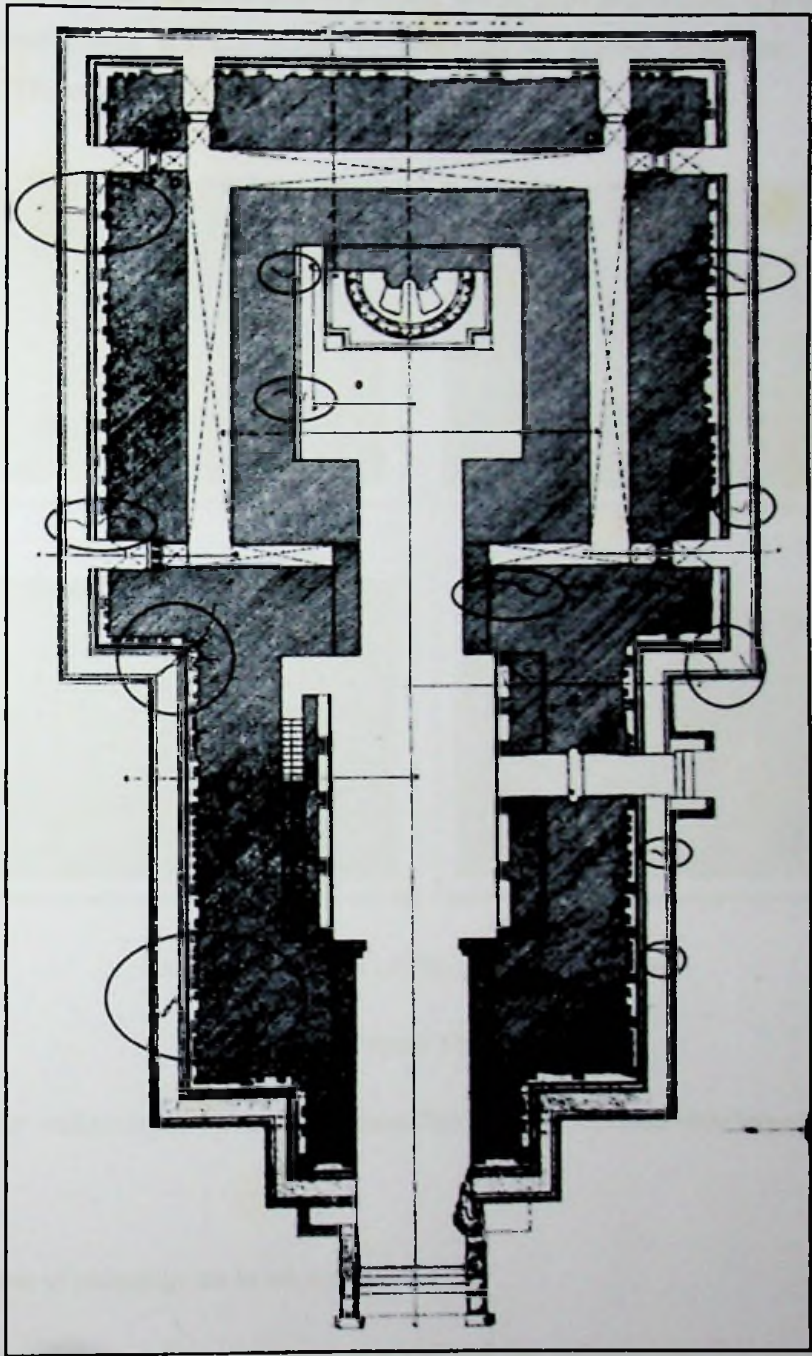
A large number of splits, micro, medium and macro, of the kind already refer to above can be found on both interior and exterior walls of the Thivanka Image House. Some of these splits date back to some centuries. There are marks on them which indicate that they have been conserved.

Cracks on the walls of the Thivanka image house

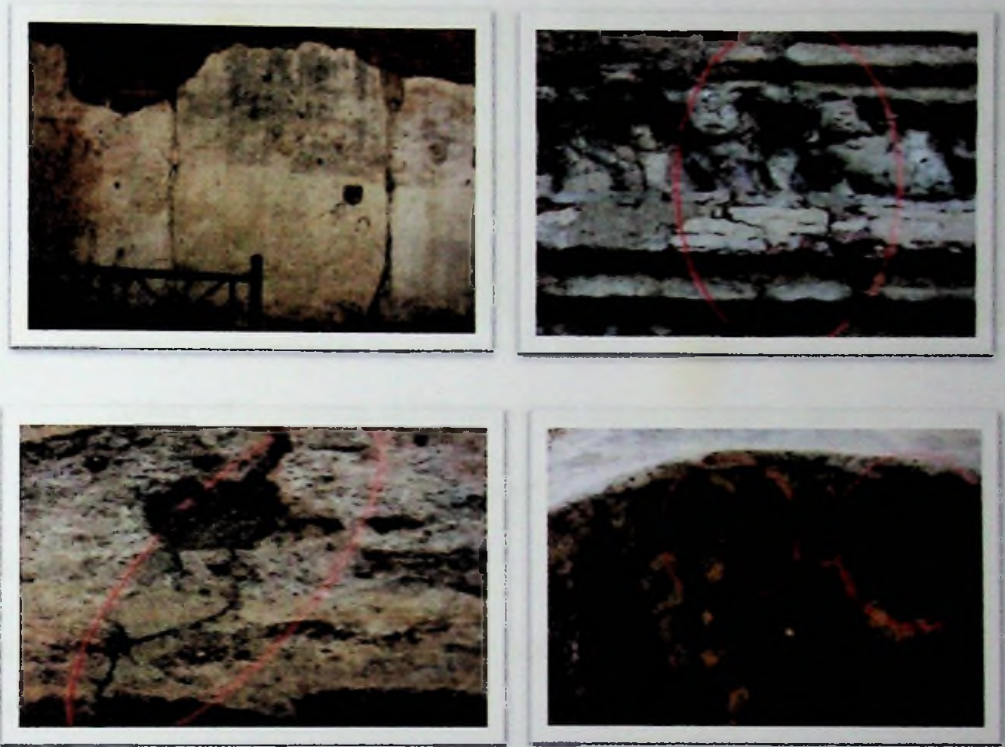
These bursts cannot be recent ones but they have been there for ages. Although no rapid increase can be noticed yet some sort of increase seems to be in progress. It is believed that some of these cracks are the results of processes of thermo expansion and thermo contraction. These bursts can be seen on interior walls.

Cracks on the walls of Thivanka image house.

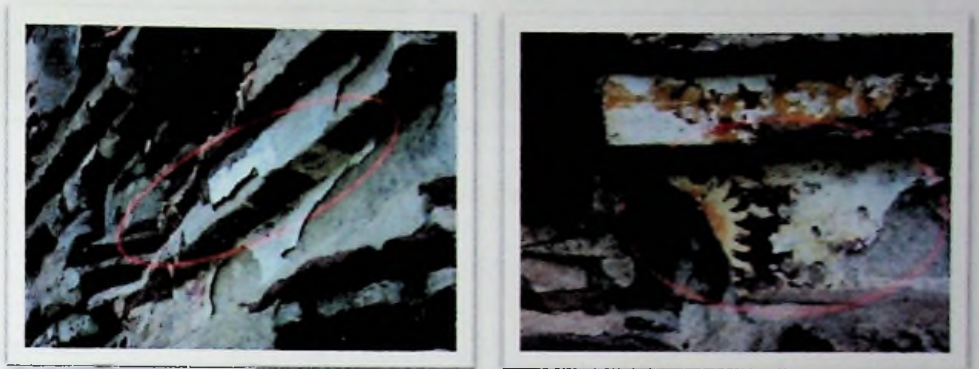
colours have been vanished. Even what remained is not the real colour but somewhat deteriorated.

Peeling off so painting and Places where colours are well preserved

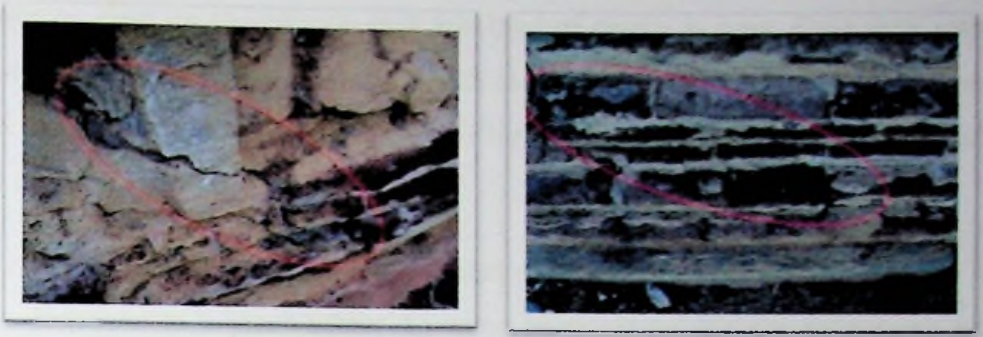
Excessive and continuous heat makes bricks hot, expand and contract and in consequence their structure becomes fragile and then burst giving way to subsidence of the base of the brick wall. This subsidence finally becomes worse when it produces a number of large cracks owing to the heavy mass it is uploading. If the processes are continued, i.e. cracks widen, a part or the whole building will break and deteriorate. A large number of such major cracks can be seen on the front side of the southern wall as well as in the interior. Those cracks referred to above cannot be recent effects but can easily be identified as a long-standing process. However, if they are in progress is a matter to be studied continuously.

Major cracks on the wall.

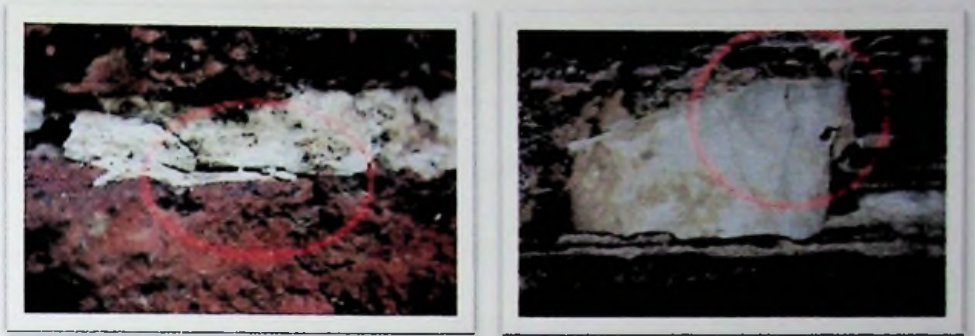
and the brick may separate from each other and remain in the form of without folds empty. This feature is common in case of southern walls and the walls with interior paintings of Thivanka Image- house.

Crack on the plaster

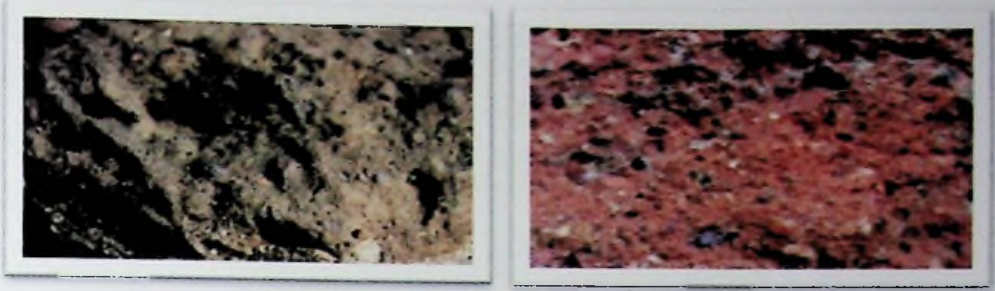
Moreover, the surface of the brick experience minute cracks, peeling off and minute holes. Process of this kind goes on for hundreds of years. And finally the bricks are destroyed in its entirety. Rain and dew make the process seedier by eroding the brick surface.

Eroded brick surface.

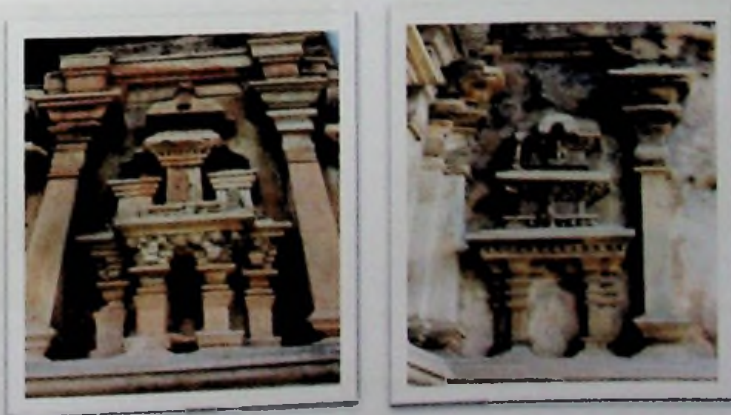
Vimana and plaster found on the north wall of the monument are well preserved on the leeward. The chief reason for this preservation of the lime plaster is that it lies on the lee ward.

North wall – Thivanka Image house - Picture 64

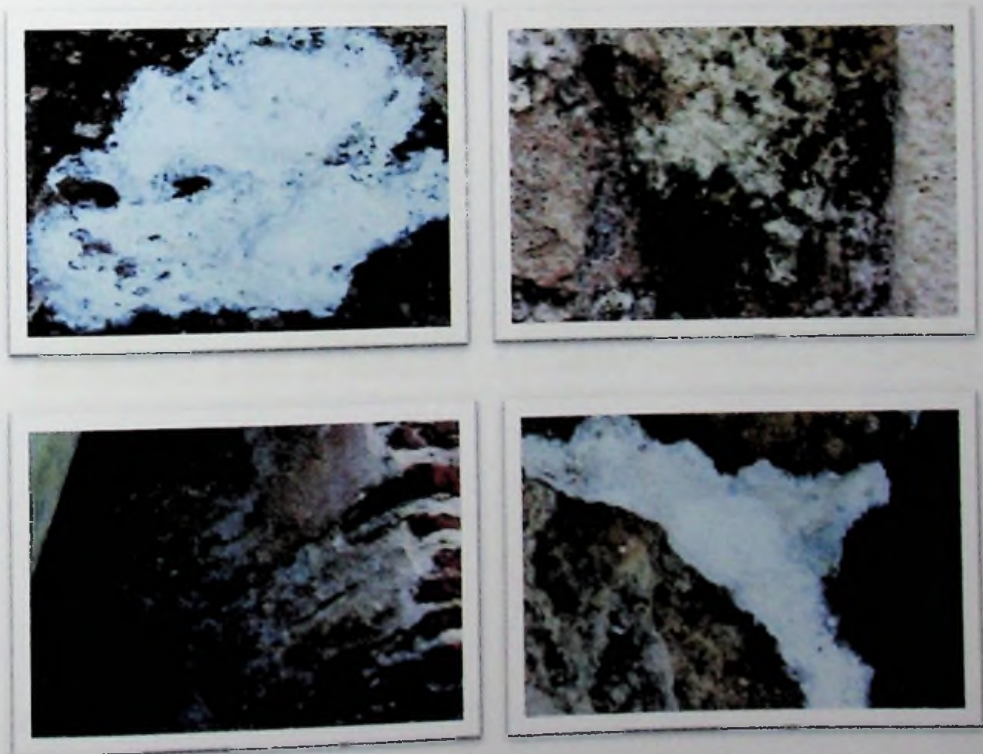
As Thivanka Image-house is equipped with a shatter roof at present its brick walls aren't wet. They are dry. Therefore infection of bacteria and fungi is little here. It is in surrounding where no ventilation and humidity is present that bacteria and fungi grow.

Fungi infection - Thivanka Image house

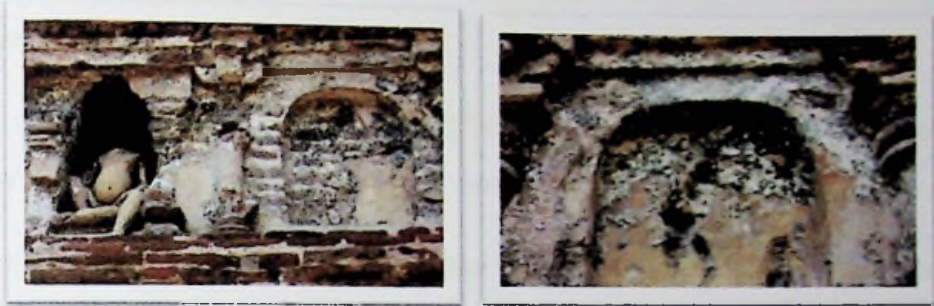
Ash and white lichen which grow on the lime plaster severely damaging it is, found widespread on the exterior of the north wall and above the base where *Garbha gruhaya* and *Antharalaya* and join. These two kinds of lichen not only deteriorate lime plaster but also a threat to the aesthetic value of the monument. Lichen damages a number of parts of the interior of the monument

Lichen which grow on the lime plaster

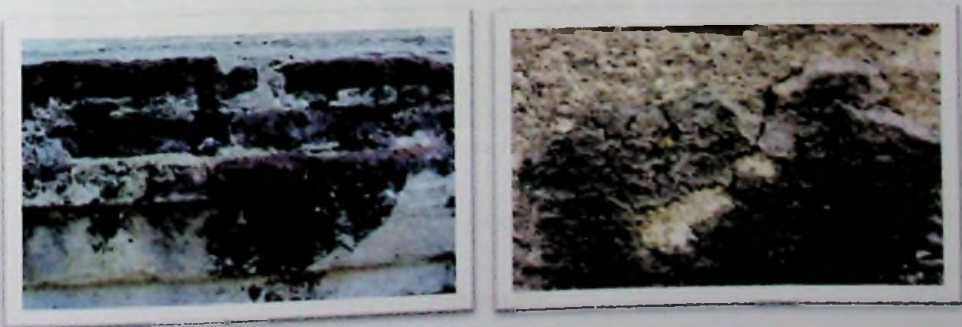
Another important biological deteriorative factor is moss which is found on brick erections and lime plaster of the monument. Damage caused by moss has been minimized to a great sentence since the set up of the shelter roof following 1980 decade. The absence of moss is due to the absence of humid environment. Therefore, spread of moss is not wide. Damage done by moss can be seen only in a few places. They also occur naturally adjoining the face.

Moss attack in Thivanka Image house - Picture 68

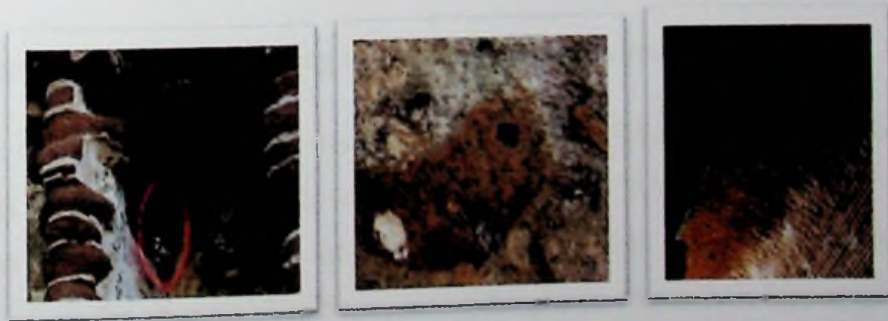
Among various sculptures, carvings, cornice and moldings a great number of potter-wasp nests can be found. Moreover, on the surface of the most voluble paintings inside the Image house several potter-wasp nests are found. Then again potter-wasp nests are a common occurrence on the of the brick arch roof belonging to the *Antharalaya* built by the central cultural found recently. Throughout the *Grbagruhaya* and also on the Buddha's statue potter wasp nest can be found.

Damage caused by potter-wasps

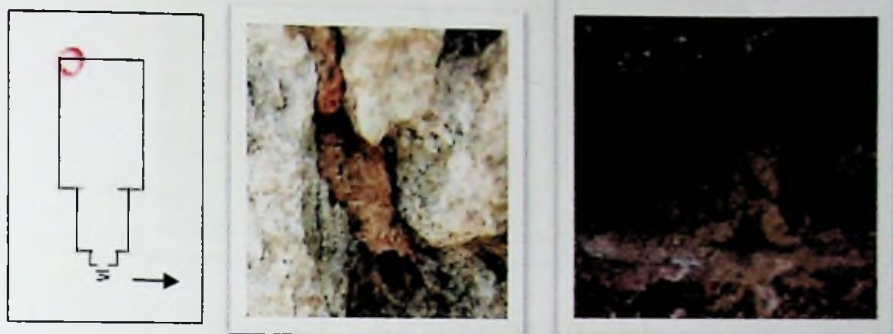
The next destructive insect found in Thivanka Image House is the termite. In the south western corner of the rear wall of the monument there is a large anthill. Traces of termites can be found on window arches and on the base where the lime plaster has been split.

Damage caused by termites

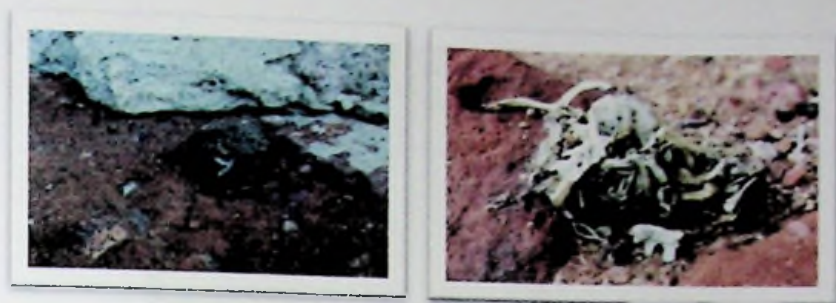
Among the quadrupeds harmful to Thivanka Image House are the monkey and the Ape. When these animals that come in large packs sit on the brick walls, and walk along them the old bricks detach from the wall and fall down. At some such occasions the bricks thus falling may collide with other old bricks or sculpture and damage a considerable portion of the monument. Further the spread of faeces of the Monkey and the Ape can be seen on the whole exterior wall and it is on the one hand threat to beauty and on the other seeds which faeces contain favors the growth of various weeds on the monument.

Excretion on monument

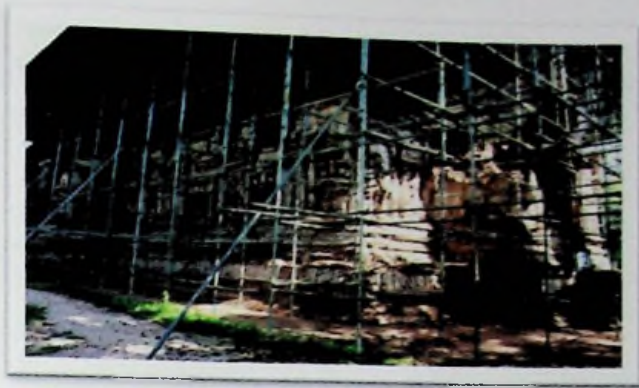
However, as these new erections leak in wet weather it has become difficult to remove the temporary roof built in order to conserve the monument. This roof made of G1 pipes places at 2x2 m distance and tin sheets is a threat to beauty of the monument.

Shelter roofs of Thivanka Image house

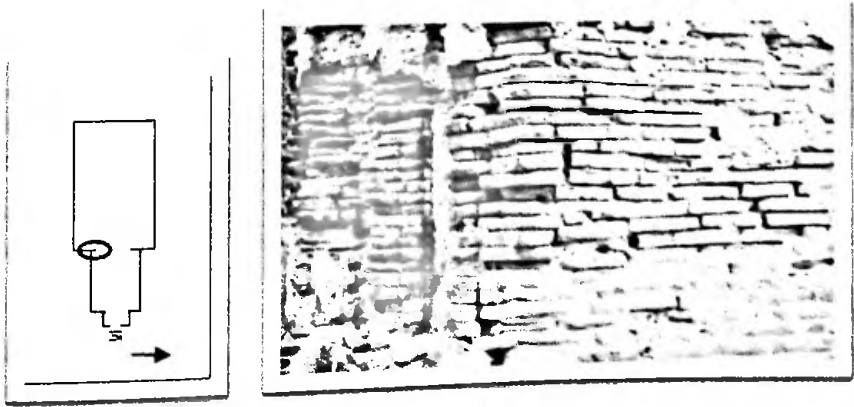
Deterioration of tender bricks and survival of the tough mortars

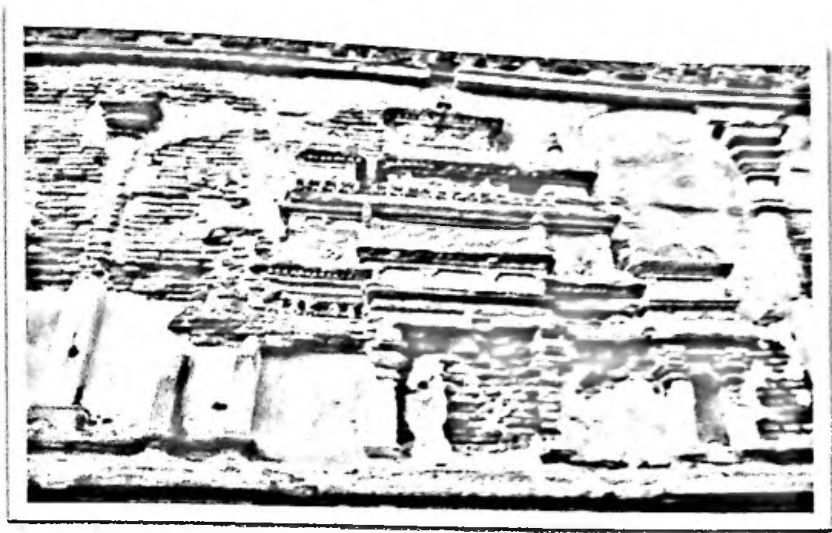
places where lime plaster has eroded

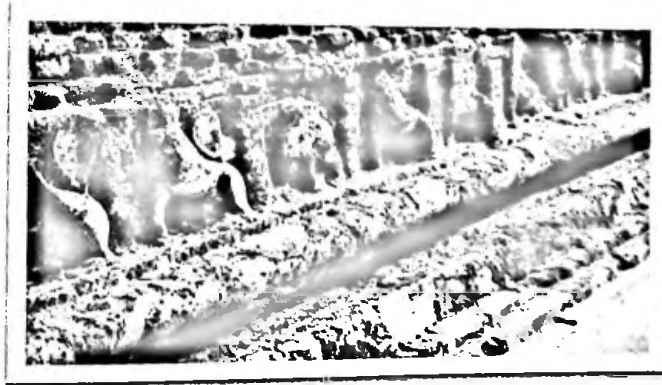
Growth of moss on molding in Lankathilaka image house

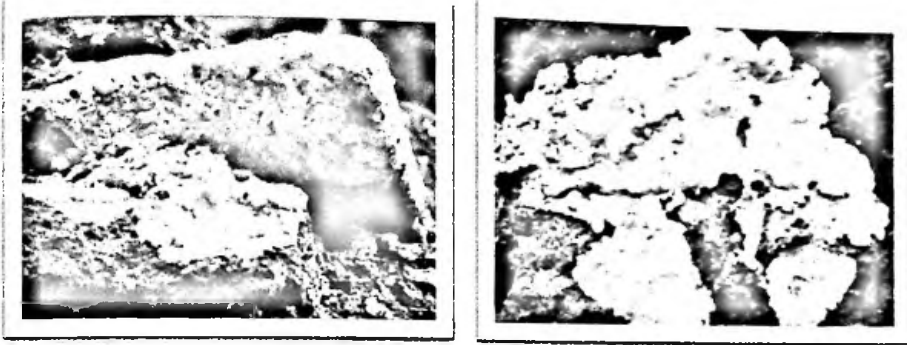
Lichen spread as isolated individual units

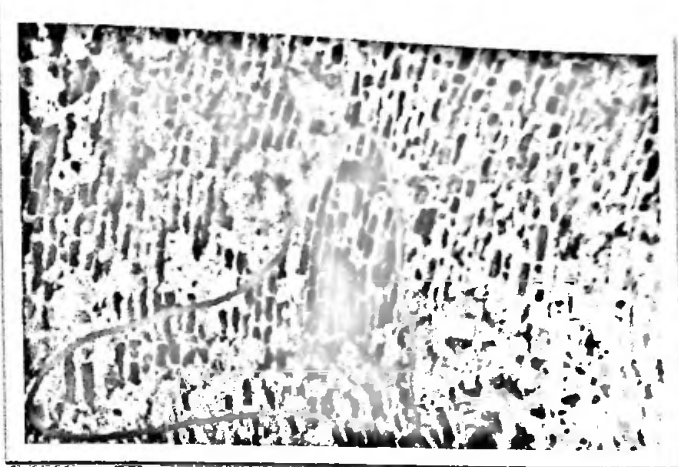
Mode of dissolving of bricks in the middle of the dome

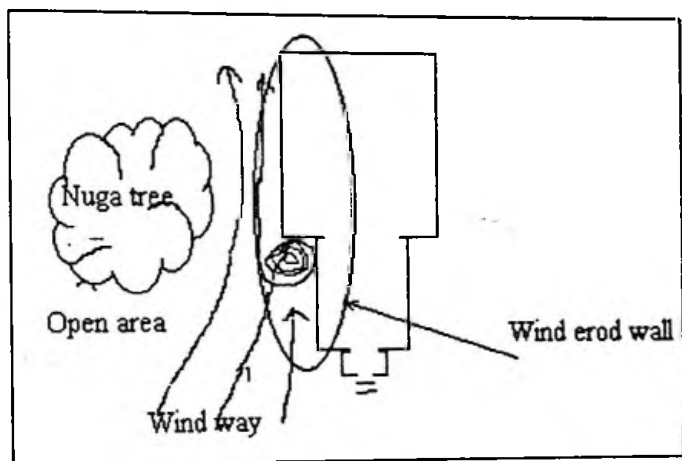
Wind erosion cause on southward wall in Thivanka image house
