INSPECTION AND ASSESSMENT SYSTEM OF HIGHWAY BRIDGES IN SRI LANKA

Thesis submitted in partial fulfillment of the requirements for the
degree Master of Science in Structural Engineering Design

Department of Civil Engineering

University of Moratuwa

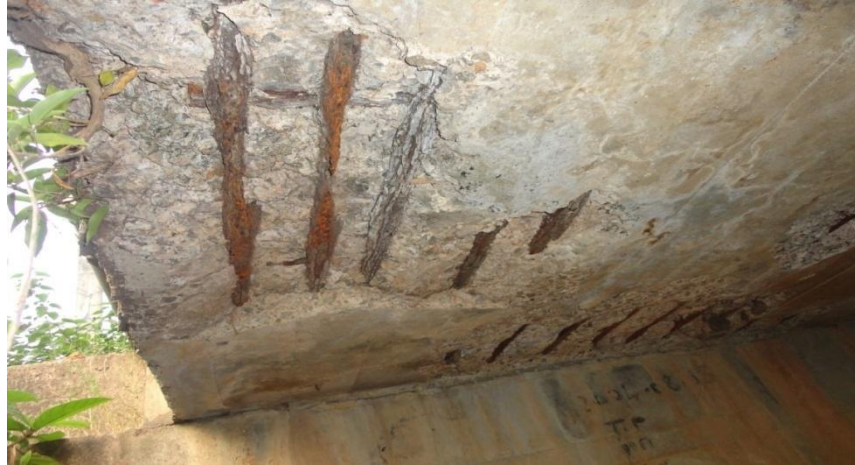
Corrosion of reinforcement in concrete is an electrochemical reaction. Fe converts to Fe^{2+} ions at anode where as O_2 and H_2O form OH^{-1} ions at cathode. Concrete contains pores and when moisture is there in pores, this OH^{-1} dissolve in pore solution. Connected pores facilitates the reaction between Fe^{2+} and OH^{-1} and form $\text{Fe}(\text{OH})_2$. $\text{Fe}(\text{OH})_2$ is unstable and get converted to $\text{Fe}(\text{OH})_3$ with O_2 and H_2O . This $\text{Fe}(\text{OH})_3$ get converted to $\text{Fe}_2\text{O}_3 \cdot \text{H}_2\text{O}$, which is a very stable product and get increased its volume. This expansion leads to "delamination" of cover concrete and finally ends up with "spalling" of cover concrete. Diffused chlorides in cover concrete act as a catalyst in the reaction. Figure 3-7 shows the initial signs of spalling in a reinforced concrete bridge beam where as Figure 3-8 shows a stage of complete spalling in a beam of the same bridge. Figure 3-6 shows excessive corrosion of reinforcement of a slab bridge due to exposing of reinforcement after spalling.

Figure 3-6: Corrosion of reinforcement underneath a slab bridge

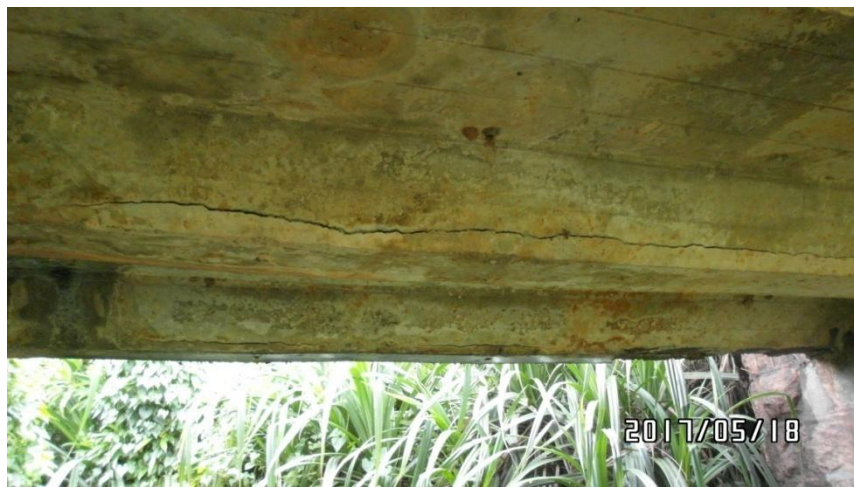
Figure 3-7: Initial stage of spalling due to corrosion of reinforcement

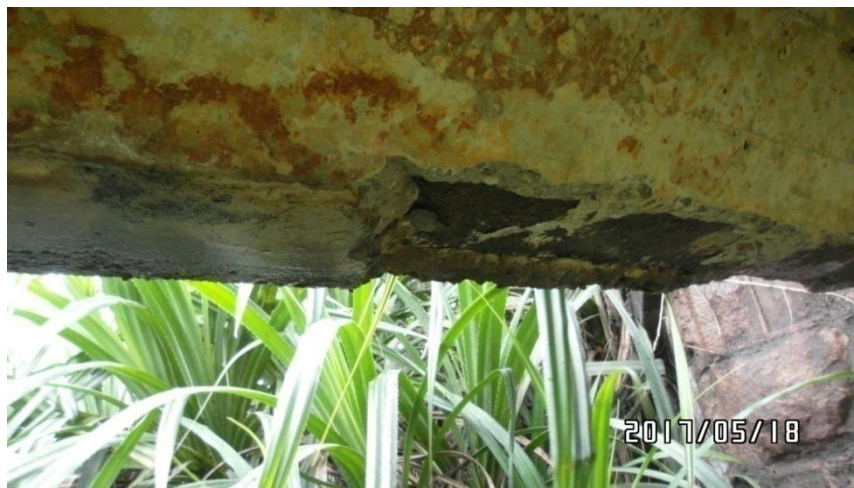
Figure 3-8: Spalling of cover concrete

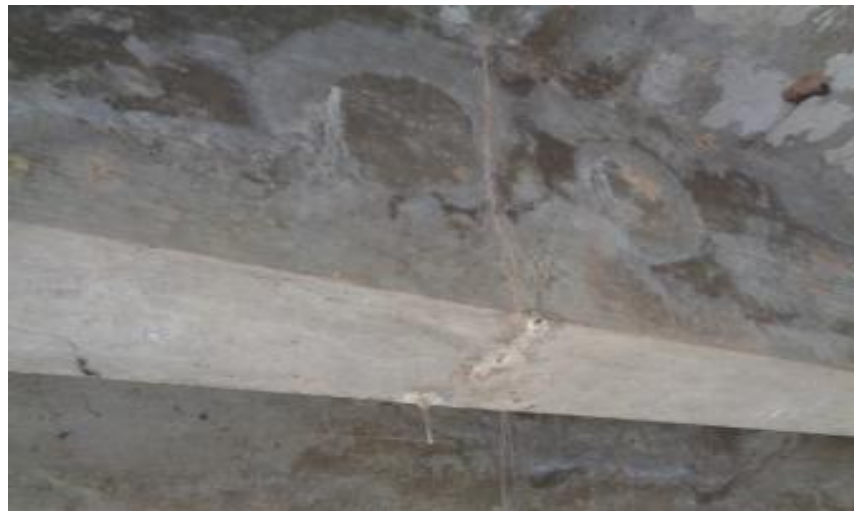
There must be cracks in hairline level to measurable levels in reinforced concrete when a section is subjected to a bending moment. Cracking alone does not mean a failure of the section but, needs attention when the crack width is visible. The scenario of cracking in prestressed concrete sections is not that straightforward as the cracking in prestressed concrete must be discussed considering the design class of the member as well. But, practically, the chance of knowing the design class of a member of an old bridge in local context is almost null. By the way, regardless of the design philosophy of a member, cracking facilitates the carbonation of cover concrete, which leads to corrosion of reinforcement. There will not be a single flexural crack in most cases but multiple cracks at close intervals, unless a crack occurred during the early age during the construction. Figure 3-9 shows a flexural crack developed in a prestressed concrete bridge beam.

Figure 3-9: A flexural crack on a bridge beam

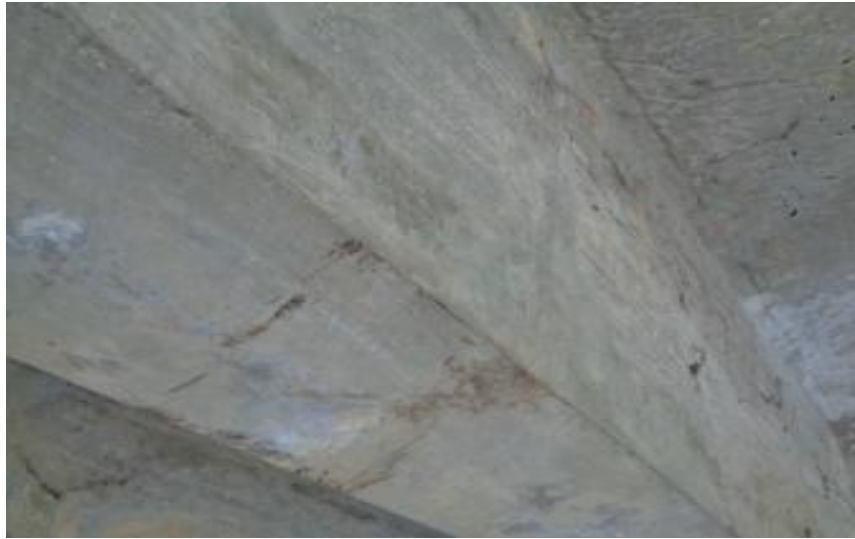
cracks. A shear crack in a deck slab at a joint between a beam and slab is shown in Figure 3-10.

Figure 3-10: Shear cracks of deck slab at beam slab joint

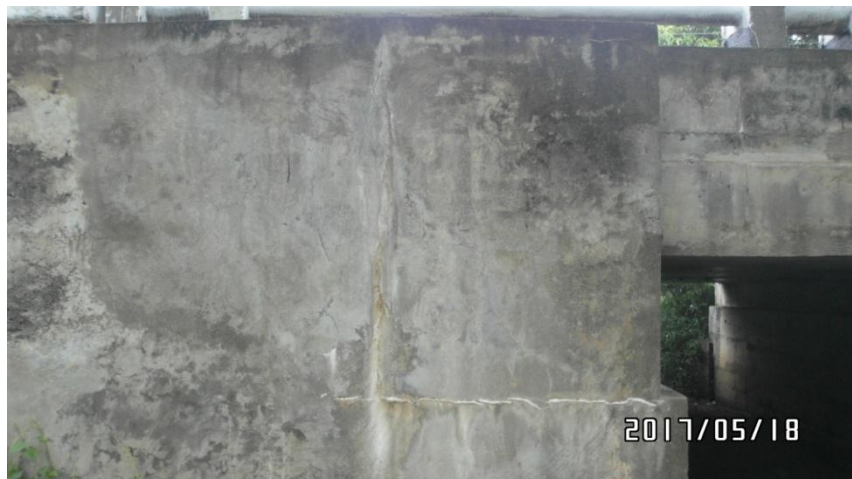
Plastic shrinkage cracks may appear in concrete during the construction stage and those are addressed before the commissioning of the bridge. Still long term drying shrinkage cracks are possible in relatively thicker sections. Figure 3-11 shows several spots of map cracking due to moisture movement in a reinforced concrete wing wall of a bridge.

Figure 3-11 : Map cracking due to moisture movement

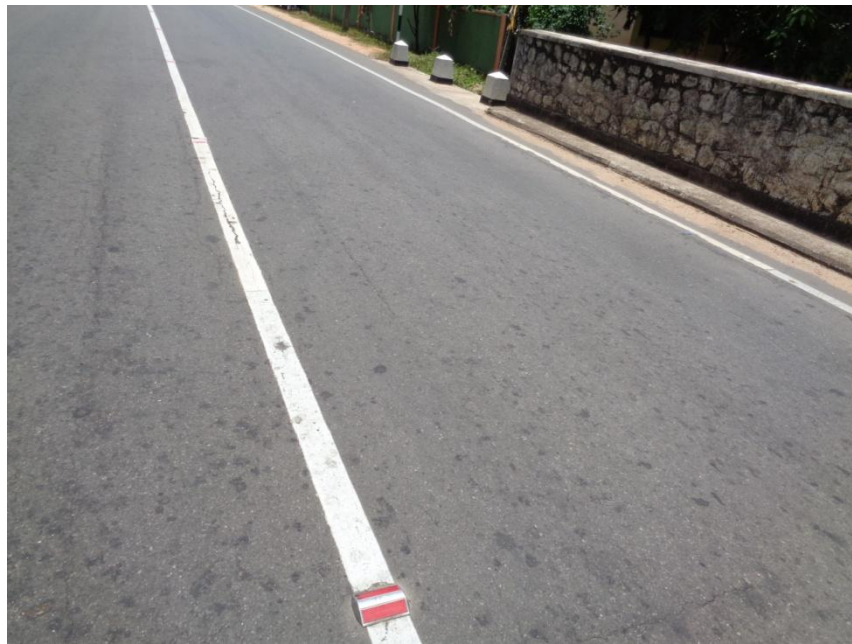
In order to have a proper lateral distribution of live loads among beams, a tie rod in certain intervals is used in local context. Due to a loosening or any malfunction of this tie rod, a relative displacement can be seen between beams. This can be identified from parallel longitudinal cracks at wearing surface as shown in Figure 3-12.

Figure 3-12: Relative vertical displacement between beams due to malfunctioning of diaphragm

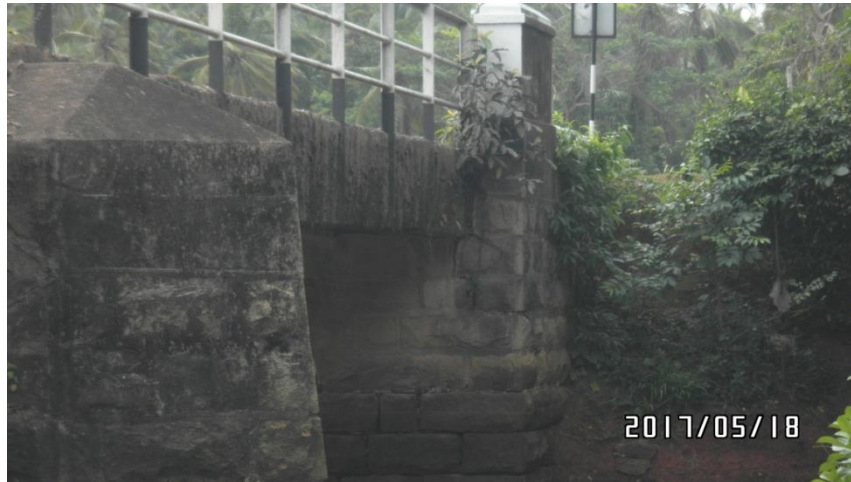
Although it does not feel serious, poor maintenance and ignorance have escalated certain cases with vegetation into an alarming level. Roots start to run through some cracks and voids and a significant pressure is applied to the element as the roots grow up. Edge of the abutment of the bridge shown in Figure 3-13 could completely dislocate in several months unless the roots and trees are removed. Similar scenario is shown in Figure 3-14.

Figure 3-13: Effect of vegetation

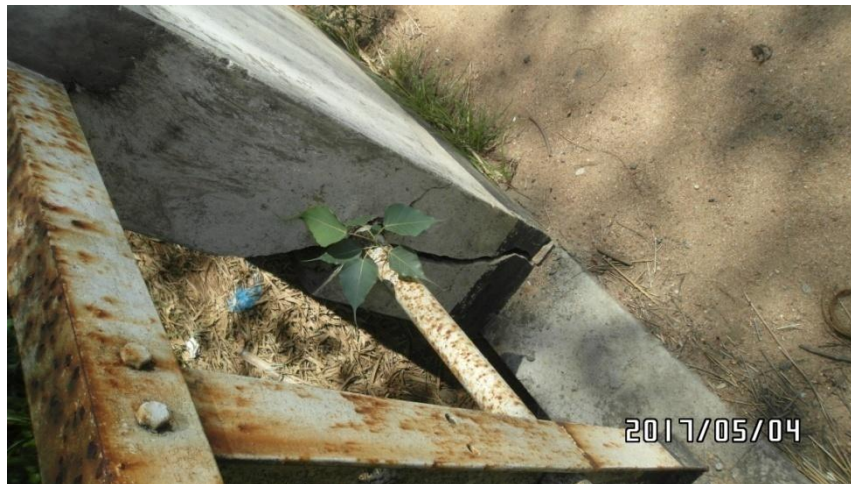
Figure 3-14: Effect of vegetation at an old handrail

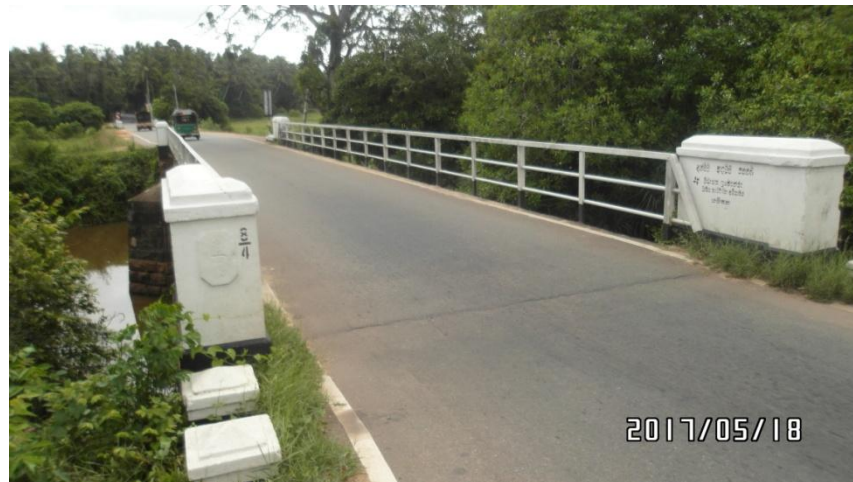
Figure 3-15: Cracking at an expansion joint, which is covered with asphalt

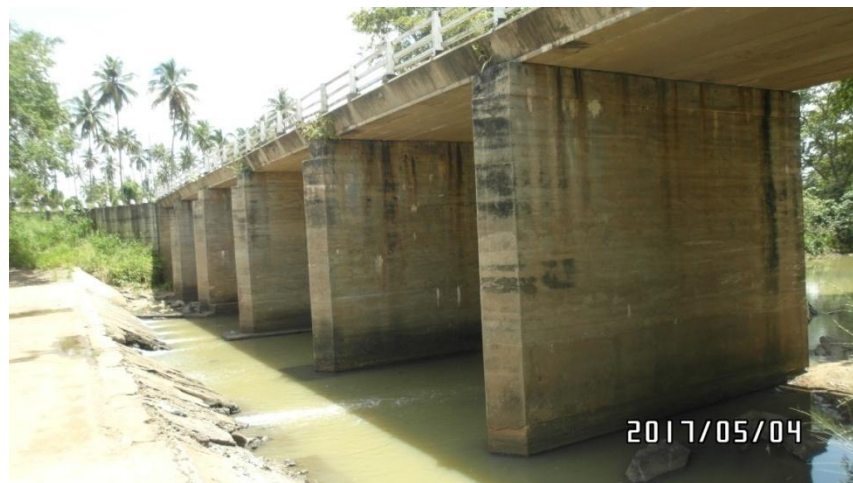
Figure 3-16: Leaking through expansion joints

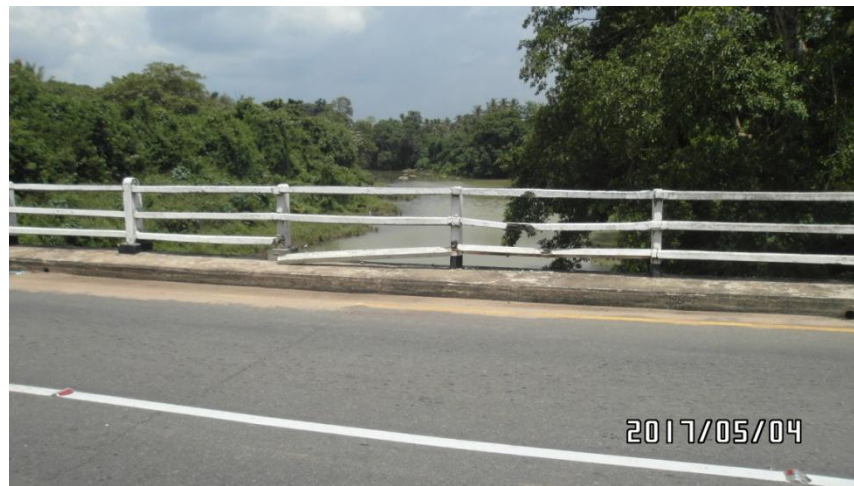
Breakages, dislocation and misplacements can be seen in many bridges. A common scenario in local road bridges with broken railing is shown in Figure 3-17. This is a concern especially for the pedestrians other than the appearance. There is another concern at which falling down broken fragments to the vehicles in overpass bridges.

Figure 3-17: Damaged handrail

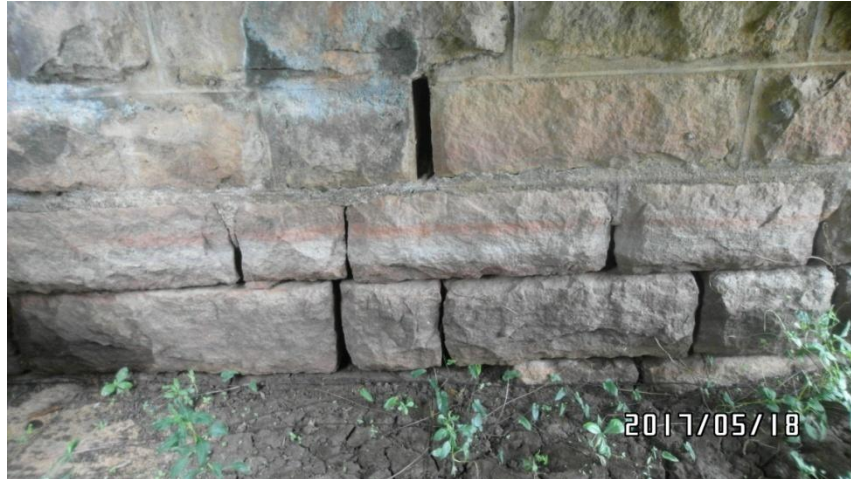
is a good example to elaborate the scenario. This is a concern especially for abutments as soil starts to pass through these gaps. This ends up with settlements at the approaches.

Figure 3-18: Dislocation of mortar at an abutment wall

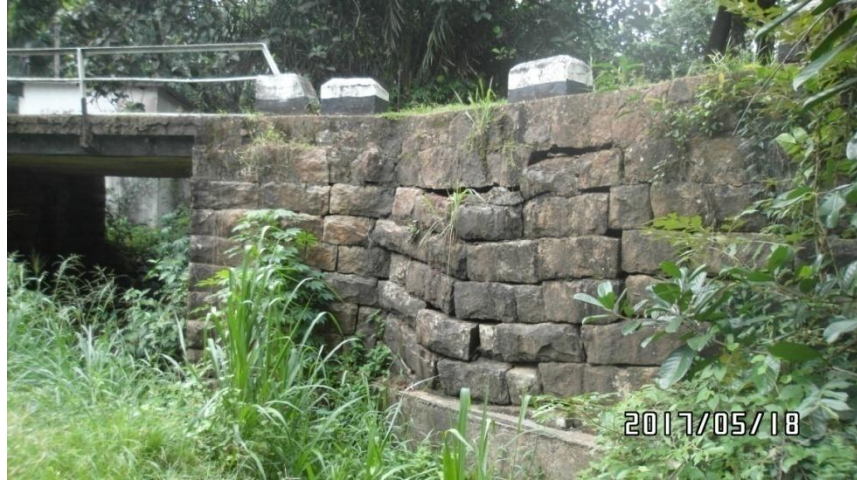
Figure 3-19: Lateral movement of dressed stone wingwall

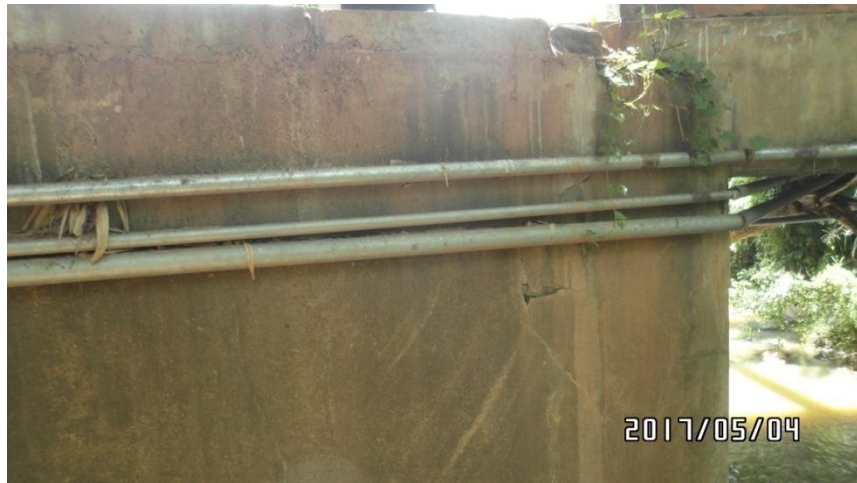
Figure 3-20: Cracking at wingwall due to lateral earth pressure

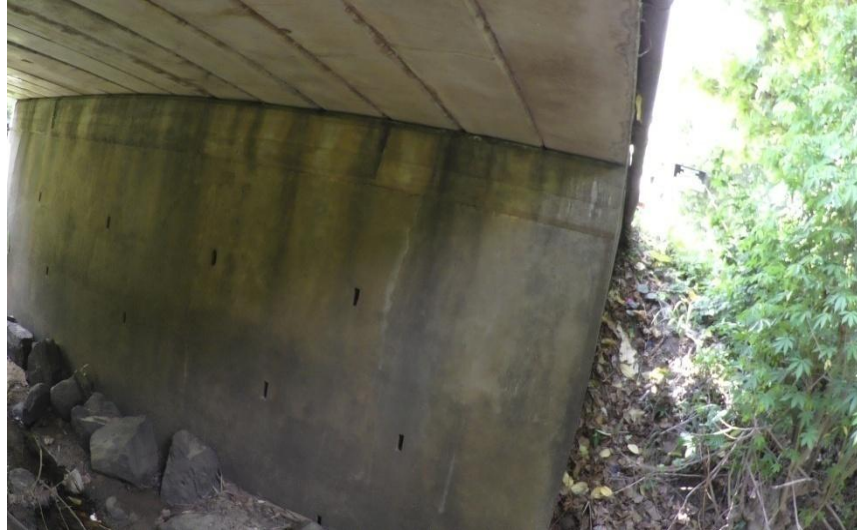
Further, vertical cracks in rubble walls and dressed stone walls due to settlements are also common in local bridges. Figure 3-21 shows a rubble abutment wall with several vertical cracks.

Figure 3-21: Vertical crack at a RRM abutment wall due to settlement

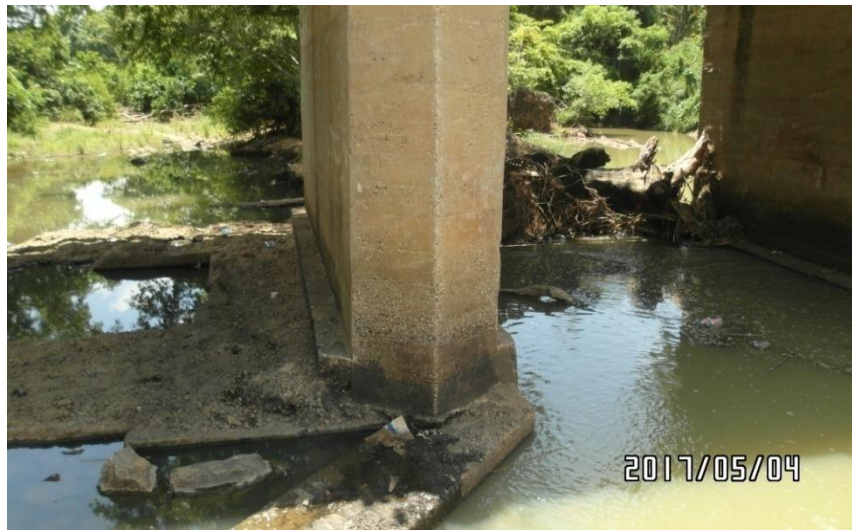
Severe weathering of cover concrete in several areas were observed during field investigations. Momentum of the flowing water caves into the element slowly with the time. Figure 3-22 and figure 3-23 show the effect of weathering in a pier column and an abutment wall. Fortunately there is a protective layer of concrete on the foundation of the pier, which is shown in figure 3-22, and it can be seen that the protective layer of concrete is severely weathered.

Figure 3-22: Weathering of cover concrete in a pier

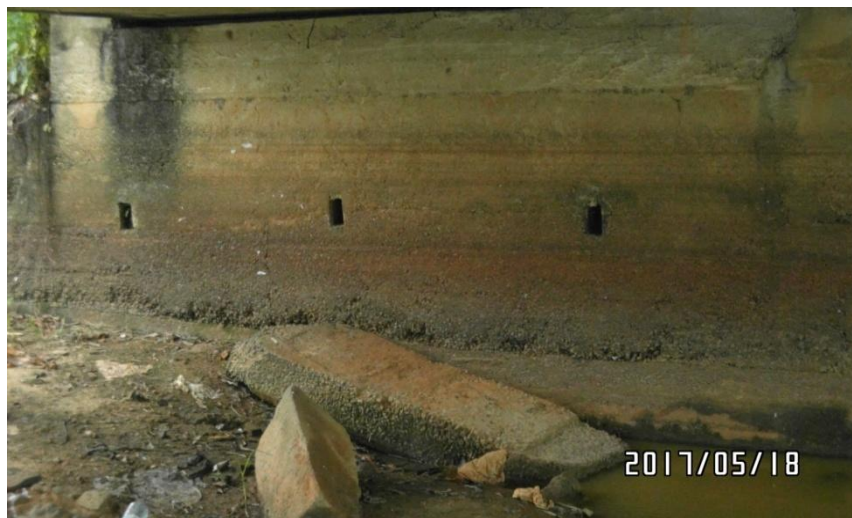
Figure 3-23: Weathering of cover concrete in an abutment wall

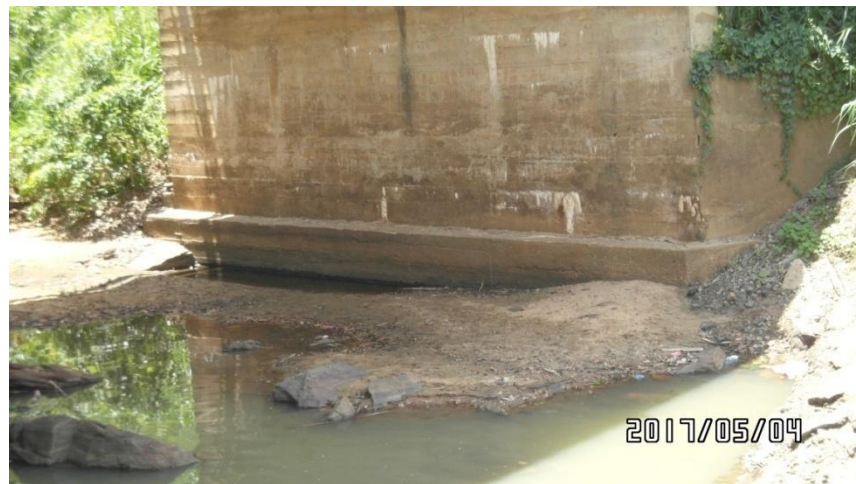
The impacts of scour and river bed erosion were discussed comprehensively under the "literature review" section. Several cases of scour were observed during the field investigation. Figure 3-24 shows a foundation of an abutment, which is critically scoured.

Figure 3-24: Scouring of foundation bed

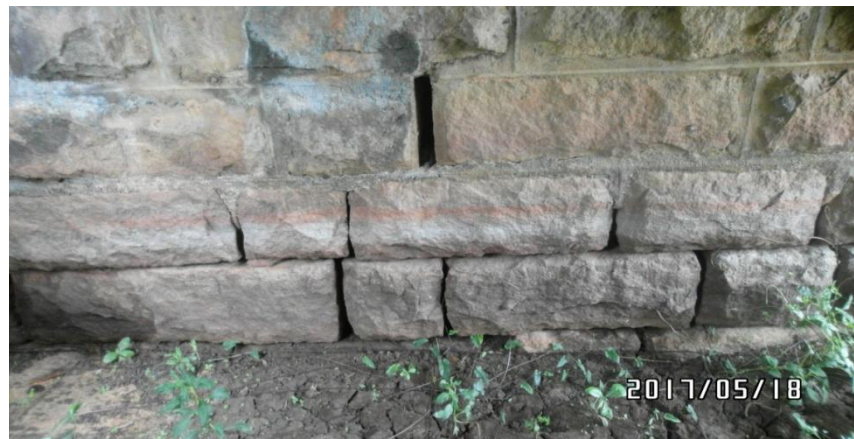
As per the proposed inspection form an Inspector may record 20% of mortar dislocated, which is a sign of extent level of the distress. At the same time based on the description of this distress, the inspector has to choose whether the gaps created by dislocated mortar allow soil to pass through the wall, which is a sign of severity of the same distress.

Figure 3-27: Mortar dislocation of a dressed stone abutment wall

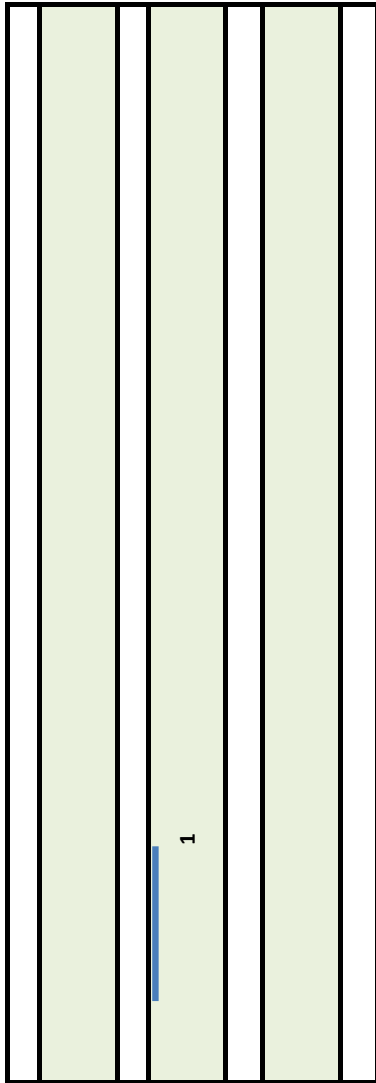
1 - Shear crack

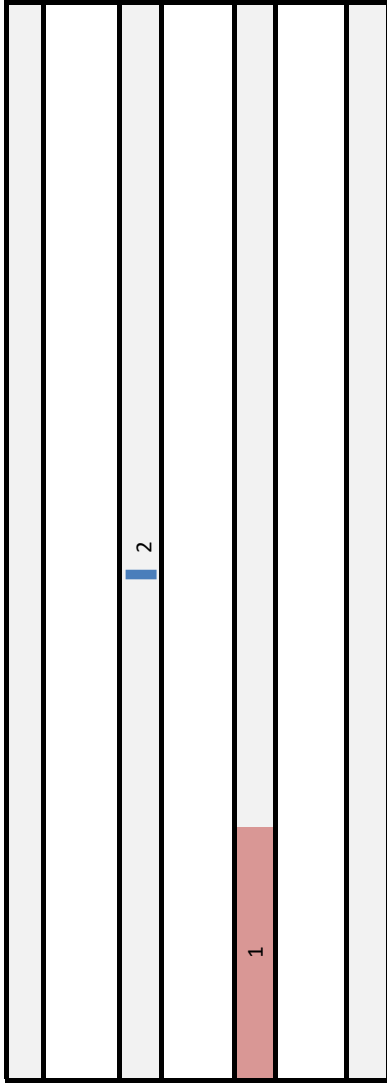
1- spalling - 5000 mmx200 mm

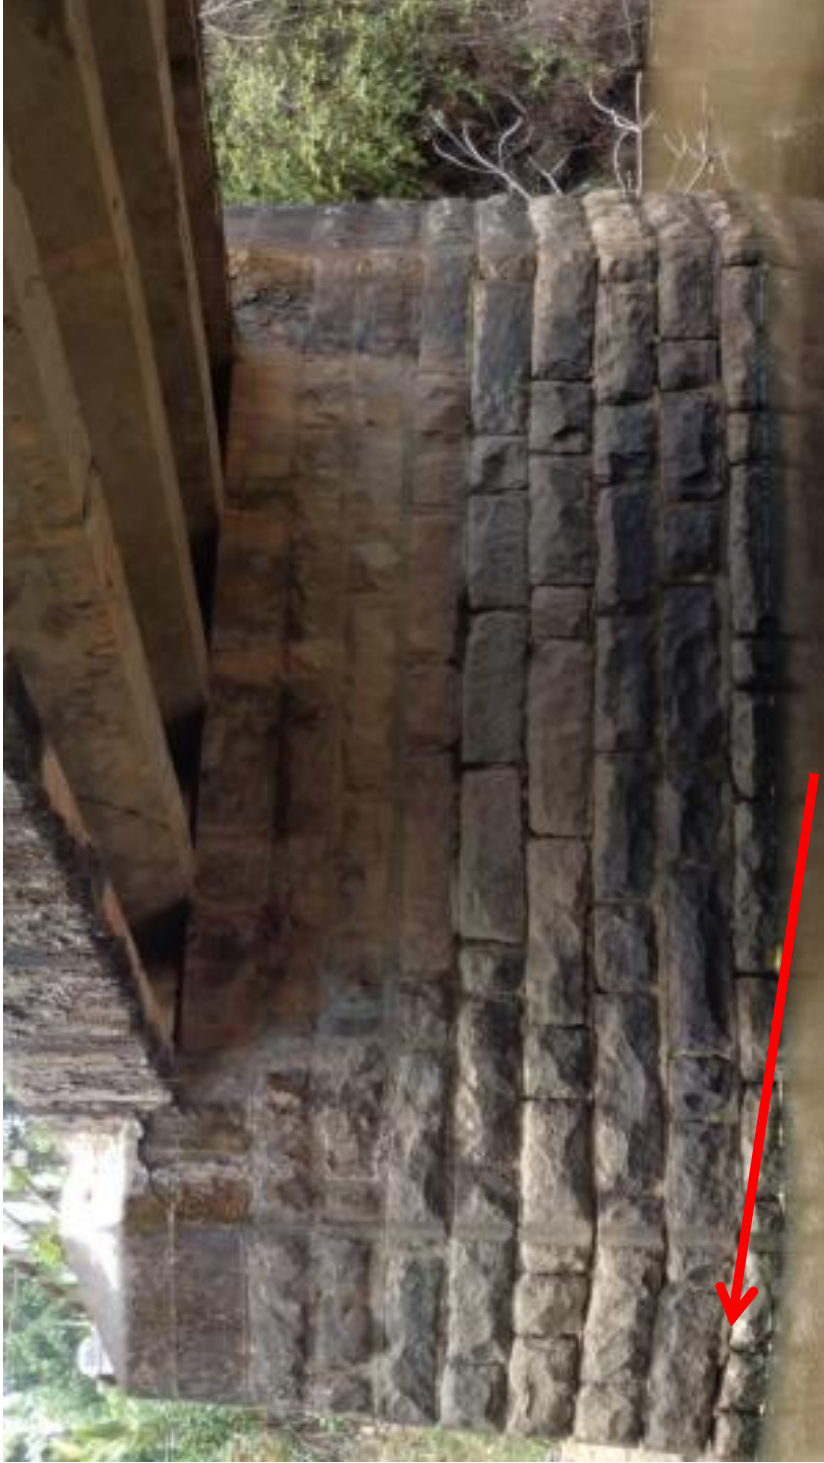
Mortar dislocation due to water pressure at upstream

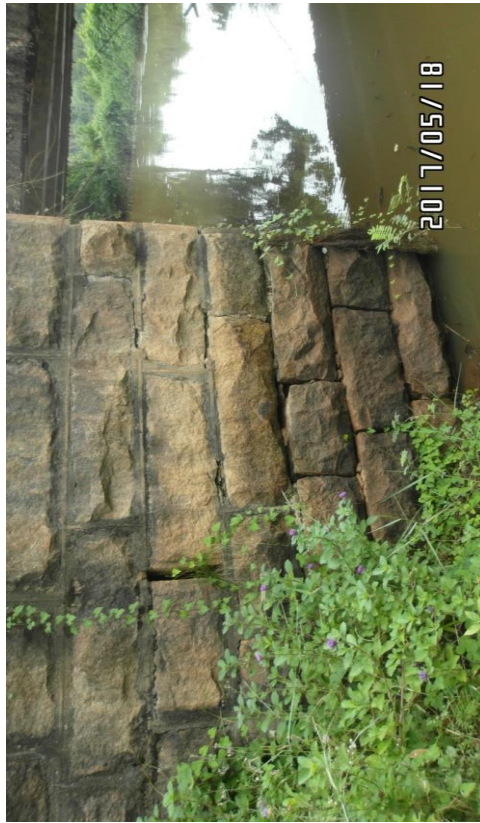
2 - Mortar dislocation due to upstream water pressure

1 - Crack due to lateral earth pressure
