**ENHANCEMENT OF THE STABILITY AT THE SITE  
OF AN ANCIENT LANDSLIDE IN A ROAD CUTTING  
WITH DRAINAGE AND REINFORCEMENT – CASE  
HISTORY AT GINIGATHHENA**

Master of Engineering in Foundation Engineering and Earth Retaining  
Systems

Department of Civil Engineering  
University of Moratuwa  
Sri Lanka

August 2019

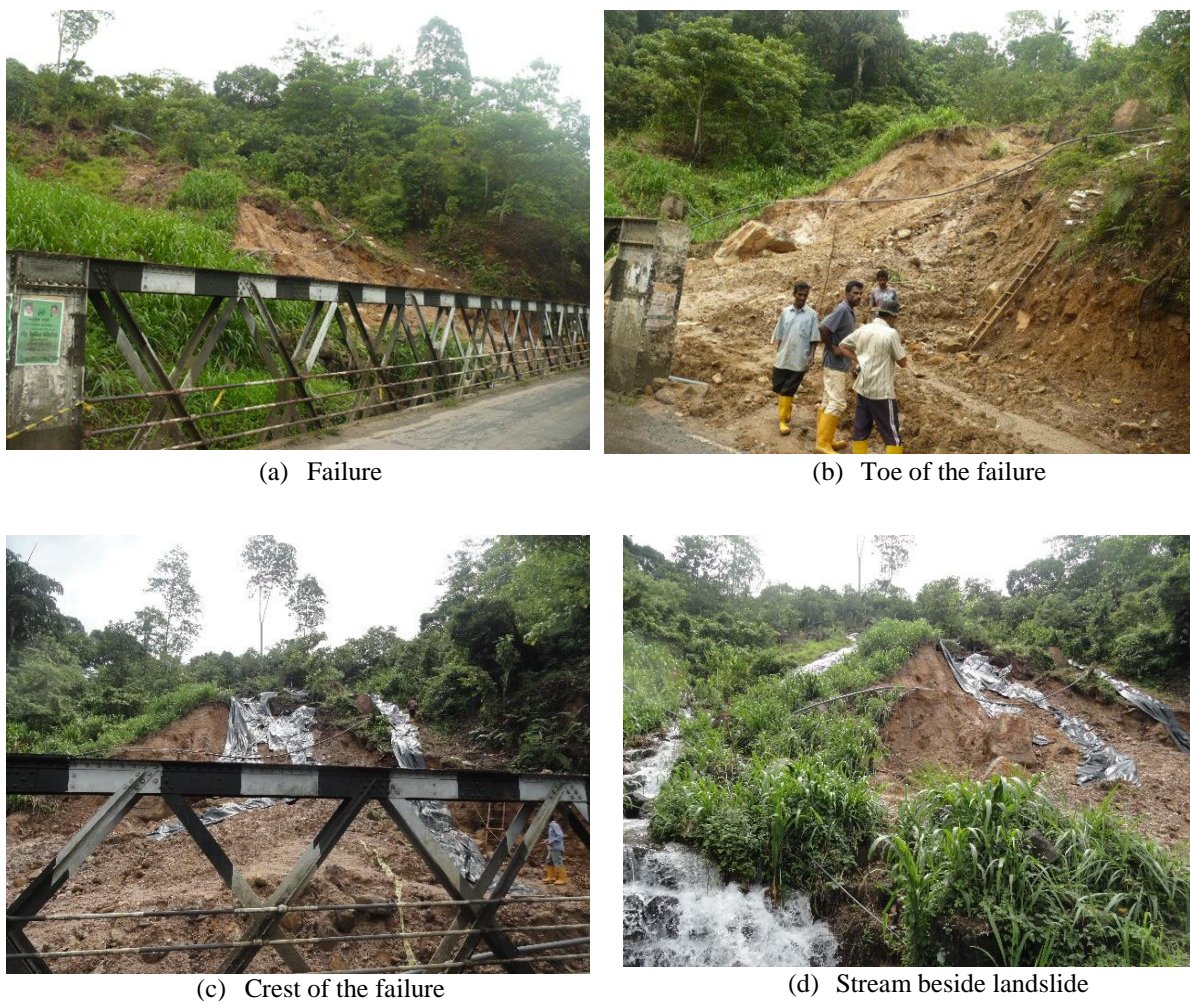
bridge. It was reported that there was no rain at the time of failure, but it has been further activated with continuous heavy rain received few days later into the area. According to information received from the community living in the area and the field evidence, numbers of other cutting failures had occurred within the area during rainy seasons. Geomorphological features at the site indicates that there had been a landslide earlier (Figure 3.3). Several tension cracks have been developed in the middle and head part of the landslide and some boulders were slightly moved towards the road side as shown in Figure 3.4.

Figure 3.2 : Landslide on June 2014 (*National Building Research Organisation, 2014*)

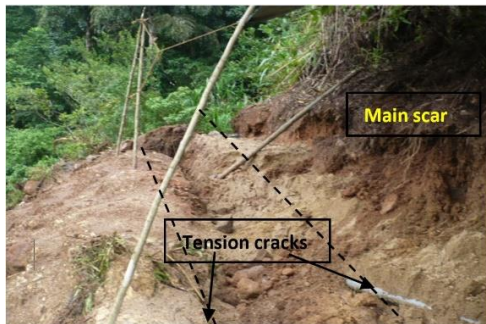
(a) Tension crack

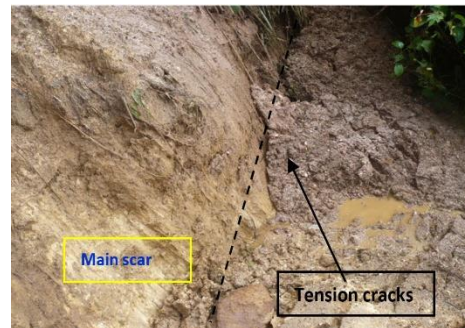
(b) Main scar

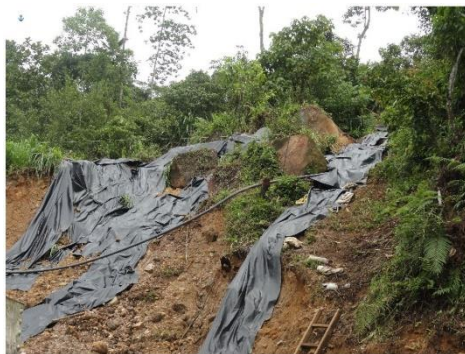
(c) Loose mass

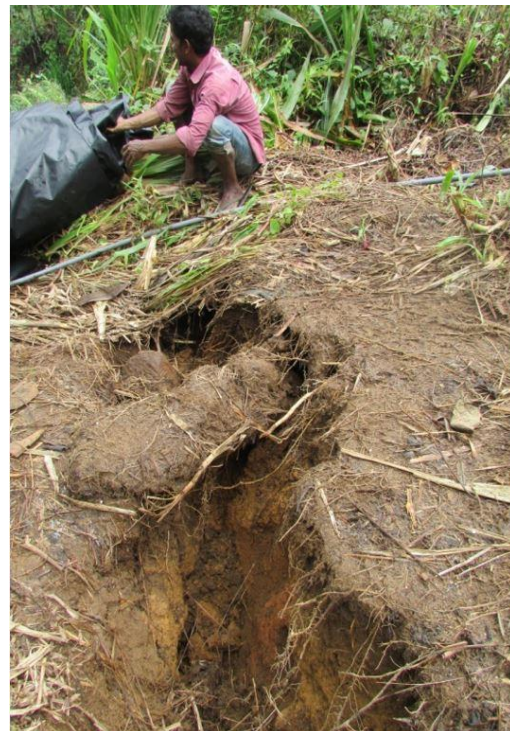
(d) Open tension crack

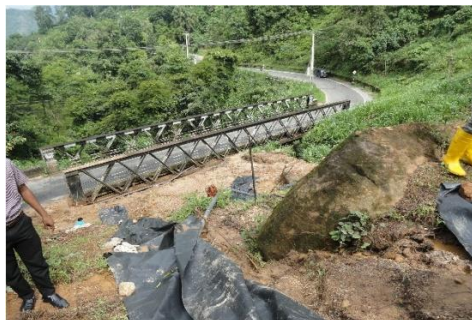
(e) Unstable boulders

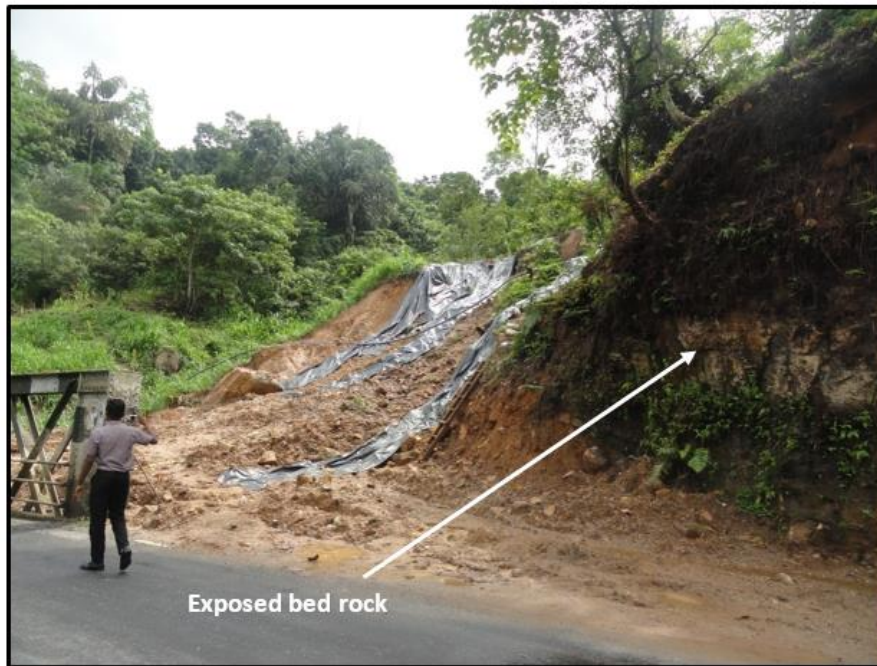
The landslide area is generally underlain by highly crystalline metamorphic rock of Highland complex (HC). The Highland complex rocks (ages 2.0-3.4 Ga) metamorphosed to granulite grade is the centrally located, NE-SW trending belt comprising mainly Charnockitic Gneisses and Granulites, Metasediments, Basic Granulites, Gneisses and Migmatites. The metasediments include Quartzites, Marbles, Pelitic Gneisses and Garnet-Sillimanite-Schist (Khondalites). The rock found at the adjacent hill can be identified as highly fractured Charnockitic gneiss with thick quartzite layers as shown in Figure 3.5.

Figure 3.5 : Exposed bedrock (*National Building Research Organisation, 2014*)

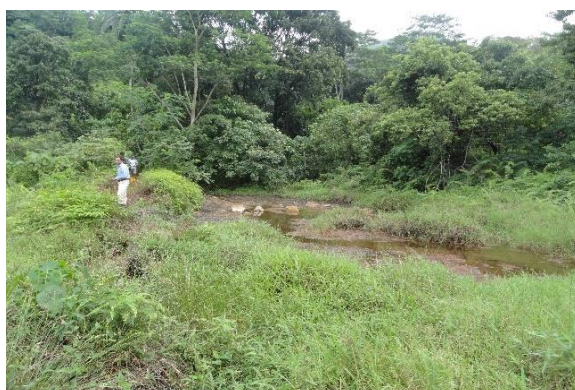
The area under investigation is a sloping land with undulating topography. Immediately above the activated landslide, there is a flat, water logged marshy area which can be identified as a major cause for the high ground water table prevailing in the area (Figure 3.6). Two major streams are flowing into this marshy area from the upper slope and finally come together to flow as one stream through the landslide area (Figure 3.2 & Figure 3.7). Seepages and high yielding springs are observed in the unstable mass, upper slope and even through the fractured bedrock along the road cuttings.

(a) Marshy area
