Identification of Ground Subsidence due to Collapse of Solution Cavities in Marble Rock

Department of Earth Resources Engineering, University of Moratuwa, Sri Lanka

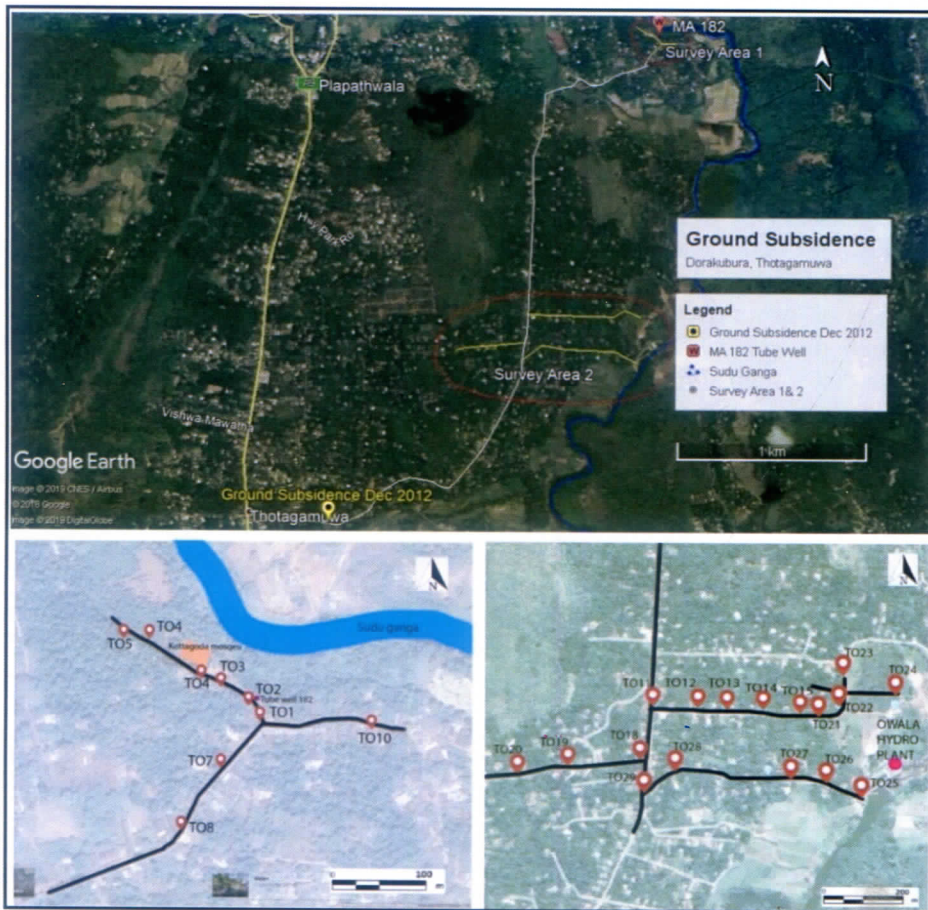
After the heavy rain fall in mid of December 2012, a significant ground subsidence encountered in the areas of Dorakubura, in Matale District [2],[3]. Dorakubara area off Thotagamuwa junction is located on A9 road between Matale and Dambulla. Ground subsidence location and GPR survey lines are shown in Figure 1.

Figure 1: Ground Subsidence at Thotagamuwa, Matale and Survey Area 1 & 2.

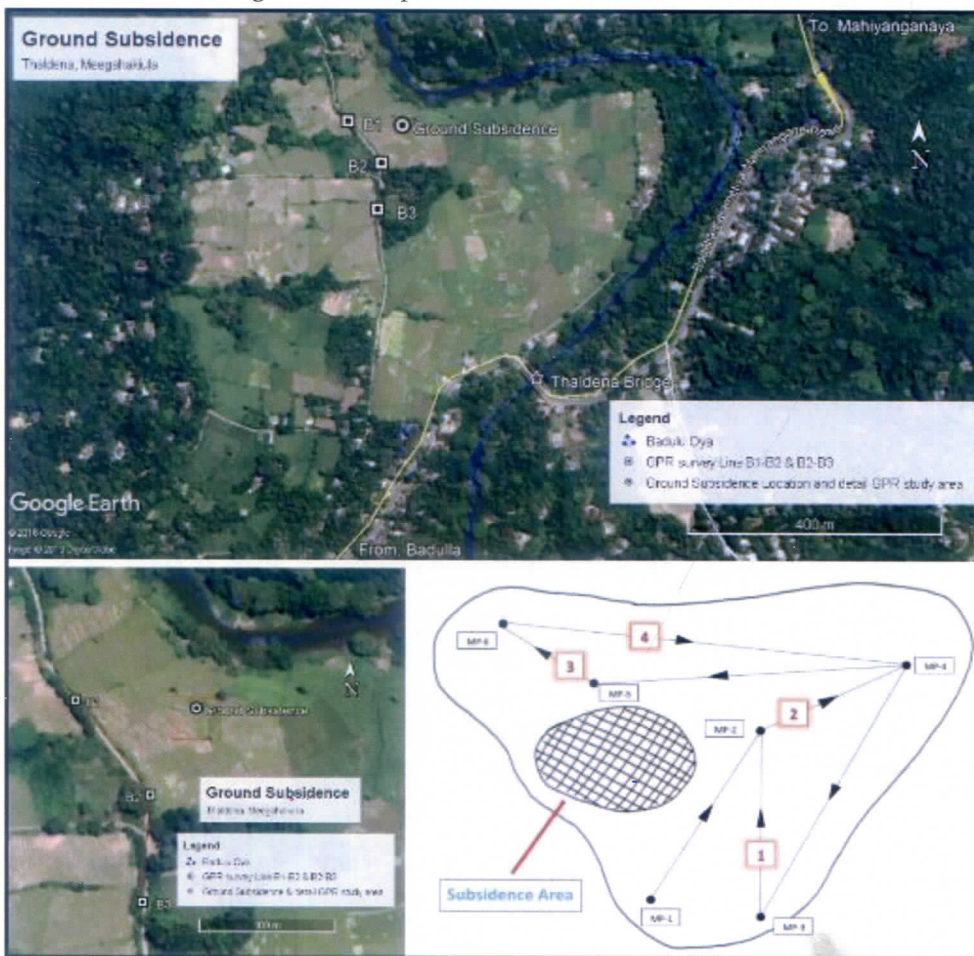
field near by Badulu Oya. The location is to the left side of the Thaldena Bridge on Badulla to Mayanganaya B36 road. The sinkhole and GPR traverses are shown in Figure 2.

Figure 2: Ground Subsidence at Thaldena, Badulla and GPR Survey Areas.

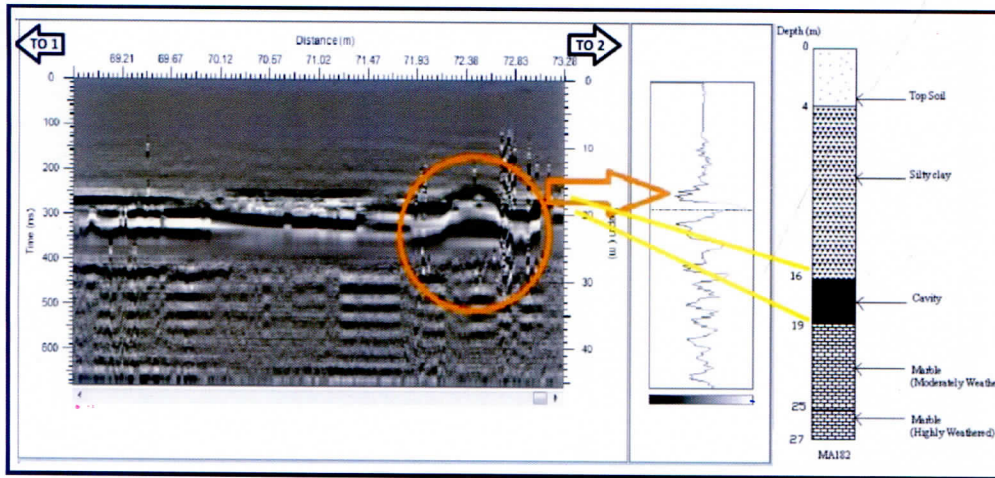
Survey area 1 of Matala GPR line TO1- TO2 GPR profile, radargram and corresponding cross section of the tube well log (MA-182) is shown in Figure 3. Presence of cavity at depth about 15-20m, at the location close to MA-182 on TO1-TO2 survey line was identified in the GPR profile. In the available well log data, cavity is indicated at 16-19m depth. Therefore, the cavity profile created from the GPR survey was compatible with the

available well log data (MA 182) for the above location.

Figure 3: GPR Profile of Survey Line TO1-TO2 and Well-log at Location MA 182.

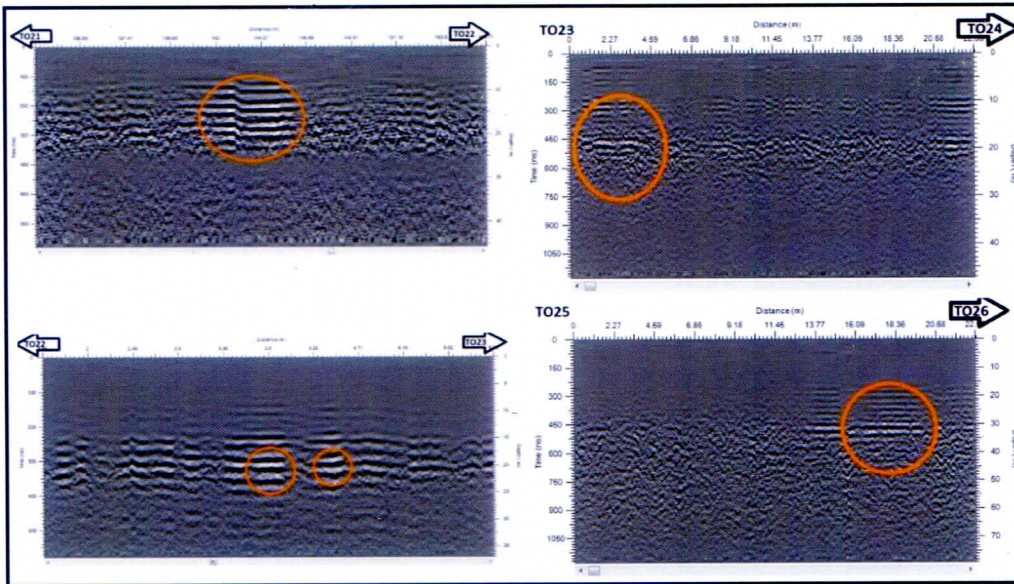
In survey area 2, GPR traverses were conducted perpendicular to the strike (E-W direction) of the marble rock band (Figure 1). GPR profile related to eastern side of the road especially closer to Sudu Ganga, several cavities were identified within the depths from 20-30m (Figure. 4). However, GPR profiles related to western side of the road, which was away from the Sudu Ganga, no cavities were identified (Figure 5).

The results indicated the presence of solution cavities towards the direction of the river in the area. It may be due to the presence of groundwater, and their movements had influenced the formation of cavities in the marble rock.

Figure 4: GPR Profile of Survey Line TO21- 22, TO22-23, TO23-24 and TO25-26.

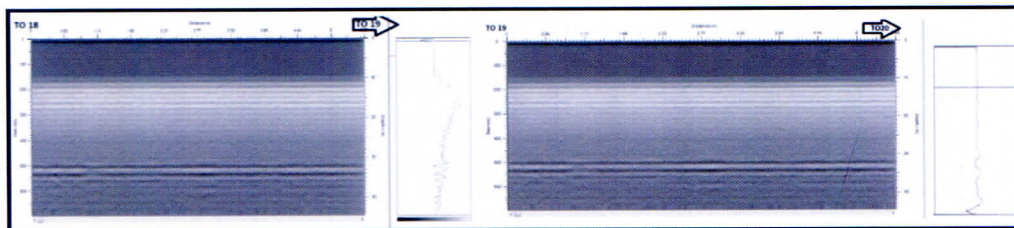
Figure 5: GPR Profile of Survey Line TO18-19 and TO19-TO20.

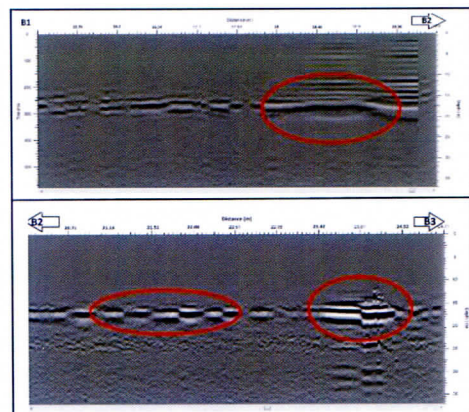
Figure 6: GPR Profile of B1-B2-B3.

GPR profiles of B1-B2 and B2-B4, only a few cavities were identified at about 20 m depth (Figure 6).

The cavities identified in the profiles B1-B2-B3 may be in connection with already collapsed cavity with an underground water path towards Badulu Oya.

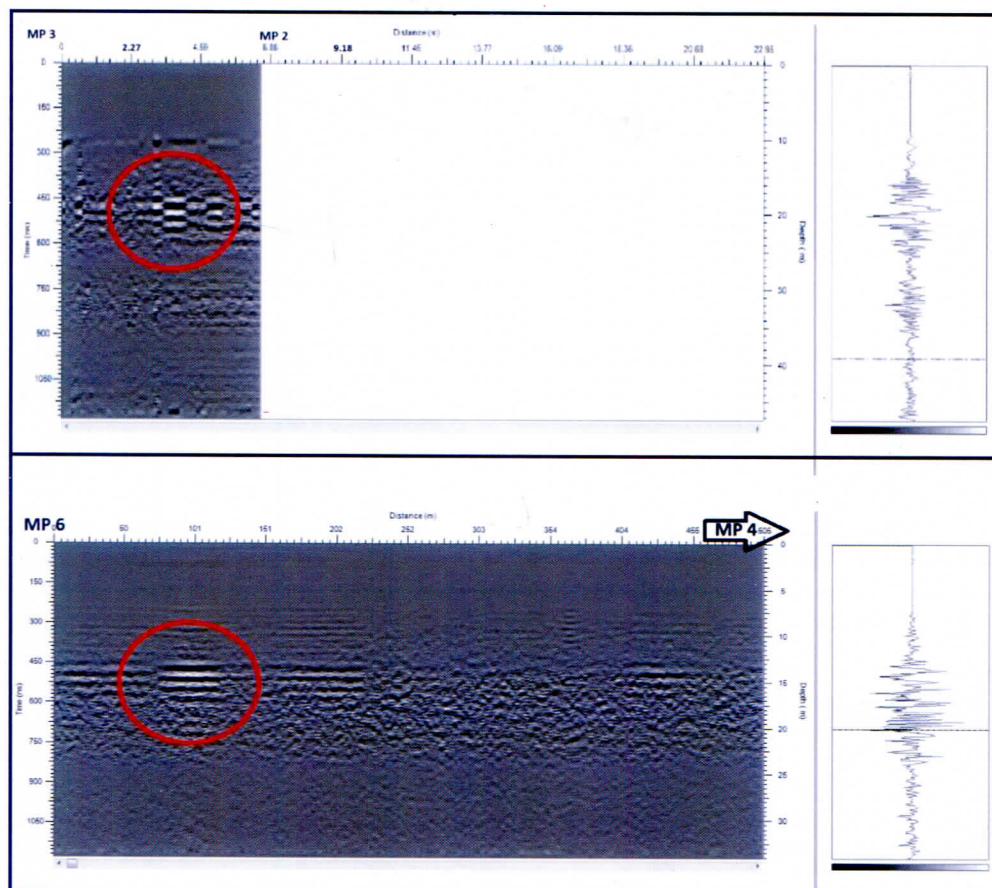
In the GPR profiles MP3-MP2 (approximately N-S) the cavities were identified at about 15-17 m depths from the surface (Figure 7) and MP6-MP4 (approximately E-W) the cavity identified at 18-20 m depths (Figure 7).

Figure 7: GPR Profile of Survey Line MP3-MP4 & MP6-MP4 at Ground Subsidence.
