STRENGTH ASSESSMENT OF STEEL TOWERS

Department of Civil Engineering, University of Moratuwa

Abstract: In the recent past, considerable number of tower failures happened in telecommunication sector and power transmission sector in Sri Lanka. However, no lessons were learnt and there is still a vacuum in strength assessment of towers. The objectives of this research are conducting data survey on failed towers in Sri Lanka and identifying causes, analysing failed electric transmission towers using finite element analysis and finding the causes for the failures and developing simple methods to check tower capacity based on available simplified models. Four telecommunication towers and a transmission tower were considered to identify the failure reasons. Structural analysis of a transmission tower was done using a finite element analysis package, SAP2000. A manual method to analyse 3D trusses was developed by combining unit load method and tension coefficient method. To ensure the validity of proposed analysis methods, a simple tower model was erected, structural analysis was done using both SAP 2000 package and manual method, failure loads were predicted using SAP 2000 package, loadi

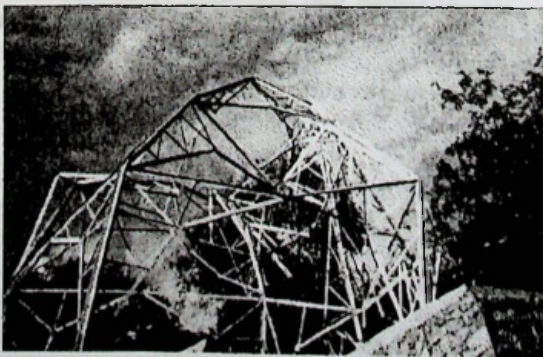
Fig 1 Beliaththa 70m antenna tower collapse

Description of antenna tower	Design as	Possible reasons for failure	Failure pattern info:
70m high at Beliatta (Mobitel) See Fig 1	Four legged steel lattice structure, designed for 10sqm antenna area	Improper erection procedures adopted. Erected without providing any of inner plan bracings. The use of temporary guy ropes in unsymmetrical manner.	Collapsed at second panel
70m high at Mihintale (Sri Lanka Telecom) See Fig 2	Four legged steel lattice structure, designed for 10sqm antenna area.	Due to tornado situation	Collapsed at second panel Twisting of the structure in its own axis during the collapse
70m high at Gampaha (Mobitel) See Fig 3	Four legged steel lattice structure, designed for 10sqm antenna area.	Overloading of antennas Affecting fault of design Fabrication detailing error	Collapsed at second panel
70m high at Horowpatana (Sri Lanka Telecom) See Fig 4	Four legged steel lattice structure, designed for 10sqm antenna area.	Due to direct hit by a Tornado Overloading due to large cable tray	Twisting around its own axis

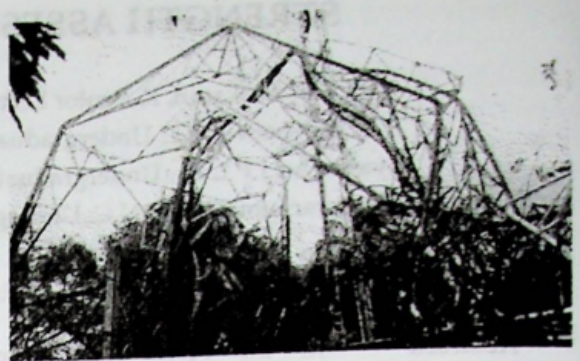
Fig 2 Mihinthale 70m antenna tower collapse

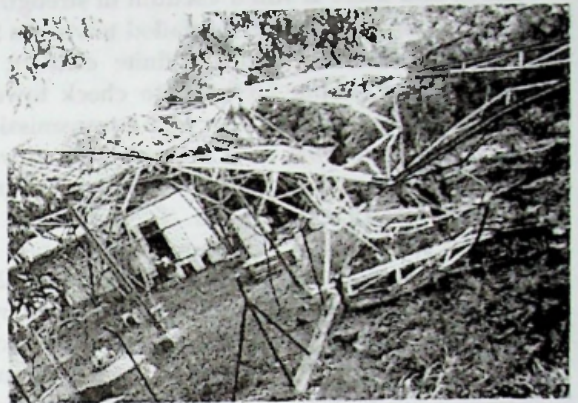
Fig 3 Gampaha 70m antenna tower collapse

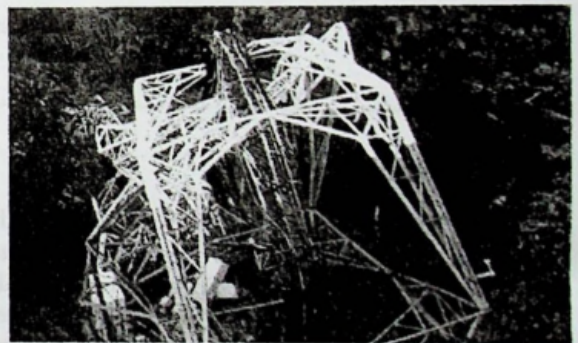
Fig 4 Horowpathana 70m antenna tower collapse

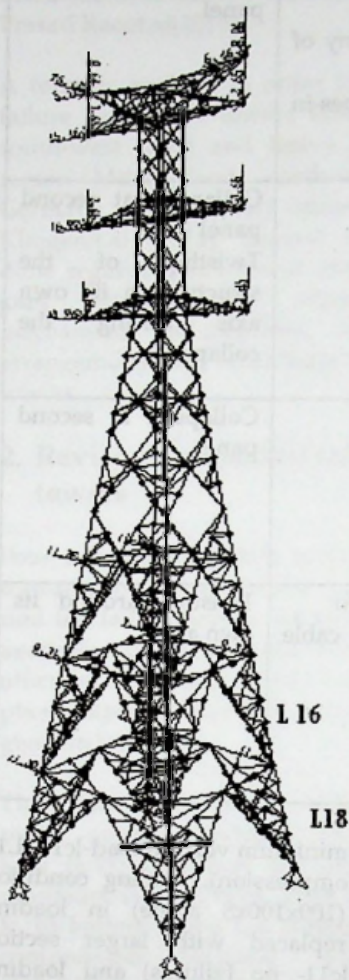
The transmission tower failed while testing under normal condition- maximum vertical load (lc11) condition and normal condition- minimum vertical load (lc10) condition. Under lc 10 bottom panel leg member failed due to compression buckling. Failed members (100x100x8) were replaced with larger members (100x100x10) and then loaded for lc10. No failures occurred so loading proceeded to lc11. Under lc11 second panel leg member failed due to compression buckling. Reason for the failure is due to improper design of tower.

condition with minimum vertical load-lc10- L18 failed under compression), loading condition 11(failed leg (100x100x8 angle) in loading condition is replaced with larger section (100x100x10) -lc11- no failures) and loading condition 12(normal condition with maximum vertical load- lc12 - L16 failed under compression.) were selected to perform analysis with SAP 2000 and verify.

100x100x10 angle it is 564 kN (depends on member lengths). From analysis axial compression forces of 352 kN for lc2, 462.8 kN for lc10 and lc11 and 486.5 kN for lc12 were obtained for bottom panel critical leg.

Fig 5 Transmission tower geometry and failed legs

For second panel leg, 100x100x8 angle compression capacity is 416 kN. For second panel critical leg, compression force of 317.5 kN for lc2, 405.6 kN for lc10 and lc11 and 421 kN for lc12. Analysis results exhibited significant bending moment in all above cases (for both panel legs). So buckling is possible in critical case.

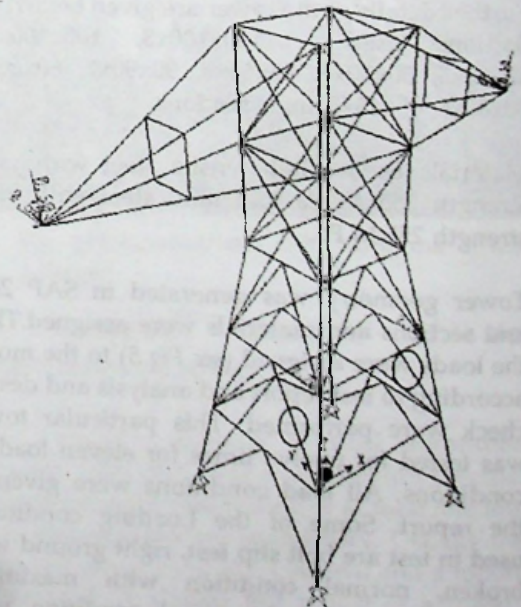
Fig 7 Generated simple model and proposed loading and member failures

Suitable nodes were selected to be loaded and failure loads and failing members were identified (see Fig 7). Two nodes in legs were selected to apply horizontal force and two arm nodes were selected to apply a nominal quantity of both horizontal and vertical loads. From analysis and design check using SAP 2000 a force of 4.1 kN on leg nodes caused failure in second panel compression bracing, as shown in figure 7.

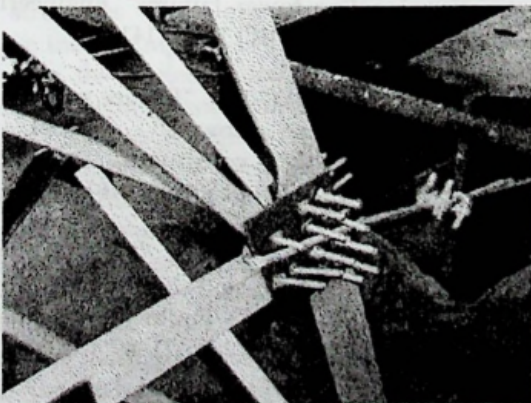
Tests resulted in completely different failures. When load on leg nodes are increased to 3.5 kN second panel horizontal member got bent (see Fig 10) and third panel leg member got bent (see Fig 9). Loading procedure continued and second panel tension member bolts failed at the same load i.e. 3.5 kN.

Fig 9 Bent leg of third panel

Further analysis was done and it was found that yielding of bolts caused above bending failures. Due to bolt yielding, tension members were not effective. To stimulate this in SAP 2000, same model without those tension

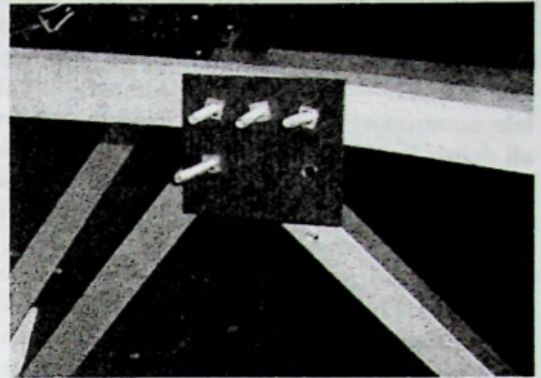
Fig 10 Bent horizontal member and bolt failure

Bolt shear capacity was tested with Hounsfield tensometer by pulling two steel plates fixed together by a single bolt. The failure occurred under a load of 3.6kN. This value was checked with the tension force induced in that bolt under failure load. Then whole model was analysed under actual failure load that is 3.5kN. A tension force of 3.28 kN was obtained in the failed connection. As the difference is not significant the cause was ensured.
