Instrumentation and Monitoring of Mahawewa Landslide off Walapane

Idirimanna IAND, Perera KAC, Bandara KMT, Kumara WGBT, Indrathilake HML, Premasiri HMR, Weerawarnakula SW and *Abeyasinghe AMKB
Department of Earth Resources Engineering, University of Moratuwa
*Corresponding author; e-mail: amkb@earth.mrt.ac.lk

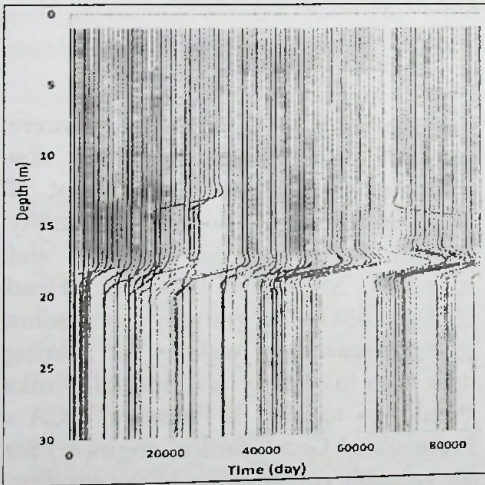
Figure 2: Strain Gauge 02 Graph (24/07/2010 to 10/01/2011)

First 6 months- Mainly two slip surfaces were identified at 13 m and 18 m depth bellow the location of SG2 (Fig 2). The slip surface at 13 m depth also can be detected at the 11 m depth bellow the SG1. This has a slow movement with the rain. The effect is varying up to 1m above the slip surface and varies with the rain fall.

Slip surface at 18 m depth bellow the SG2 has a rapid movement in whole time period. It has affection of 1 m above the slip surface and 2 m bellow the slip surface. The effect changes with the rain.

Second 6 months- New two slip surfaces are formed in shallow area with the depth of 4m and 10m bellow the SG2.

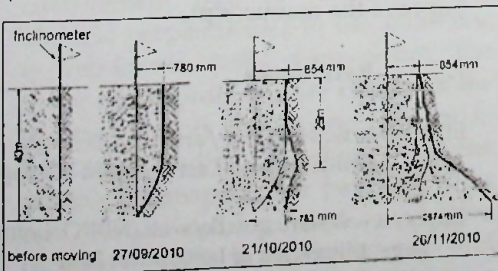
Figure 3: Results of Inclinator

At the end point of the Inclinator there is a considerable horizontal movement even below that end point of 40m depth (Fig 3). A slip surface has been identified at 26m depth below that location.

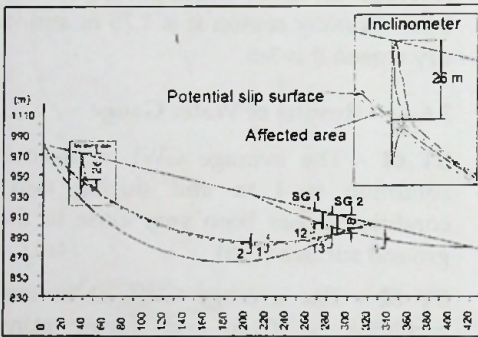
Figure 4: Potential Slip Surfaces Occured (24/07/2010 to 10/01/2011)

Mainly 2 slip surfaces could be identified by first 6 month data analysis of Strain Gauges and Inclinometer (Fig4). In next 6 months, newly formed 2 slip surfaces also could be defined (Fig5).

It is better to insert horizontal drains up to the area of abandoned lake and reduce the GWL even below the main slip surface occurring 18 m depth below the SG2. Furthermore, to increase the feasibility of the project it can be introduced an agricultural water project from the removal water to the Kumbalgamuwa and Walapane community. In here, to distribute high quality water has to be introduced deep well system to prevent middle subsurface contaminated water entering. Inserting of proper surface drainage system is also essential. It can be done by having proper maintained ditches and diversion drain system.
