ANALYSIS OF CORROSION OF AIRCRAFT FLUID PRESSURE LINES USING EDDY CURRENT

Department of Materials Science and Engineering

University of Moratuwa Sri Lanka

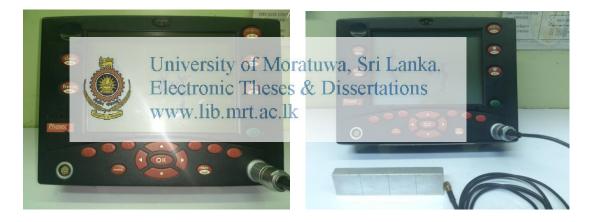
Figure 3.2: "Phasec 2D" eddy current testing machine

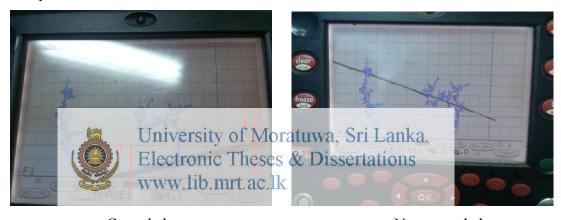
Corroded area Non corroded area

Figure 4.3: Eddy current signal of sample No.3 for Corroded and non-corroded areas

The respective corrosion signal was received over a specific axial length of the sample. It was recorded as the signal appeared from corrosion starting position and end position, from 1 to 2. The broadest signal was given by this sample and the signal was slightly different from the first two samples. On analysis of microstructure, it was found that the corrosion formed on sample No.3 is more deep, having more area of spread. The lengths from 1 to 2 were different for each sample.

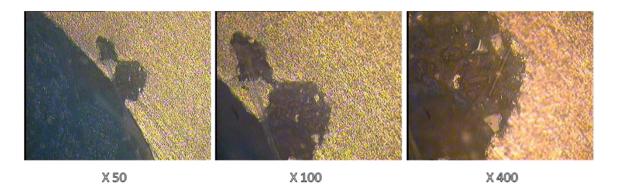
Figure 4.4: Microstructure of corroded area of Sample No.1

These images were received on analysis of sample No.1 and found that the metal tube has a localized corrosion, corrosion pit. The corrosion pit has been started from the inner surface and has been developed into the metal.

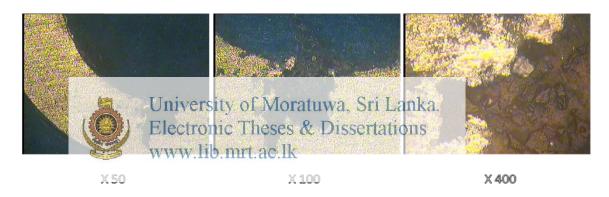
Figure 4.5: Microstructure of corroded area of Sample No.2

The depth of corrosion pit formed on sample No.2 is more than that of Sample No.1 as it was appeared in the eddy current signal.
