ANALYSIS OF FAST ATTACK CRAFT RUDDER FAILURE

Department of Materials Science and Engineering

Dissertation submitted in partial fulfillment of the requirements for the
degree Master of Science in Material Science

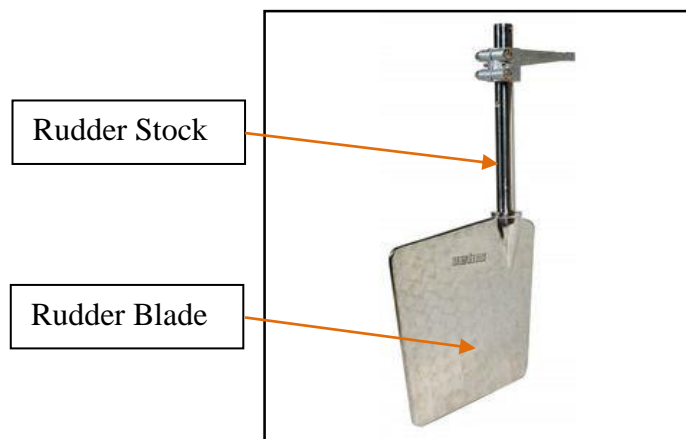
Figure 1.2 : Arrangement of a rudder

Rudders of these craft were made of stainless steel material and arrangement of a rudder is shown in figure 1.2.

However, during the last few years, it was observed that frequent rudder failures of these craft and most of failures occurred from the place where rudder blade connected to its stock.

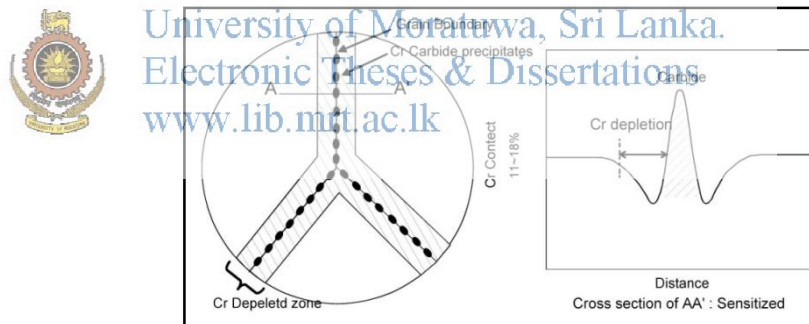
Figure 2.6 : Carbide precipitation and chromium depletion zones [20]

Figure 2.6 shows that the local chromium depletion is such that the chromium level can become low enough that it is not even enough to be stainless and certainly will have much low corrosion resistance than the surrounding area [11]. Carbide precipitation could be controlled by following means [16].

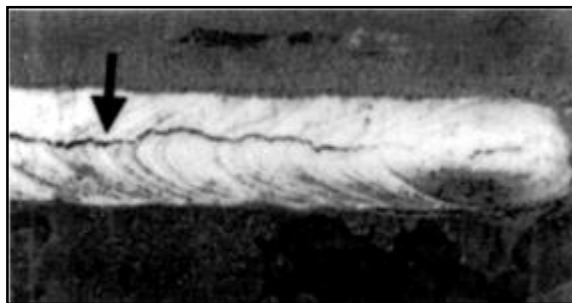
Figure 2.7 : Hot Cracking [24]

Hot cracking is caused by low melting materials such as metallic compounds of sulfur and phosphorous which tends to penetrate grain boundaries. When these compounds are present in the weld or heat affected zone, they will penetrate grain boundaries and cracks will appear as weld cools and shrinkage stresses developed. Hot cracking increases remarkably for phosphorus and sulfur contents in excess of 0.015% and 0.010% respectively [21]. Hot cracking can be prevented by adjusting the composition of the base materials and filler materials to obtain a microstructure with a small amount of ferrite in the austenite matrix. The ferrite provides ferrite-austenite grain boundaries which are able to control the sulfur and phosphorous compounds so they do not permit hot cracking. It is essential to use filler metal that can create 5% to 10% ferrite in the welded microstructure, which is required to prevent solidification cracking [22]. The ferrite content at the weld metal and the heat affected zone should be in the range of 25% - 75% to give optimum mechanical properties and corrosion resistance[23]. Figure 2.7 shows a hot crack at the weld.

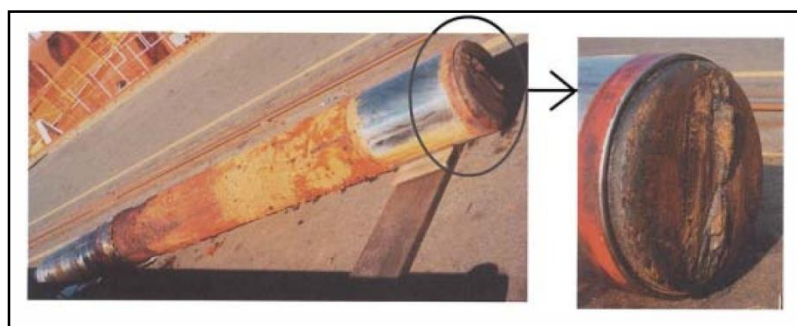
Figure 2.11: Failed rudderstock of Tanker ship [35]

Underwater inspection in dry dock revealed that the rudderstock was found broken, having sheared off where the rudder is secured to the rudderstock. After dismantling, the sheared surface at the break of the rudderstock indicated a typical fatigue failure. A picture of relevant broken rudderstock is shown in figure 2.11.

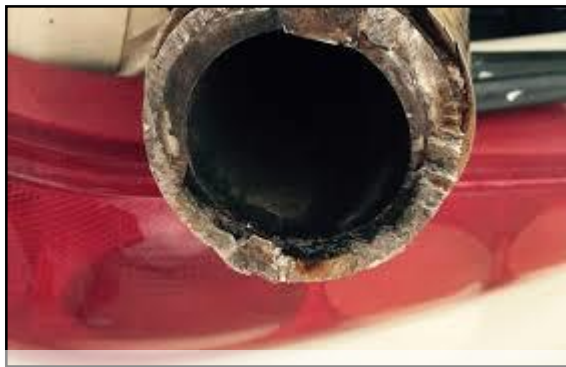
While the sailing boat at the Rolex Middle Sea Race, experienced loss of boat control. Investigation revealed that broken of rudder from its rudderstock. The failure on the rudderstock happened at a welded joint inside the blade and relevant picture is shown in figure 2.12.

Figure 2.12: Failed rudderstock of lightwave 485 sailing boat [36]

Rudder failure of lightwave 485 sailing boat during Rolex Middle Sea Race in the year 2015 [36].

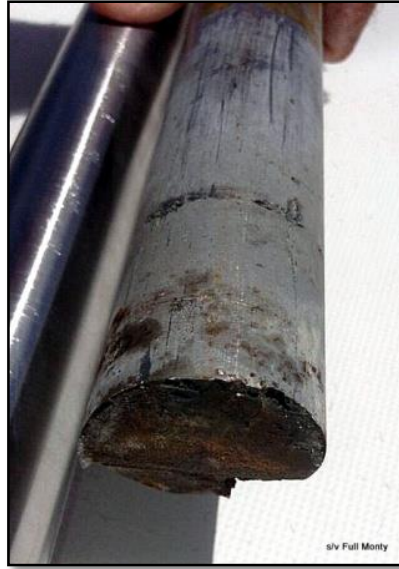
While a Catamaran hull sailing boat sailing near Tonga Island, observed poor maneuverability of the boat and observe starboard rudder was not visible. Underwater inspection revealed that rudder broken from its rudderstock and break in the rudderstock was due to crevice corrosion. Relevant picture of the failed rudderstock is shown in figure 2.13.

Figure 2.13 : Failed rudderstock of Catamaran hull sailing boat [37]

Lost of starboard rudder of a Catamaran hull sailing boat near Tonga Island in the year 2014 [37].

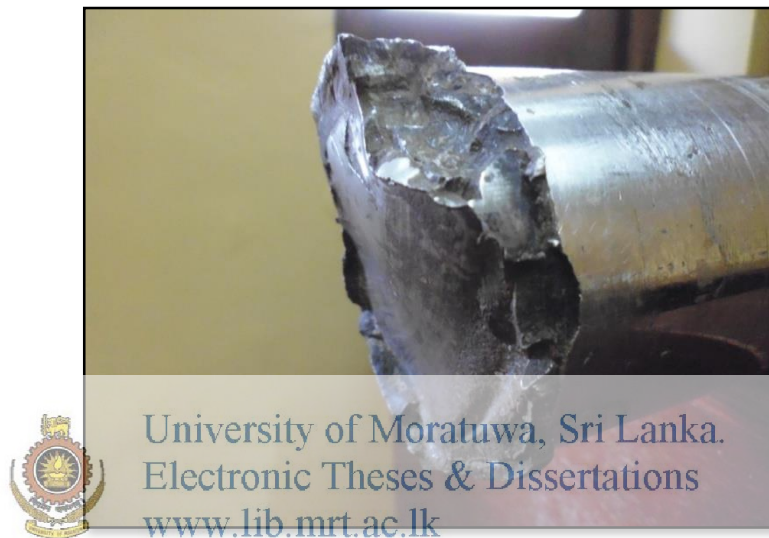
Figure 3.1 : Failed rudder stock

Examination of failed rudder was performed based on available recently failed rudder stock shown at figure 3.1.

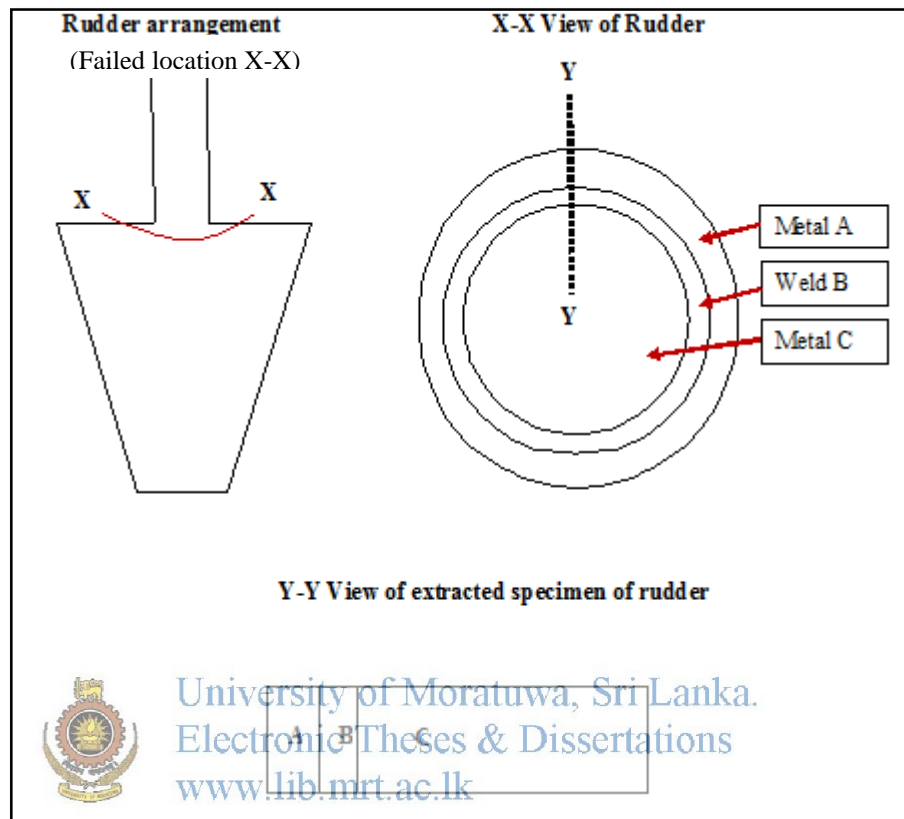
Figure 3.2 : Specimen extracted sequence from failed rudder

An optical microscope available at the University of Moratuwa was used for the observation of the metallographic microstructure of materials used for fabrication of failed rudder and the weld. Specimen was extracted from the failed rudder stock and extracted sequence for preparing the specimen from the failed rudder is shown in

figure 3.2 and following processes were carried out to prepare the specimen. Further, optical microscopic inspection was carried out to examine materials of all sections of the specimen.

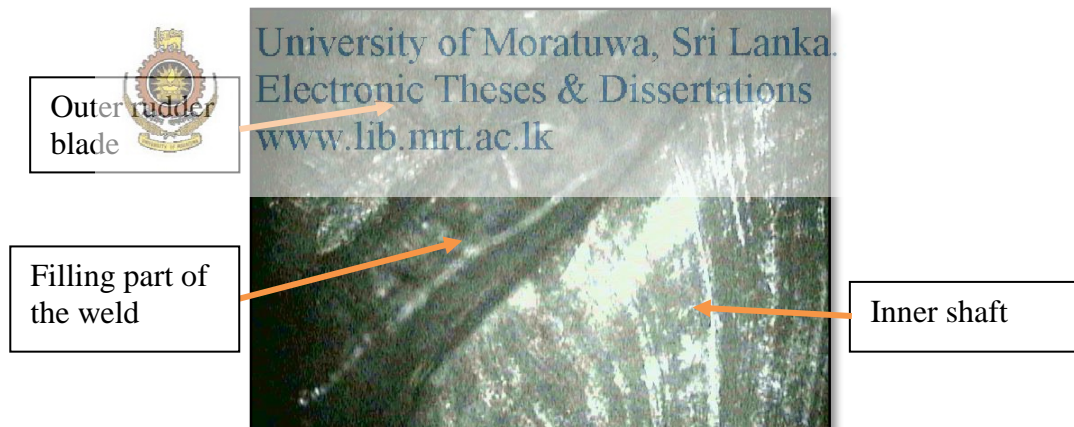
Figure 4.3 : Welding joint of inner shaft to outer rudder blade portion

It was also observed that filling part of the weld joining inner shaft (rudder stock) to outer rudder blade portion looks completely different at the fracture surface and same is shown at figure 4.3.

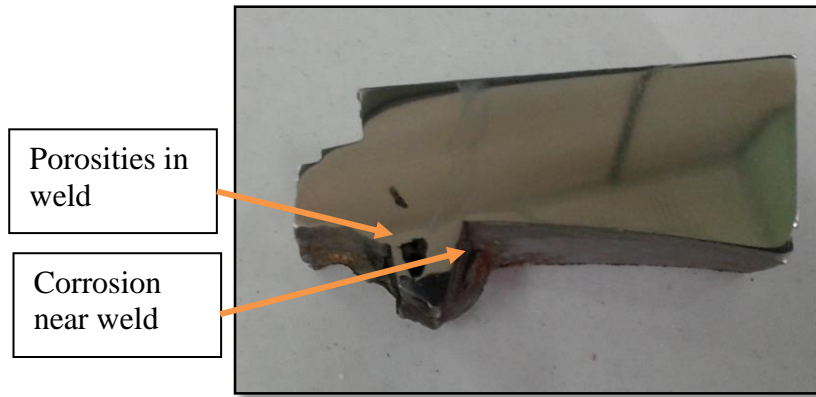
Figure 4.4 : Defects on failed rudder specimen

It was observed that there were number of defects in the weld such as considerable porosities and corrossions marks beside the weld. A specimen prepared from failed rudder stock shown at figure 4.4 revealed those defects.

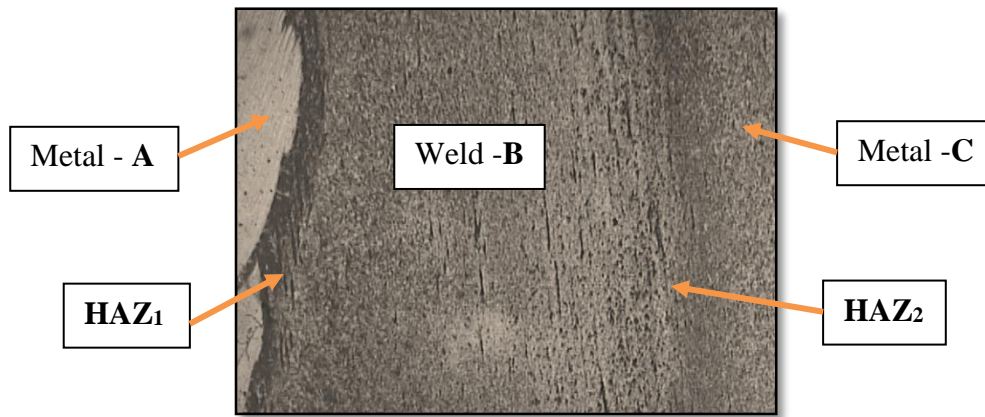
Figure 4.6 : Microstructure of all section of specimen -50X

Microstructure of the specimen covering all three sections indicated at figure 4.5 is shown at figure 4.6.

Preparation of the specimen for micro level inspection was carried out initially using ferric chloride etchant. However, it was observed that metal A (portion of rudder blade) does not clearly visible with ferric chloride etchant. Then specimen was etched with Carpenter etchant which is suitable for austenitic stainless steel and the result was found to be satisfactory. Since, austenitic stainless steel has a strong anti-corrosive layer with the presence of high chromium and Nickel amount, it is harder to etch.

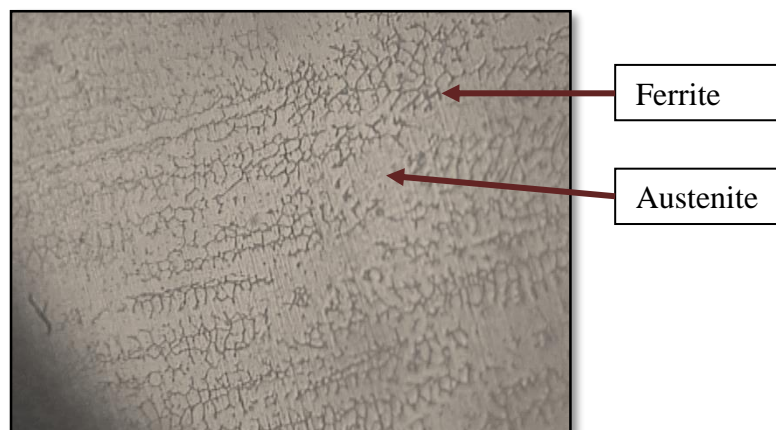
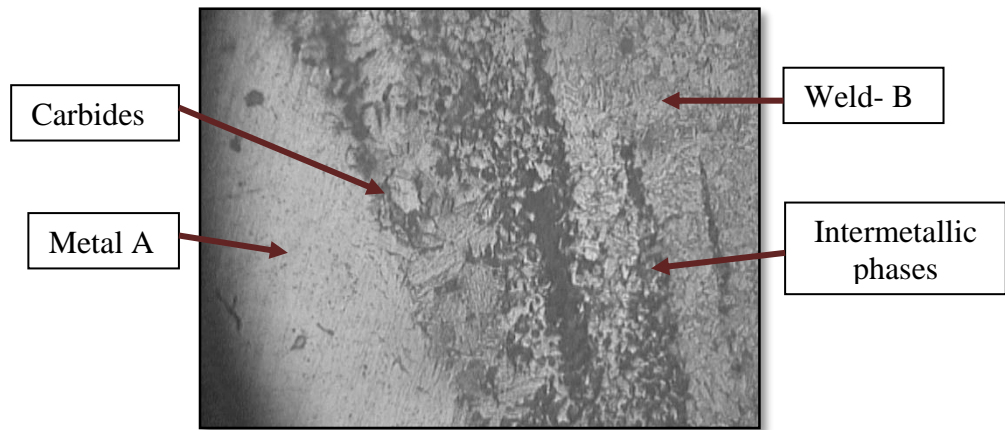
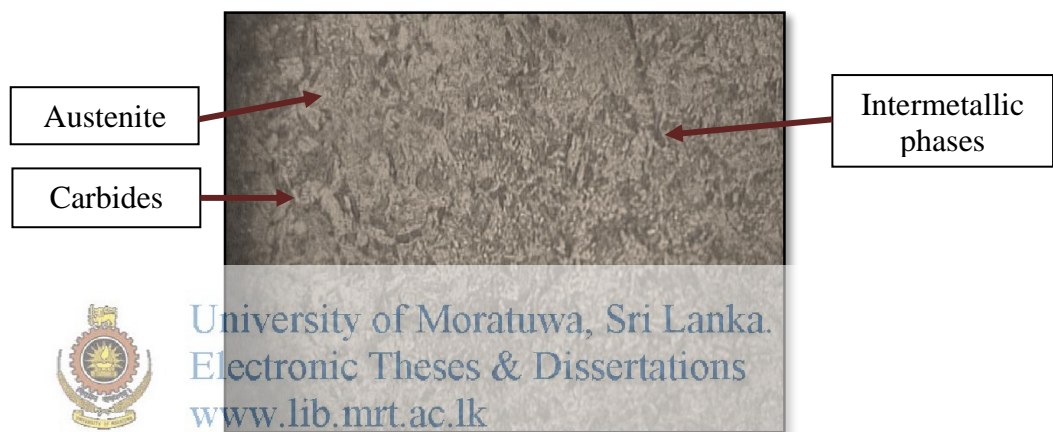
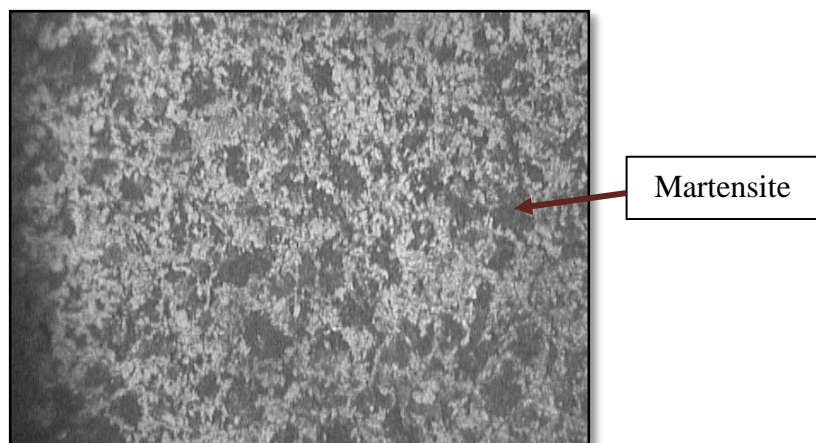
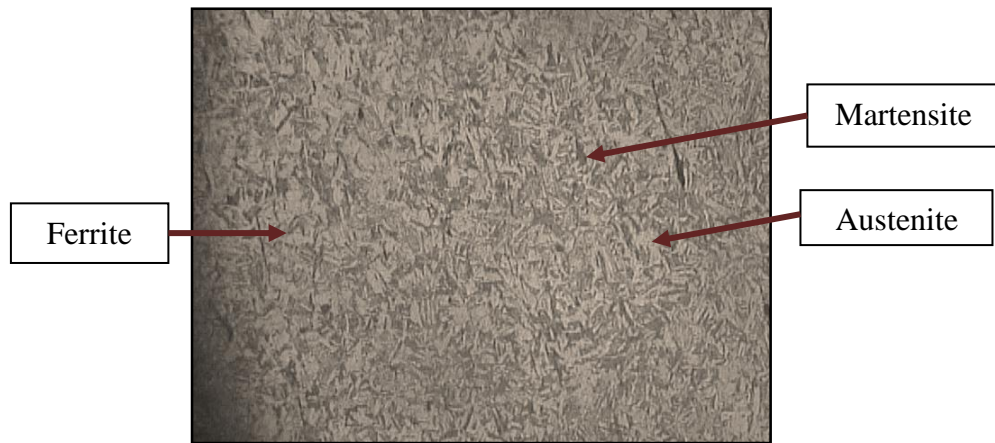
Microstructures of section A, HAZ₁, B, HAZ₂ and C of the specimen are shown from figure 4.7 to 4.10 respectively.

Phases presents in the above shown microstructures are as follows.

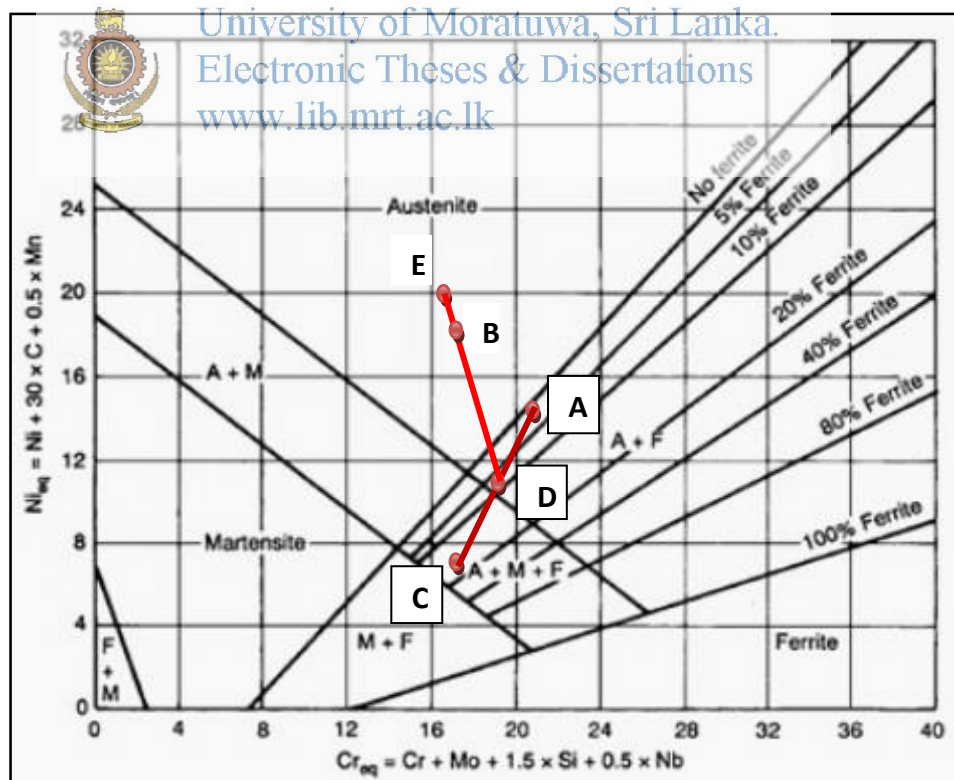
Figure 4.12 : Failed rudder materials floated on Schaeffler Delong Diagram

It was assumed that both base metals ‘A’ and ‘C’ are playing equal part for the weld and point ‘D’ is the equivalent of both base metals. Further, it was assumed 20% dilution between base metal and the welding electrode; point ‘E’ is the welding rod composition. Therefore, as per above Schaeffler Delong diagram it was revealed that base metal ‘A’ is having austenitic microstructure with about 2-3% ferrite, base metal ‘C’ microstructure having martensite and austenite with about 18% ferrite. Microstructure of weld ‘B’ is a complete austenitic structure.

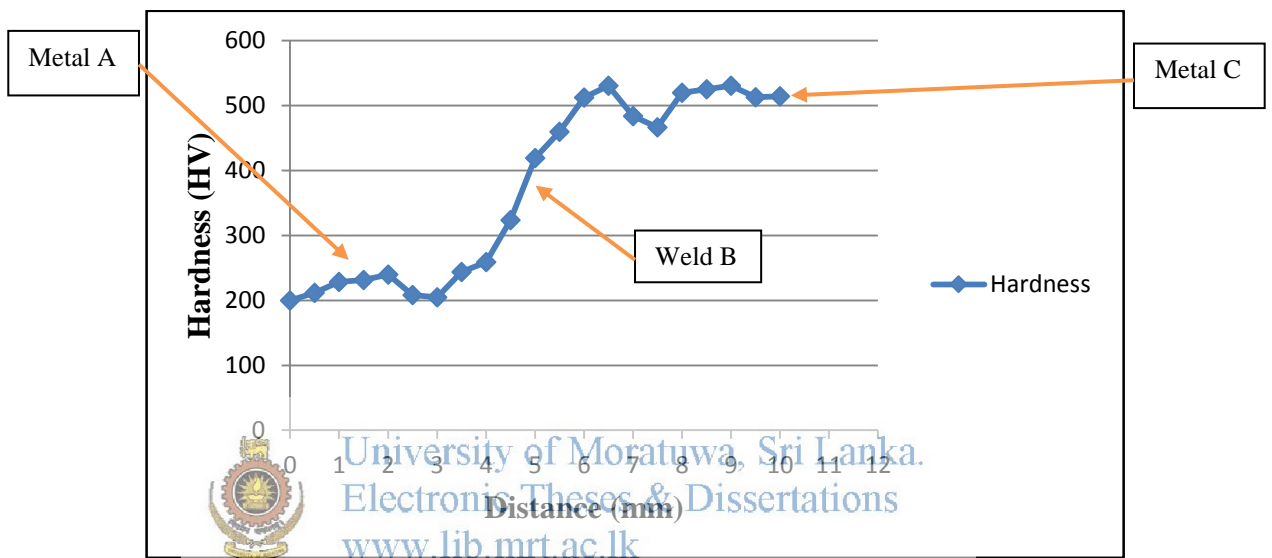
Figure 4.13 : Graph of micro hardness vs distance (failed rudder)

Micro hardness measurement values indicated at table 4.2 and the graph at figure 4.13 revealed that hardness of inner portion of the rudder (rudder stock) is very high compared to outer portion of the rudder (rudder blade). Therefore, metal used for rudder stock having more of martensitic microstructure.

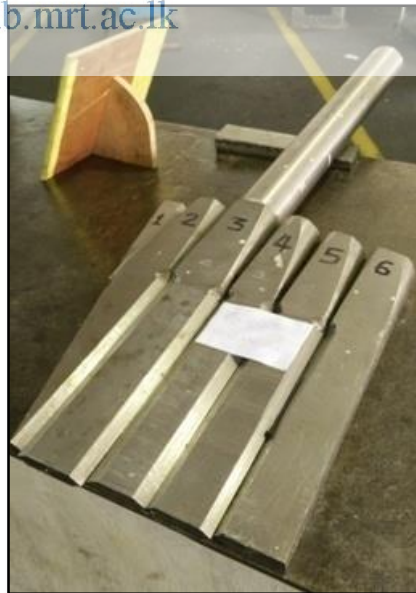
Figure 4.14 : Arrangement of shaft prior to welding

As per the welding parameters indicated at section 3.3.2.3, metals were exposed to considerable temperature and time. Hence, it was created favorable condition for carbide precipitation during welding which is susceptible for intergranular corrosion.

c. Continuation of welding until completion of entire welding electrode, keeps the weld metal and HAZ hot over a longer period, allowing more time for precipitation of carbides or formation of intermetallic phases.

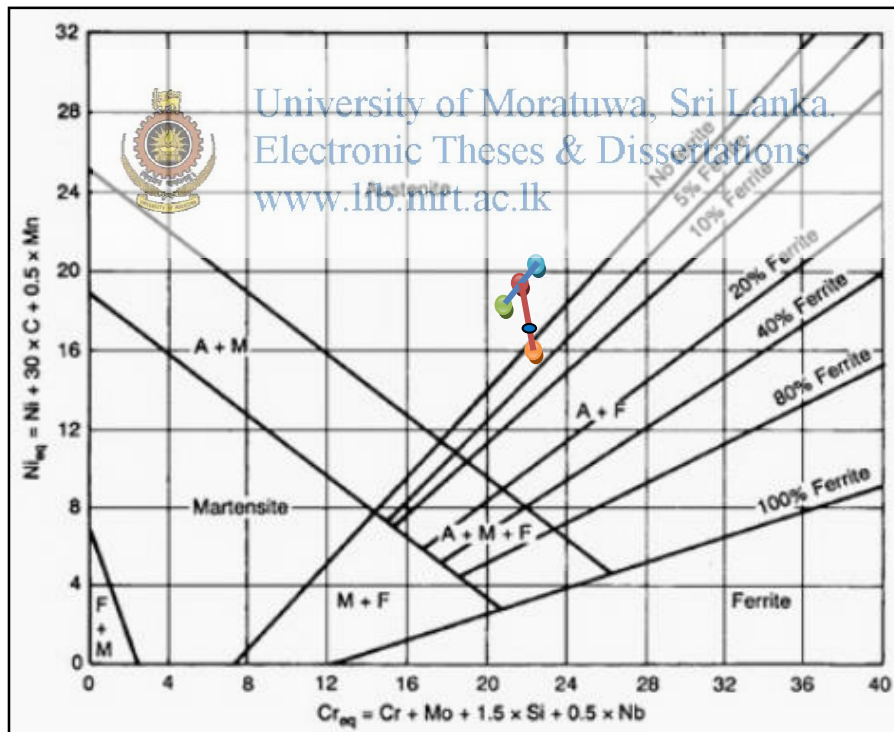
Figure 4.16 : Schaeffler Delong diagram for new rudder metals

- A1- Used Shaft
- B1- Purchased Shaft
- C1- Equivalent Composition
- D1- Welding Electrode
- E1- Resultant Weld (with 30% dilution)

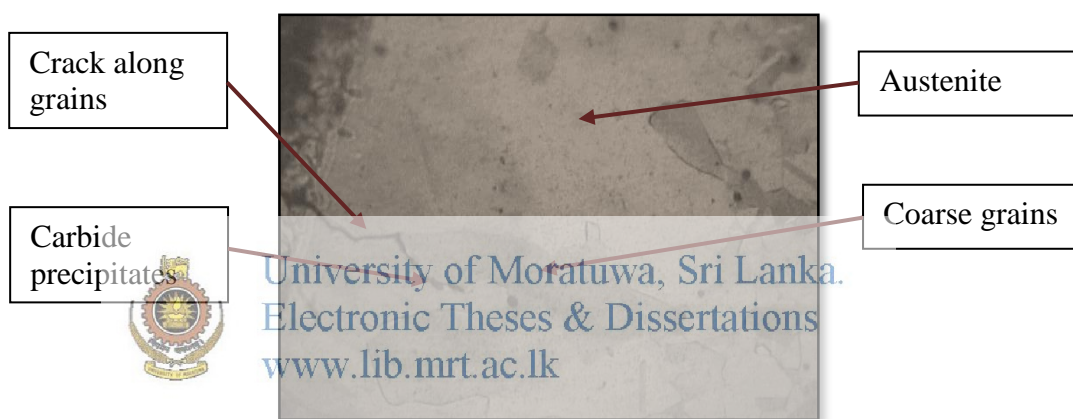
Figure 4.17 : Microstructure of HAZ of used shaft– 400X

Microstructure of the heat affected zone (HAZ) of used shaft shown at figure 4.17 was revealed it contain coarse grains and a crack along the grains.

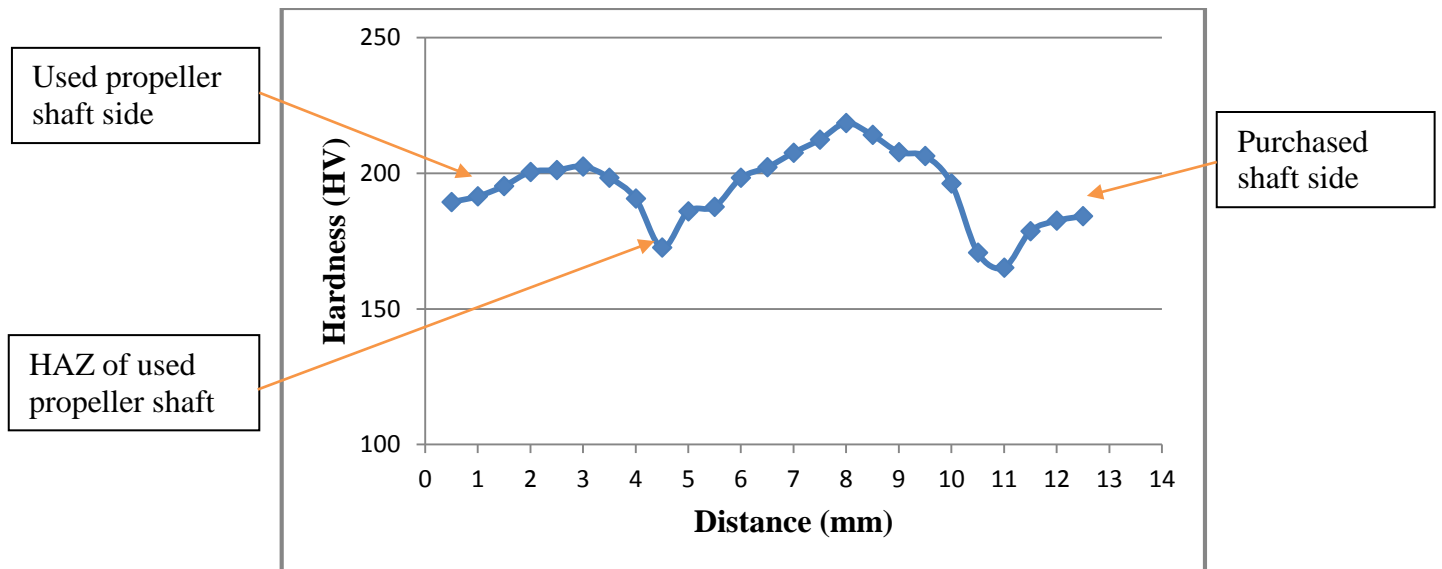
Figure 4.19 : Graph of micro hardness vs distance

Figure 4.19 was revealed that hardness of used propeller shaft is slightly higher compared to that of purchased shaft and hardness of HAZ of used propeller shaft drops.
