Assessment of Rehabilitation Options for Environmental Impacts of Abandoned Mines

Department of Earth Resources Engineering, University of Moratuwa, Sri Lanka

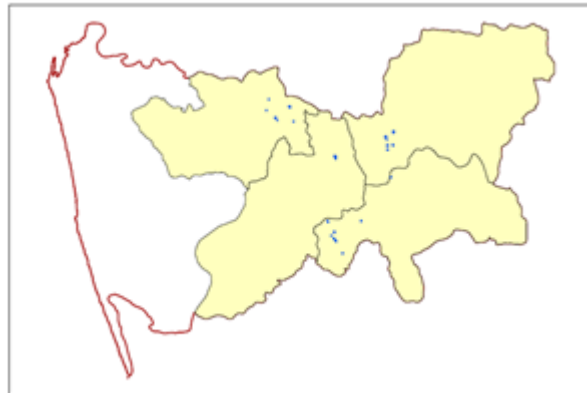
Figure 2: Identified abandoned quarry locations in the Colombo district.

Through the analysis, it identified 24 abandoned quarries that were available in the Colombo district. Among these quarries, it prioritised two quarries based on the population density and the presence of water resources around those quarry locations.

Identifying abandoned quarries that have been neglected for the past three years or more, without a proper closure plan in Colombo district through a classification of satellite images (Figure 2) and using them to prioritise the quarries according to the selected two criteria (Figure 4 and Figure 8). Based on the topography (Figure 6 and Figure 10) and the land use (Figure 5 and Figure 9) of the surrounding, two quarries are selected and, using the literature review study, sustainable and appropriate rehabilitation methods can be suggested for Sri Lankan quarries.

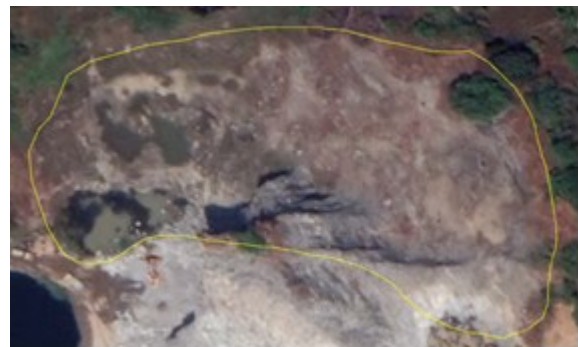
Figure 4: Google Earth image of the quarry with the highest population density.

The operations of the quarry started before 2004 and ceased operations of this part at the end of 2016. This mine has an area of 13,057 m². The land use and the topography around the quarry are shown in Figure 5 and Figure 6, respectively. The surrounding area around the quarry was categorised into 100 m, 200 m, 500 m and 1 km buffer zones.

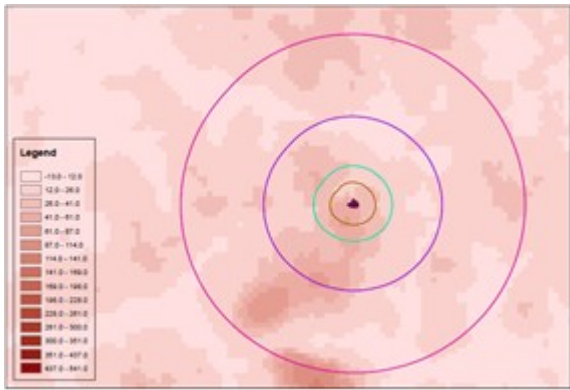
Figure 6: The topography around the quarry.

Quarry 1 is located on uneven ground when compared with quarry 2, as in Figure 6 and Figure 10.

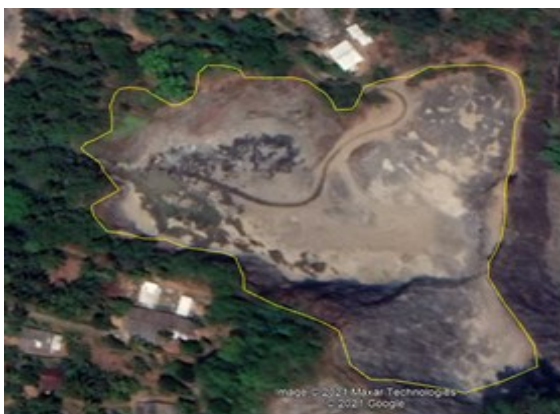
The Kelani River flows within 1 km of this quarry. Therefore, this quarry mine was selected for the rehabilitation process.

Figure 8: Google Earth image of the quarry with nearby water resources.

This quarry started its operations before 2014 and ceased operations in 2017. It has an area of 17,091 m².

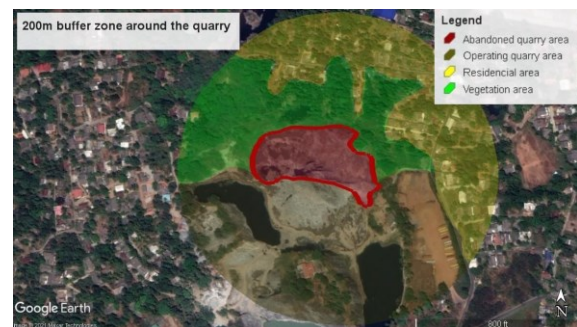
Figure 11: Google Earth image of quarry 1.

When considering the land use around quarry 1 within 200 m, the major amount is covered by the currently operating quarry

(nearly 40% of the area). The rest of the area is for residences and vegetation.

In the case of quarry 1 (Figure 11), the impact from the operating quarry is higher because a major amount of the area within the concerned buffer zone is covered by the operating quarry. And also, the vegetation around that quarry is considerably lesser.
