Landform Planning - From Void to Vegetation

Abstract

Iluka Lanka Resources has mineral resources within the Puttalam District of the North Western Province of Sri Lanka and is in the early stages of development of the Puttalam Mine and Industrial Development Project (PMIDP).

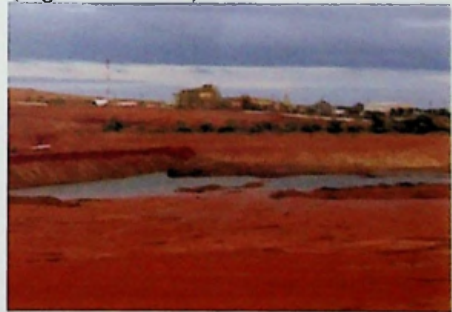
Figure 4: J-A During Mining 2009.

Iluka's operations at J-A progressively rehabilitate this arid region's native vegetation while mining is in progress (Figures 4 and 5).

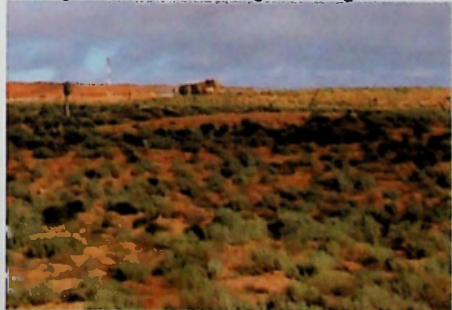
Figure 5: J-A Progressive Rehabilitation 2016.

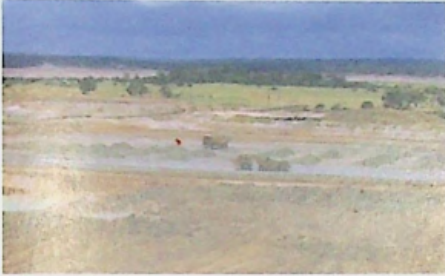
Figure 8: Yoganup West During Mining 2006.

More loamy soil was added to the soil profile in the pivot irrigation area. This allowed greater pasture production over the summer given the greater PAW in the loamy reconstructed soil. The former Yoganup West Mine was returned to an operating dairy within four years from mine closure (Figures 8 and 9) and pasture yields are significantly higher than pre-mining yields[4].

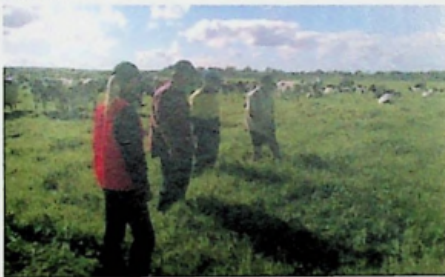
Figure 9: Yoganup West After Rehabilitation.

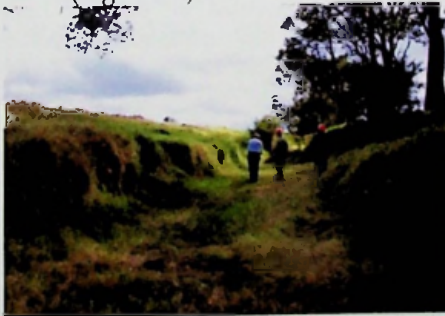
Also at Yoganup West a one kilometre section of the Ludlow River was disconnected and significantly degraded prior to Iluka commencing work (Figure 10).

Figure 10: Ludlow River Pre-mining 2004.

The river channel ran between two mine pits and the channel bottom was untouched representing the original ground level. As part of the rehabilitation process Iluka identified the importance of restoring the river to its historic state.

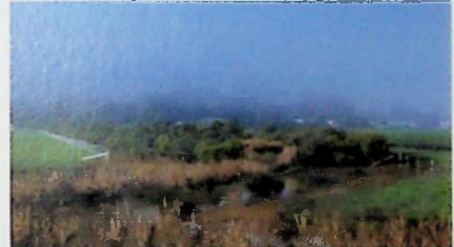
Following the completed studies, a hydrological design was implemented that improved the water flow, managing the natural flooding that can occur in the region. The original design included meanders which were subsequently straightened following unexpected erosion levels. The final river course had a wider channel allowing the width to naturally slow the water flow and stop erosion. Native species indigenous to the area were also planted to enhance the biodiversity of the river (Figure 11).

Figure 11: Ludlow River Restoration 2014.
