# Remote Sensing and GIS Approach for Tsunami Damage Assessment -A Case Study

Premadasa WN, Jayalath SDDL, Weerakoon HMAB and  
\*Dissanayake DMDOK

Department of Earth Resources Engineering, University of Moratuwa

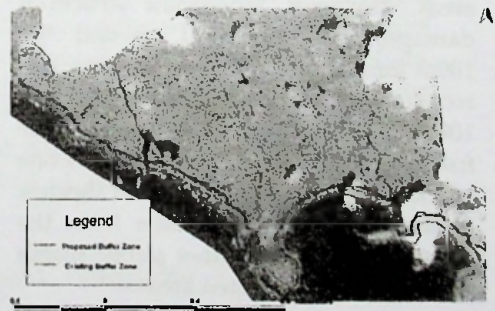
Figure 6. New buffer zone limit of the area

The buffer zone imposed by the government is 100m from the coastal

line. But comparing with the inundation data we suggest that there should be alterations to this buffer zone. A new buffer zone (Figure 6) limit was developed using the existing buffer and inundation data.

Structural damage occurred due to tsunami is very high within the 100m areas. However, significant structural damages have occurred beyond the 100m limit in some areas. Therefore it is recommended to extend the existing 100m buffer zone up to 200m distance from the shore. Network analysis is one of the reliable tools for generate shortest possible path for evacuation from the existing schools and other public places located in the inundated areas.

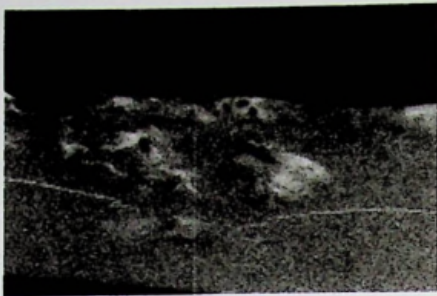
Figure 7. 3D model of the study area

Present area is mostly a flat land area except a limited numbers of high elevation locations. Using the 3D model (Figure 7) higher elevation locations were selected as evacuation places. People are advised to gather to the gathering places or else use their own vehicles to evacuate to safe places. Shortest path available (Figure 9) was identified using the arc view3.2 network analyst extension. (Turk and Gumusay, 2004)
