**Study on Deterioration and Conservation of Brick
Monuments in Polonnaruwa.**

D. Chandrasiri Chithrananda
April, 2010.

Study on Deterioration and Conservation of Brick Monuments in Polonnaruwa

A thesis presented to the University of Moratuwa, for the Master of Science degree in the Architectural conservation of monuments and sites.

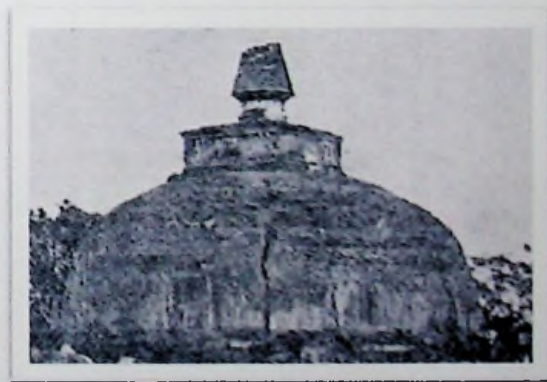
Picture - 07

At the times of excavation, this Thupa was up to the third Pesa walalu submerged with ruins and broken parts. Much of the ruins could be removed away from Dagoba by June 1910. Wonderfully "Tun Mahal Pesawa had been protected as though by the same ruins.

Ancient photographs of Kirivehera

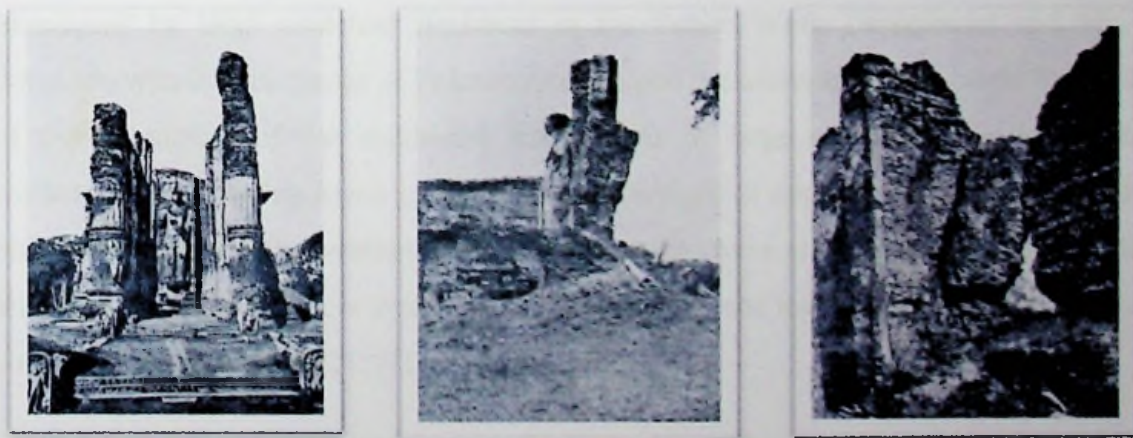
Picture - 08

As per the description of this report the building was utterly dilapidated. Only a half of back side wall to the North and West had been left. Wall parts between the entrance hall and the chamber house too had been crumbled down. Walls had been isolated. Very small aperture only remained at the entrance hall due to falling out of inner and outside plasters. It was very dangerous relative to the thickness and height. These conditions could be seen on the south wall as well as on north wall. The entrance door was high as the columns and the connection between walls was wholly destroyed. They were in precarious condition. Everywhere there were dangers openings, blasts on all brick walls. Hence the excavations should have been done with utmost care and risk.

Ancient photographs of Lankathilaka

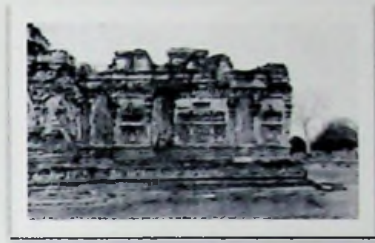
Picture - 09

South east wall of inside Vihara wall was also repaired. A large part of entrance hall along with the door frame and the lined had been crashed down (ASCAR. 1910-1911:514/38).

Thuparama image house at the beginning of 19th Century

It was not intended to re-construct the roof on it although it had been destroyed. It was necessary to make strong the walls which were crumbling down. Steps were taken to protect pilgrims from crashing of walls etc. (ASCAR. 1910-1911:514/38). Final repair work was done by September 1911. Foundation of the wall etc was repaired along with loosened parts of north, south and west walls. Walls on the both sides of the frontal door were re-constructed and the door frame was assembled upright. Further the brick facade fallen near to north entrance and upper parts of walls along with entrance walls of north and south have been raised. Chamber house floor was concreted. Grilled iron frames were fixed to keep away bats etc. Fitting seats were made to place four standing Buddha statues.

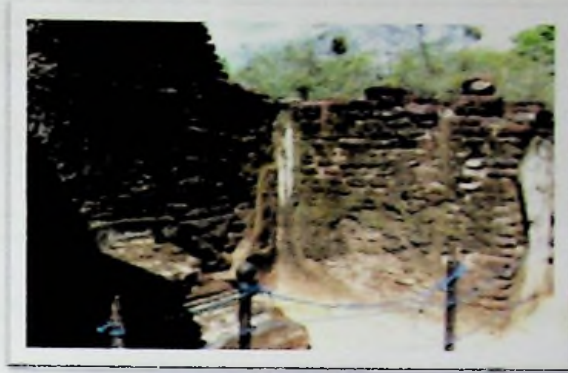
Picture 30

Deterioration of plaster Palace of king Parakramabahu

Plaster has been eroded here because it was soft. Hard bricks have survived. But if erosion goes on the building will be damaged. It will also destroy its aesthetic values of building.

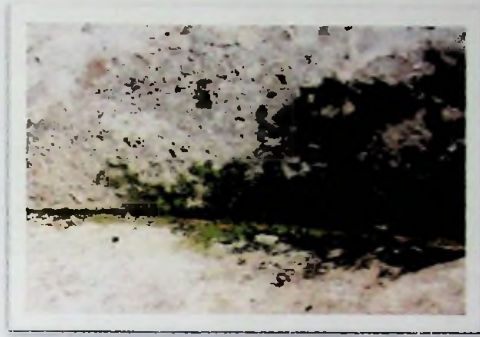
Pictur 33

It can be seen in the interior of Parakramabahu palace that bricks near the ground level as well as the lime plaster layers are weak owing to salt infection

Salt infection Palace of king Parakramabahu

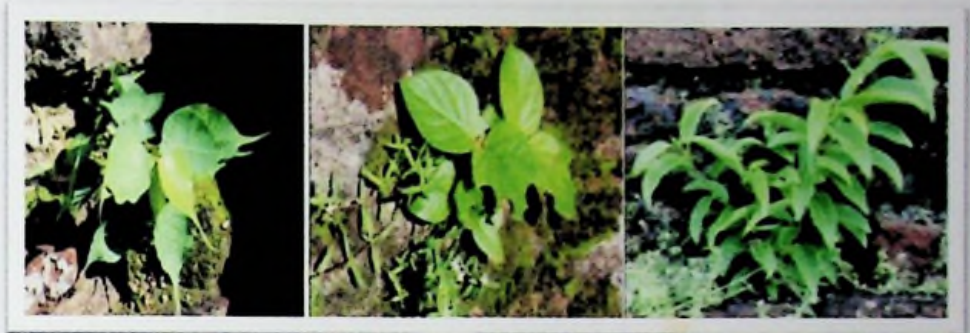
Picture 34

deteriorating factors such as plants, species of grass. Bacteria, Algae, Lichen and moss. There were also plants belonging to trees with branches and foliage such as Bo (*Ficus religiosa*), Nuga (*ficus virens*), Aehetu (*Ficus tinctoria*), Kolon (*Adina cordifolia*)

Bo

Kolon

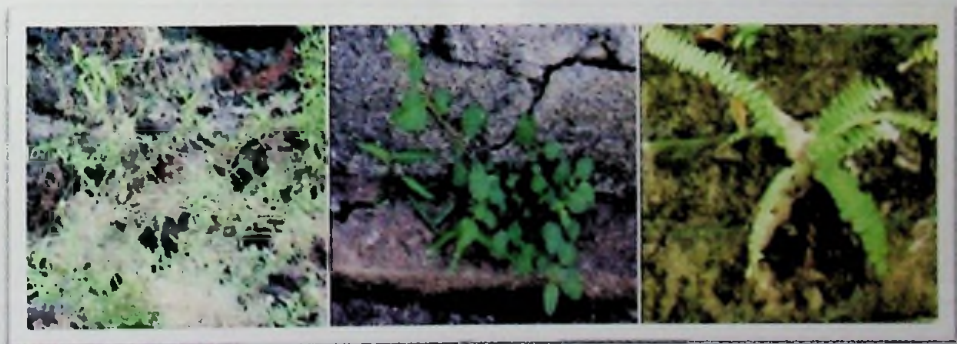
The whole monument has been covered with these plants. In the random plants such as Thuththiri (*Chrysopogon Aciculatus*), Wal sarana (*Trianthema portulacastum*), Wal pathpadagam (*Oldenlandia corymbosa*) and two other unidentified plants were found on the brick wall of the Parakramabahu palace. They are also widespread.

Thuththiri and

Wal sarana

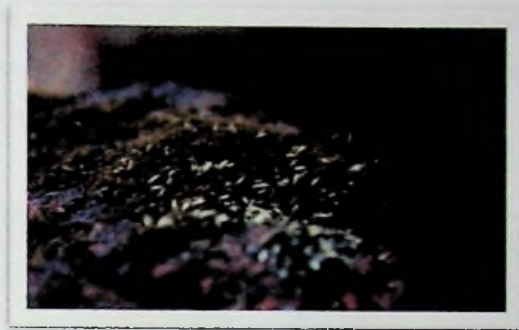
Picture 36

On this monument bacteria and fungi infection hardly can be identified. Only in a few places on brick wall some fungi and bacteria we could identify.

Fungi Palace of king Parakramabahu

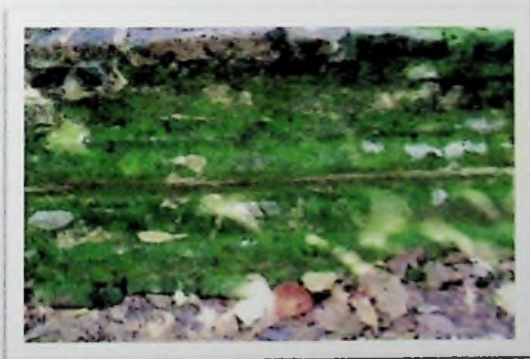
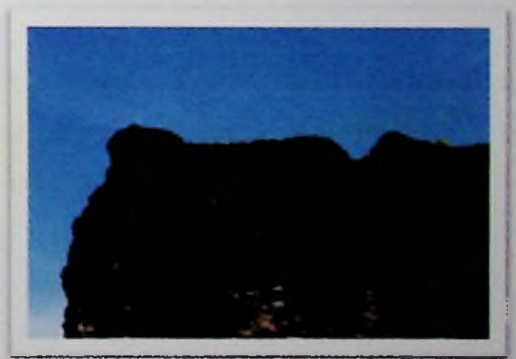
This is the most widespread and harmful micro organism found on brick wall and plaster Parakramabahu palace. Black and green moss is widely grown on upper parts of brick walls on which rain directly falls.

Green colour moss

Black colour moss

Moss in Palace of king Parakramabahu

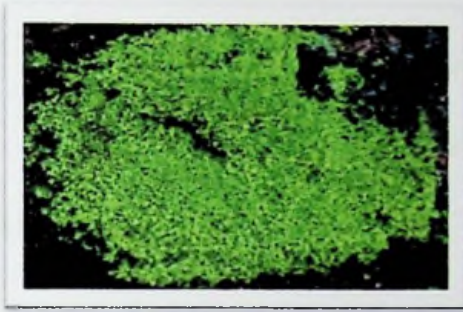
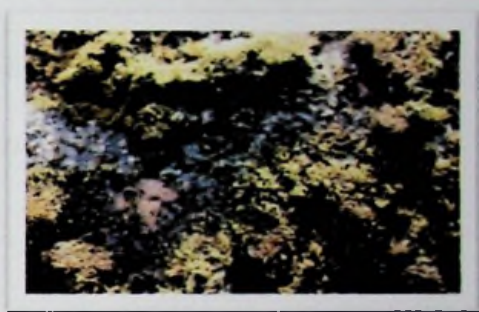
In Parakramabahu palace on brick wall and plaster with the increase in humidity the growth of algae also seems species to be also seems to be on the increase. Especially green and brown varieties seem to be widespread.

Green algae

Brown algae

Algae in Palace of king Parakramabahu

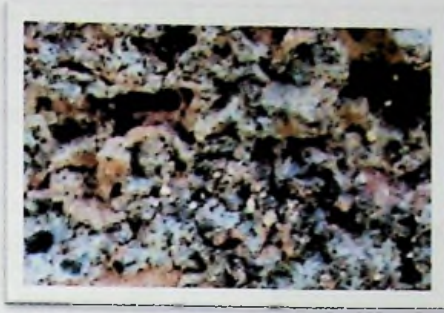
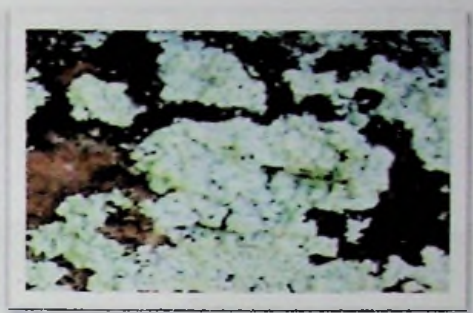
It is very clear that much of the brick wall surface of Parakramabahu palace is covered with lichen. On brick constructions and lime plaster whitish light green, ash and black varieties are found in abundance. Many of them are shall like and leaf like in form.

Black Lichen

Light green, Lichen

Lichen in Palace of king Parakramabahu

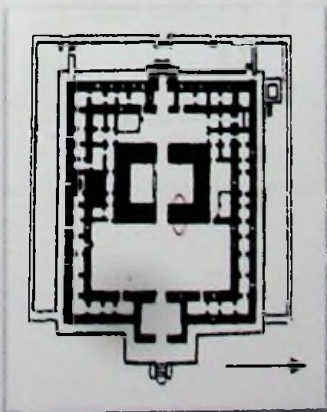
Picture 40

A large number of micro bursts caused as a result of heat movement process on bricks used to erect the Parakramabahu palace can be seen. As shown in the plan below such damages can be noticed on interior walls of the palace. These are small cracks and thus can be called as micro bursts. This process can, of course continue and it leads to gradual decay of the surface of bricks and ultimately destroys the brick. It has caused age old destruction. This kind of deterioration is common among the exposed bricks lacking lime plaster.

Small cracks on bricks

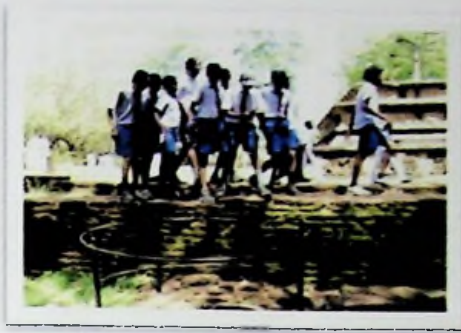
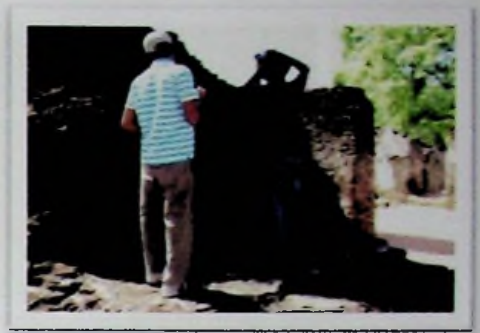
Picture 45

Some visitors walk on conserved brick s wall and damage them

Continued activities of the nature are a threat to both existence and beauty of the monument. Lime plaster well preserved and belonging to the back base has been cracks and in some places algae has been grow. Many places were covered by moss. The following instances deserve special mention. (i) Negligence of and erosion that occur (a) on the holes in to which timber beams had once been inserted and (b) surrounding of (a) referred to above (ii) absence of removal of moss, plants, trees etc. grown on uppermost parts of the monument, and (iii) negligence of blackened appearance caused to upper parts of the monument by moss. It is a pity that no attention on the part of the conservation has been paid to prevent very severe damages caused to lime plaster layers of the rear parts of the palace which are covered with lichen, algae and moss. This state of affairs is a threat to beauty and both existence of the monuments

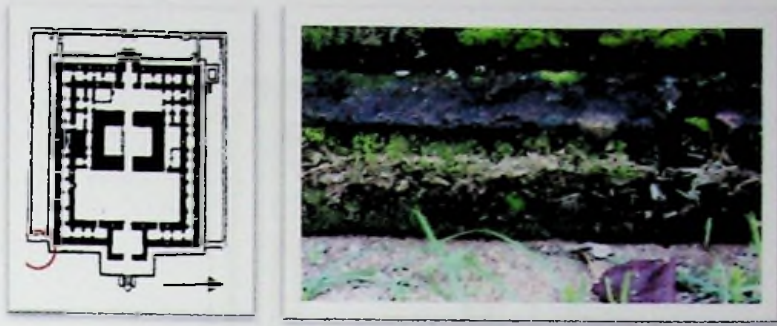
Picture 46

In seasons when heavy rain falls comparatively more water accumulates around the west base of the monuments. Such accumulation of water is a great threat to the existence of the monuments.

Evidence for the submergence of the base

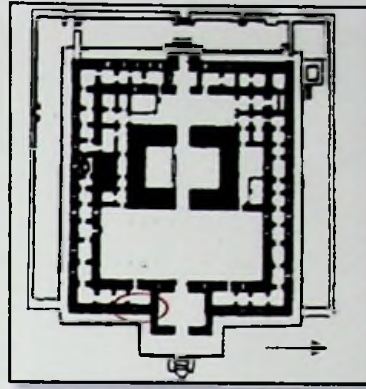
Area in systematic survey

We selected on area $1 \times 1 \text{ m}$ high by the base left to the entrance in accordance with the east of the foundation Parakramabahu palace and we divided this area into three squares. Then we studied the plants found in these three squares.

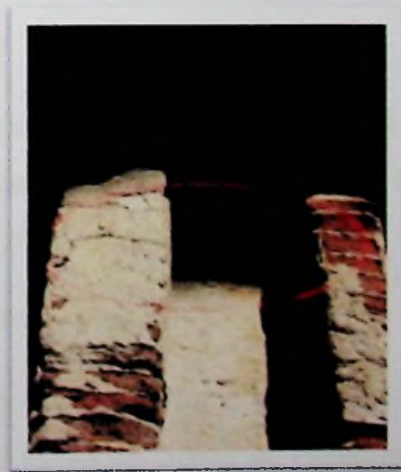
Picture 56

Lime plaster which the brick of the monuments consists of cracks when exposed to excessive heat and then all of a sudden changes the heat drastically. Then the plaster separates from the wall and fall down. Due to continue process of expansion and contraction of heat that went on for the centuries plaster on the exterior wall as well as interior walls have produces a large number of major and minute cracks on walls. The kind of damage is more widespread on exterior walls where it resembles a cobweb. These cracks are the most widespread on the southern wall do the Thivanka Image house.

Micro cracks on the southern wall

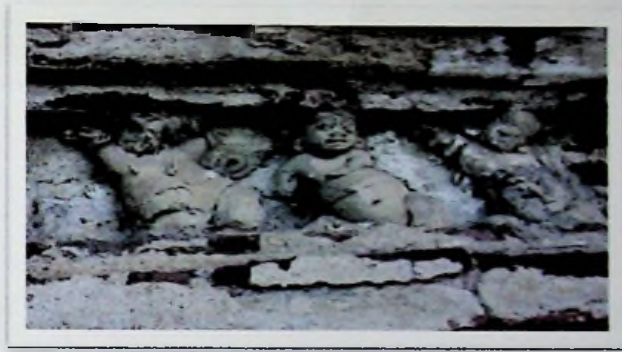
Picture 57

But at present lime plaster has been peeled off and some of the animal figures have been destroyed to a great extent. In some parts animal figures have been totally deteriorated.

Gana (Dwarf) figures totally damages by thermal cracks.

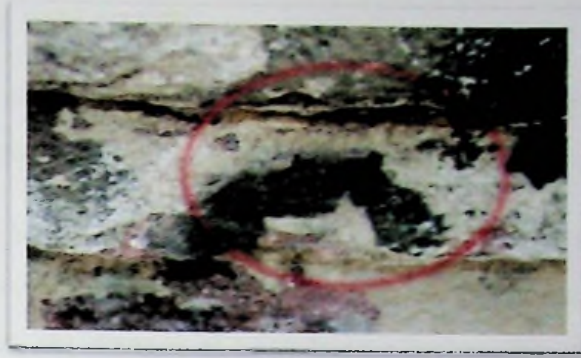
Picture 60

Stains of black moss can be found even on the lime plaster of the interior of Thivanka Image House. The surface referred to above had painting on it at the beginning and was subsequently destroyed and is being destroyed further by moss.

Peeling off of moss along with lime plaster.

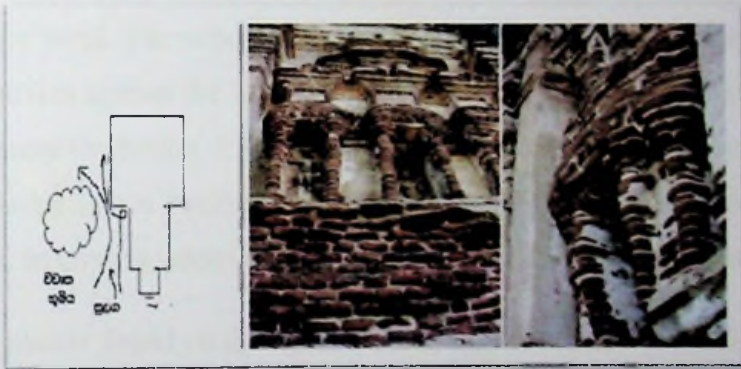
Picture 62

The southern wall of the Thivanka Image House more than the other walls has become an object of wind erosion as it (a) stands on a higher location compared to other monuments, (b) absence of taller trees adjacent the southern wall and (c) surrounding of the monument is absent from trees. In a study of monuments open to wind in erosion in n Polonnaruwa, Thivanka Image house comes first. We say this because it is in this monument that whole of the wall inclusive of its plaster, brick etc. have been totally eroded by wind.

Wind eroded south wall - Thivanka image house

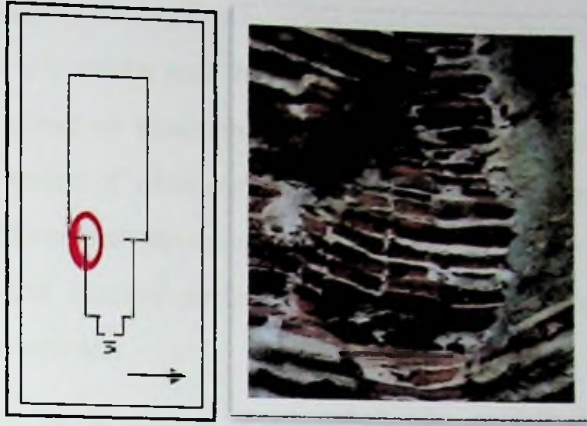
Picture 63

Wind has eroded all vimana, pillar, dwarf figures, lion figures, sculpture of the south wall as well as and molding done by lime plaster of the base. All angular linear shape of the monument has been turned somewhat spherical. The following picture shows how wind has eroded the brick and the plaster.

Corner of the wall eroded by wind

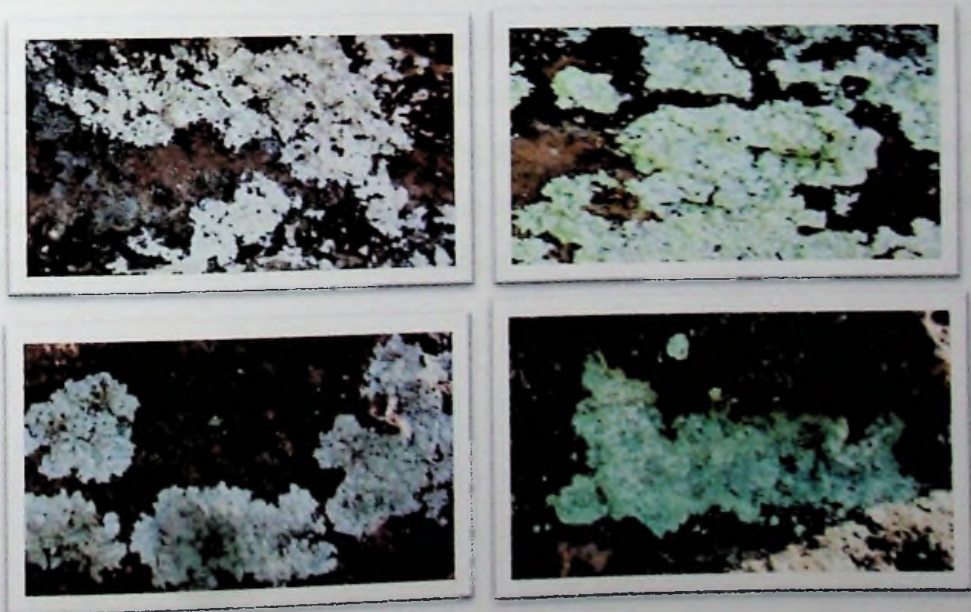
Picture 66

Fungi infection in Thivanka image-house

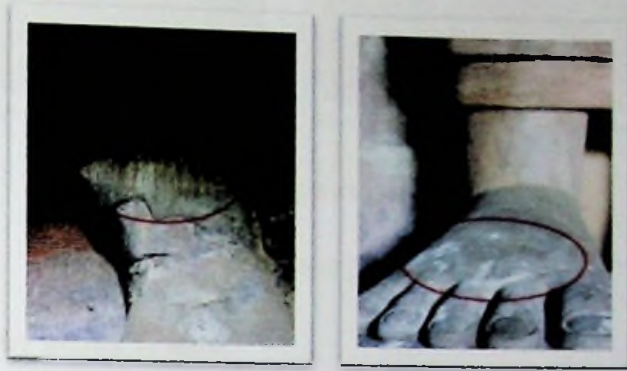
Picture 71

In dark corners of the upper parts of wall in Thivanka Image House animals such as pigeons, bats and swift swallows live in their nests. Although we were not in a position to see them because they were living very high yet we could identify the places where the animals were by means of the places where their faeces were found and also through the call. The presence of bird faeces on the shoulders of the Buddha statue is very common. You can observe that the birds chiefly live in nests built in the dark zone between the shoulders of the Buddha's statue and the wall. It can be seen that regions such as the right shoulders, the thigh of the right foot and the instep of the foot are defiled by faeces of birds. The dark environment that

Damage caused to the statue by birds.

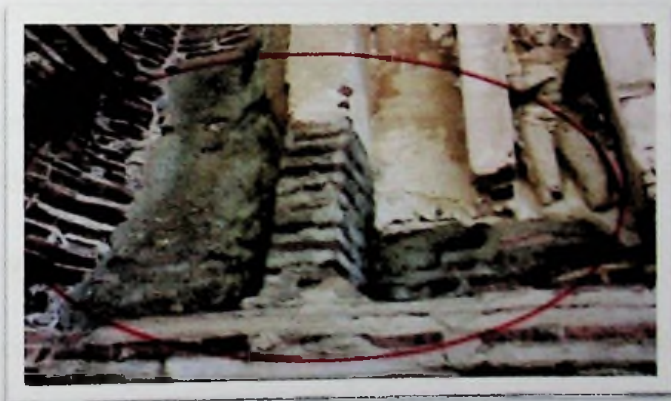
Picture 74

Further, certain parts of *Viman* on southern wall which had been eroded by wind were subsequently conserved using cement distorting the original erection and without understanding artistic value of the original erection or colour of raw material used. This is also a threat to beauty.

Unsuitable conservation

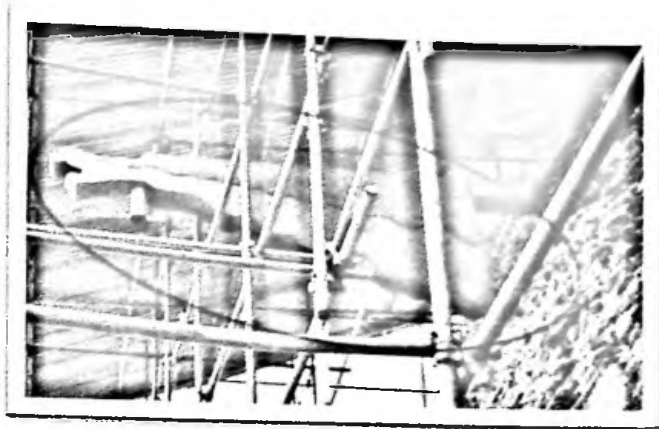
Picture 75

Guttering made of sheets and meant for removal of water collected on the roof does not go with the ancient look and beauty of the monument. One who looks at the monument at once will be convinced of the unsuitability of raw material and that of the new erection.

Unsuitable guttering

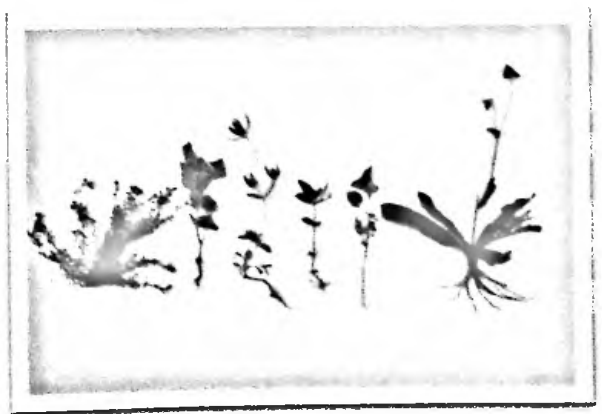
Plants grown on bricks walls of the Thivanka Image house, their characteristics and the damage caused to the image house by them.

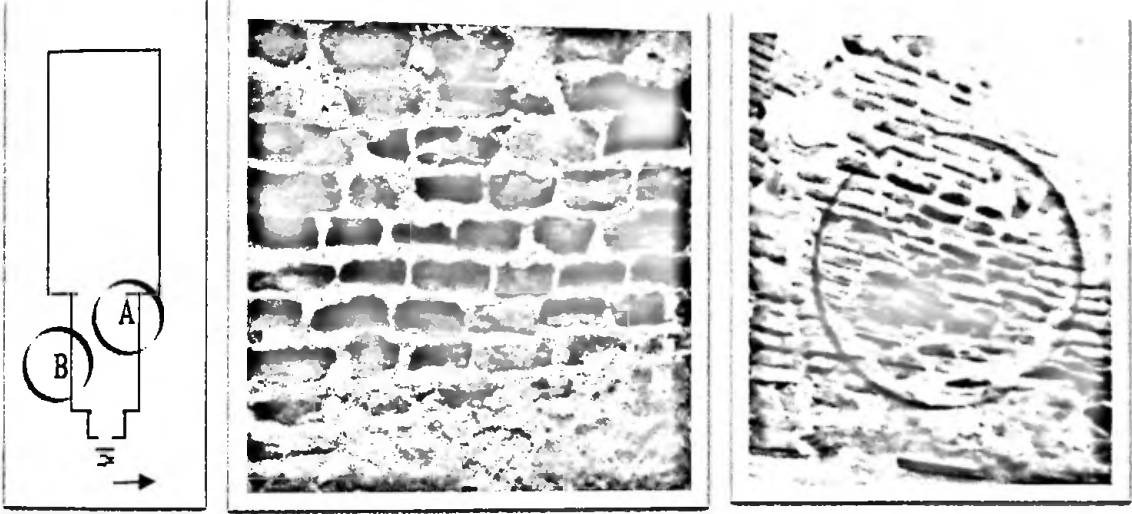
A) Interior of movement B) Southern wall of monument- picture 81

Survival of mortars while deterioration of soft brick and plaster

Which had been wade in erecting Lankathilaka Image House readily eroded in face of erosive factors on bricks walls here and there. Such brick dissolved giving way to openings. This has a harmful effect on both strength and beauty of the monument. Such opening which replaced the dissolved bricks are found

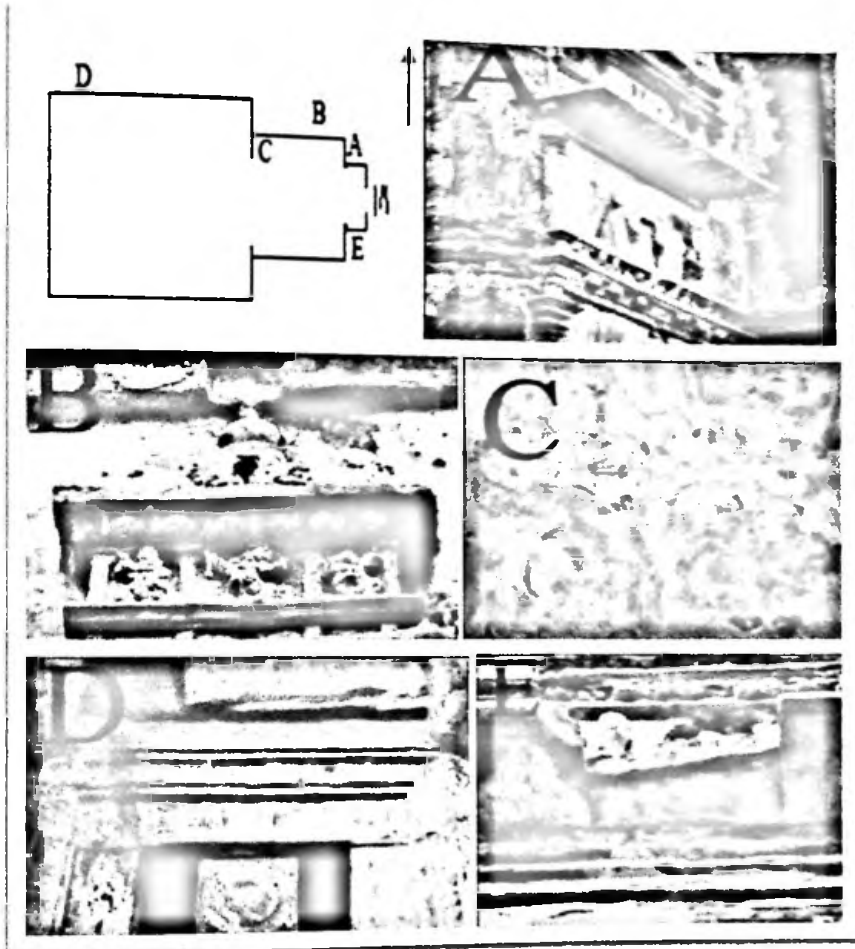
Picture 82

These fragments of colouring and painting provides us with evidence for the feat them this whole building was white washed with lime, colour washed furnished with paintings. Yet, due to fact such as breach of the roof and exposure of the monument to sunlight for a number of centuries the colouring has been destroyed.

protected in panting and colours Lankathilaka

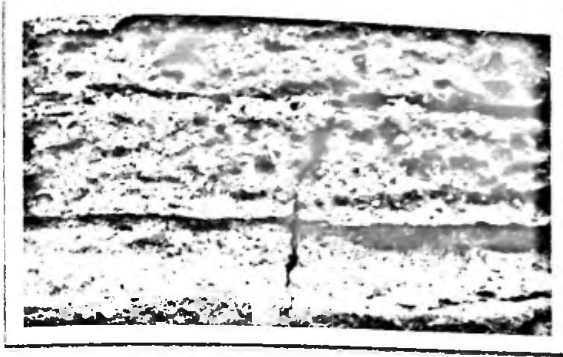
Not only bricks but also its medium of building, i.e. lime plaster may in face of excessive sunlight get heated, expand and in case of sudden contraction may crack, become powder and fall. Again the plaster which has been used to spread on the wall in face of thermal movement has cracked and it is somewhat like a cobweb.

Micro cracks in bricks

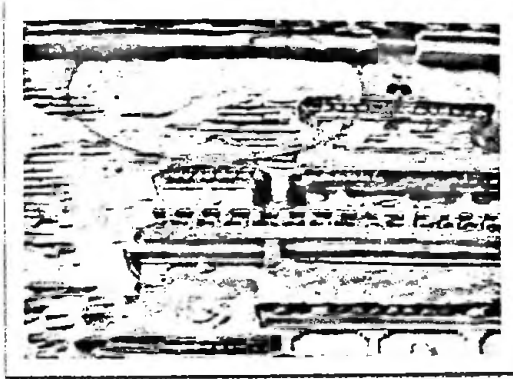
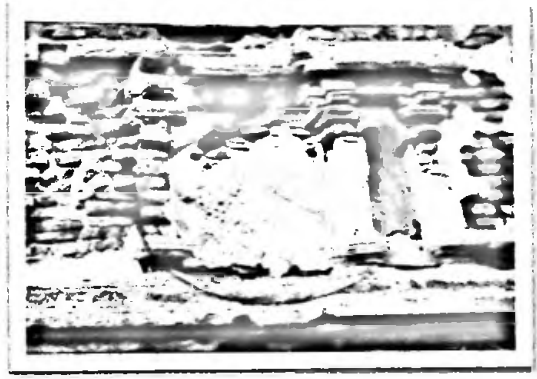
Picture 83

Micro cracks in bricks and plaster

Compared with other walls, the occurrence of cracks in plaster of the kind is more probable on the southern wall and northern wall and Lankathilaka Image House which receive heat during a greater part of the day.

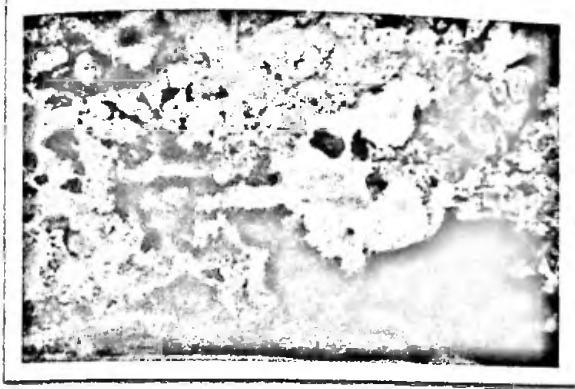
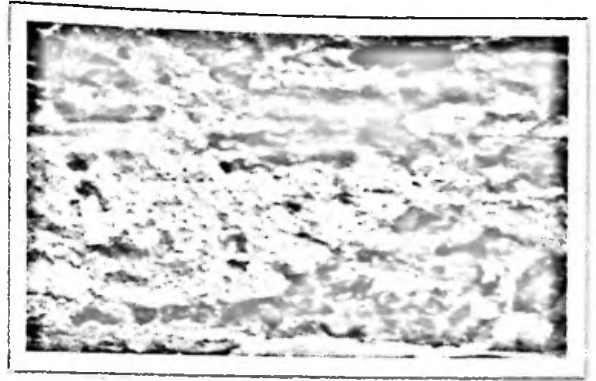
Picture 84

absorbed. By the movement through capillary suction increases and (ii) various salts dissolved in the underground water deposit as crystals on brick walls and crack both brick and lime plaster and drop particles in the form of powder.

Salt infection in wall

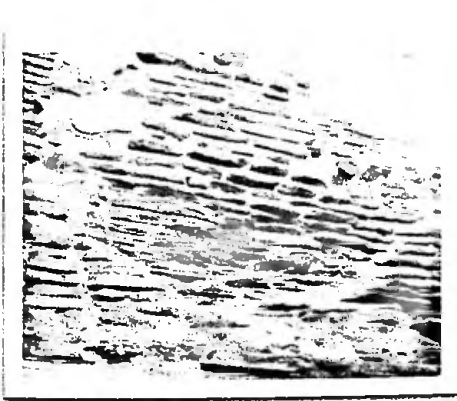
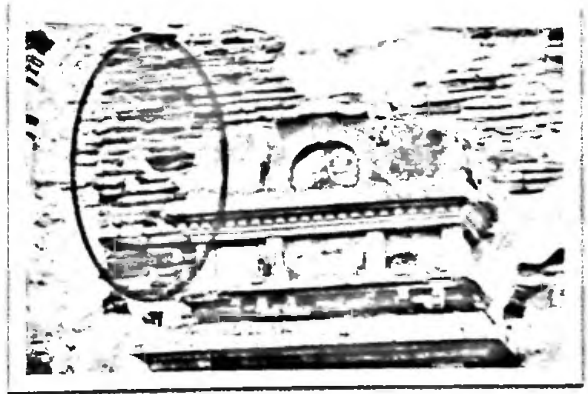
Picture 87

The southern wall of Lankathilaka Image house has been greatly damaged more by wind erosion. There bricks which had already been made infirm by the action of rain and salt are now victims of wind which erode them giving them various features.

Parts of the southern wall eroded by wind

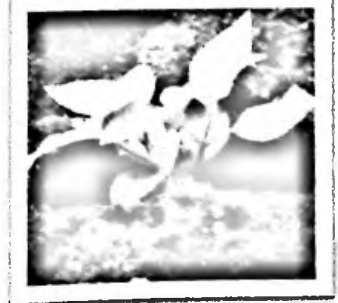
As the upper parts of the interior of the monument has turned a suitable environment for the growth of trees one can find development of a number of different plants here.

Trees in Lankathilaka image house

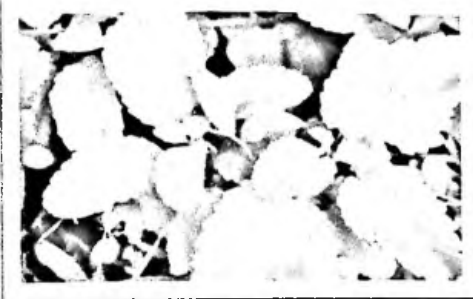
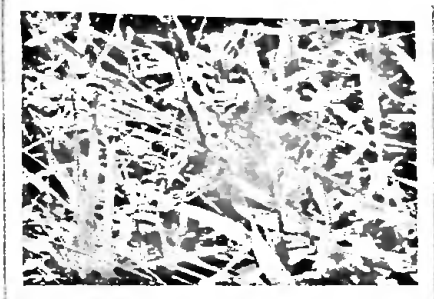
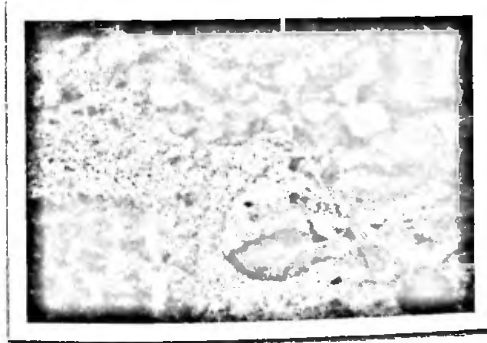
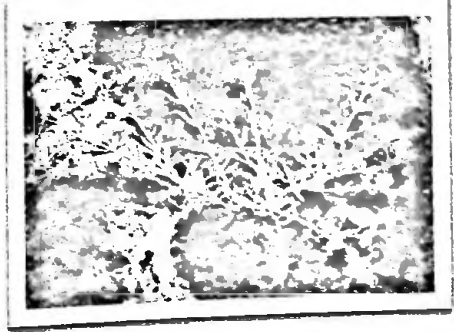
Plants grown on brick erections of Lankathilaka Vihara as we found in the sampling study

Plants in Lankathilaka image house

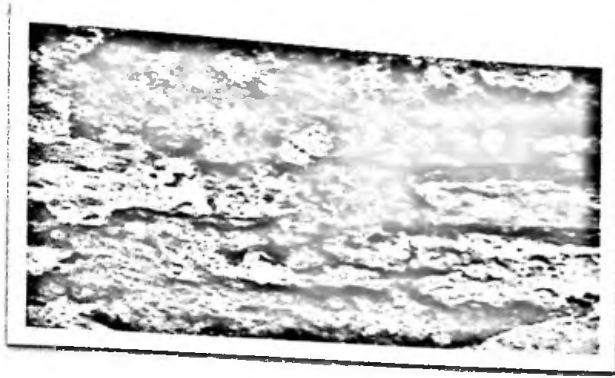
Picture 92

On regions near the floor of the interior a thick growth in moss can be seen.

Moss in interior side in Lankathilaka image house

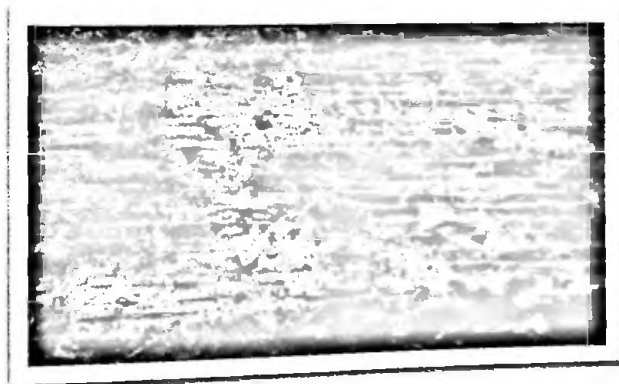
On bricks of the monument, resembling flower patterns, white, blue and light green lichen is found here and there on the one hand as isolated individual units and on the other hand as a range covering a vast area. The spread in comparatively, less on the exterior of the monument where as it is found as a range on interior walls which are shaded and humid.

Lichen spread as a range

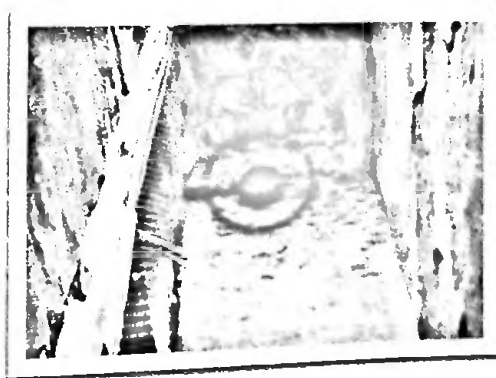
Picture 95

Further these were also a few nests built by wasps inside the tunnel.

Nests built by wasps in Lankathilaka image house

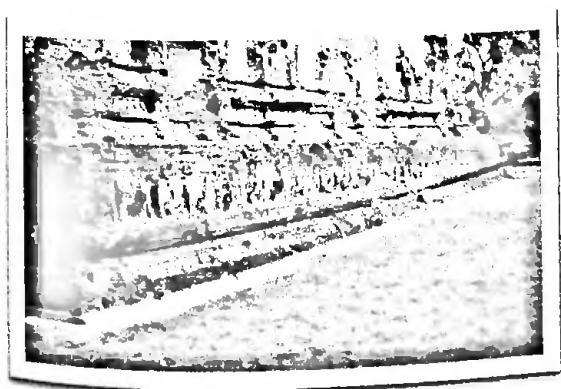
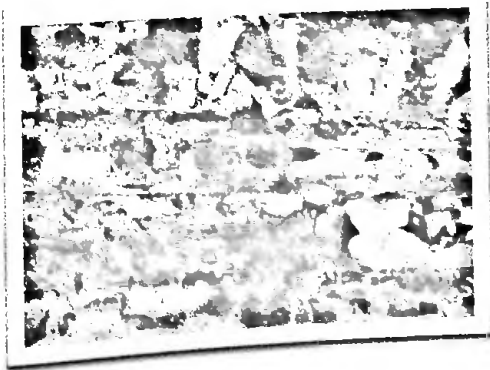
Picture 96

Door and window were completely collapsed long ago. When the past number of centuries are taken into account relative to other parts of the monument not much of damage has been caused to the base. No large cracks of considerable size or subsidence can be seen here except that lime plaster spread externally has undergone severe damage. The lime plaster in covered by moss, lichen and small plants.

Base of Lankathilaka image house

Outside the monument on the molding near the base excessive growth of moss can be found. Majority of this moss is green and black in densely distributed biological deteriorative factor on the monument in it's entirely.

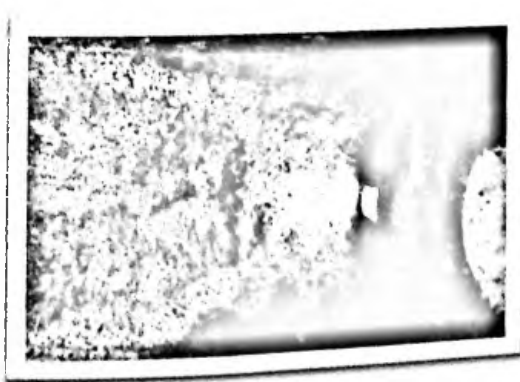
Out of the erection built following the *Gedige* tradition in Sri Lanka, Thuparama Image house of Polonnaruwa is the only one extent with vaulted roof made of brick. This erection can be designated as one of the most significant of its kind made of brick following the *gedige* tradition. This building which consists of three parts, *Garbagruhaya*, *Aantharalaya*, and *Mandapaya* has a roof which is an arch resting upon an excessively wide brick wall. But owing to subsequent deteriorative factors its roof made of brick and belongs in to the front *Mandapaya* and *Aantharalaya* has been collapsed.

Protective vaulted roof

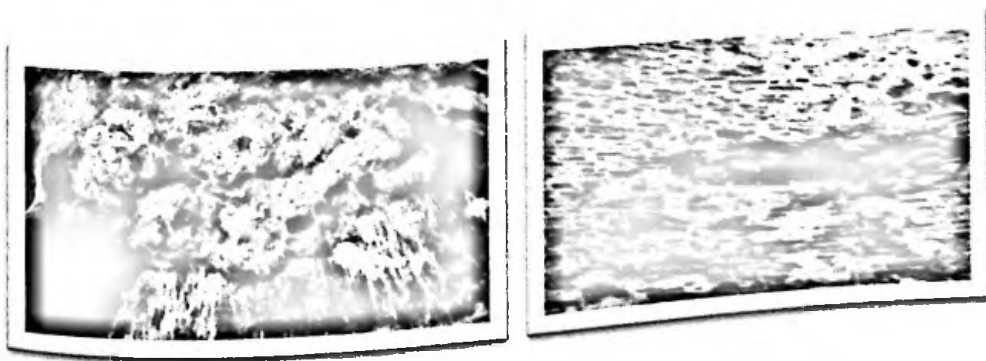
A large number of nests built by swallows can be seen at the entrance to the *Garbagruhaya* in the *Antharalaya*. Walls have been stained by faces of swallows. Again swallows have built nests at the center of, the dome roof of the *Garbagruhaya*. Activities of these animals cause grave damage to both existence and beauty of the monument.

Nests of swallows - Picture 101

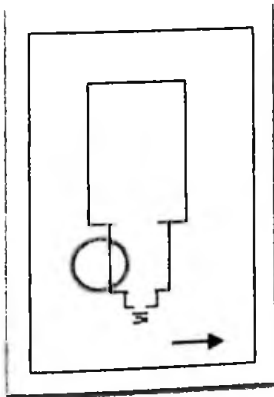
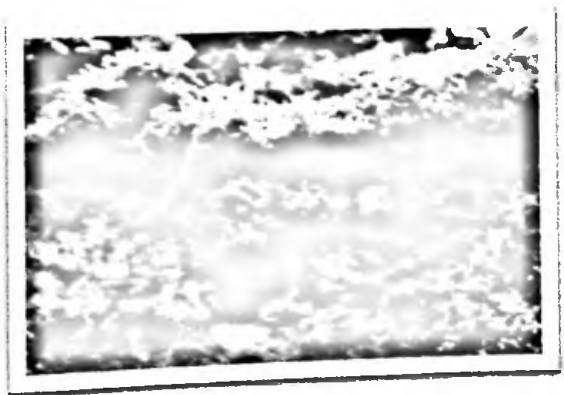
Algae infection is found both in the interior and exterior of the Thuparama Image House. The growth is noteworthy specially interior of front and side walls of Mandapaya of which of roof has broken. They grow very well here because the environment is humid and but they damage bricks and plaster of the monument and a threat to its beauty.

Algae infection in Thuparama image house

Green algae as well as brown algae can be found here. They grow on plaster and harm the beauty. Compared with Lankathilaka, Thiwanka Image house, Kiriwehera, Prakramabahu palace etc. Thuparama Image house has the least algae infection in it. Algae infection is found at the base of north wall in the exterior of the monument.

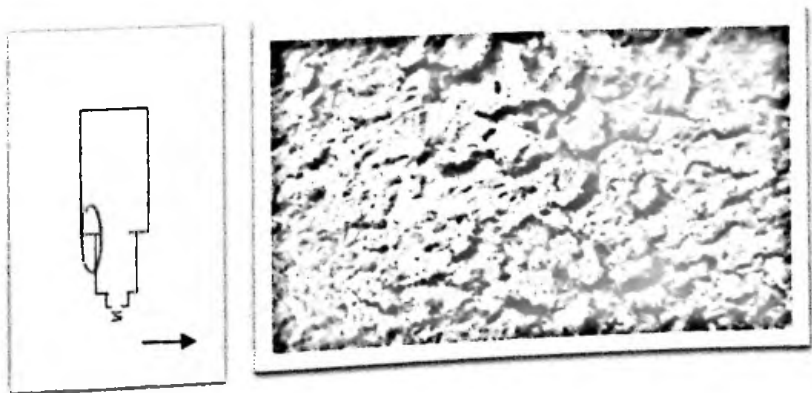
Compared with other monument white and light yellow lichen infection is lesser here. But on the base of the southern, northern and western walls where *Antharalaya* and *mandapaya* join. Light blue lichen with moss are grown covering an extensive area. Light green lichen is grown under the gutter of the northern wall. Light green lichen is grown under the gutter of thee northern wall. Light green lichen is in the process of being grown on the upper part of the southern wall.

Lichen infection in Thuparama Image house - Picture 107

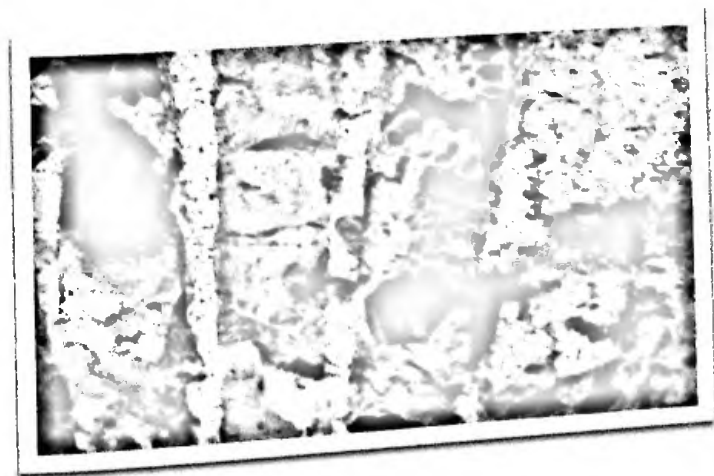
Potter-wasps have built exceeding large number of nests inside *Garbagruhaya* at its rear, in interior of western, southern and northern walls, on side walls and on the firm seat in which the Buddha is seated.

Invading erections of Potter-wasp the infirm seat

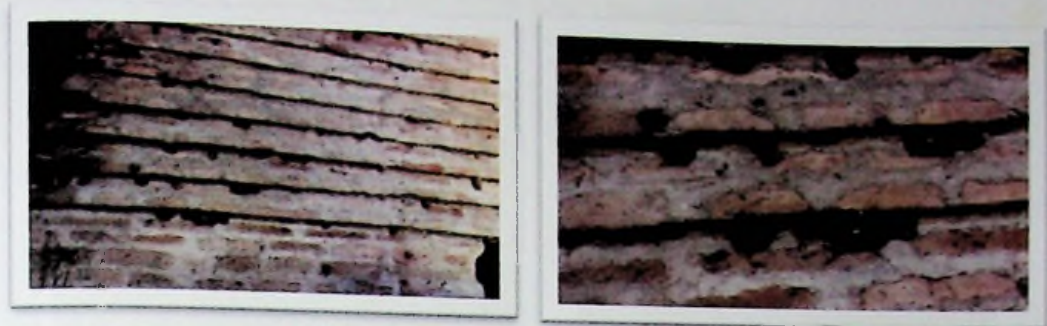
Picture - 109

Attact of Potter-wasp in Thuparama image house

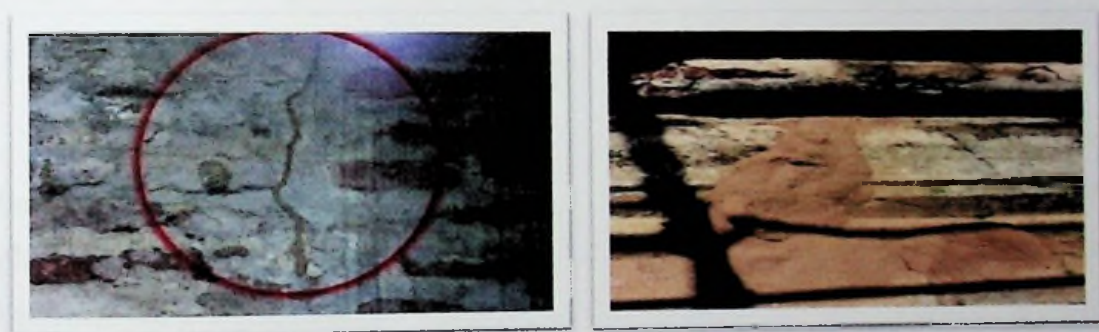
Mode of life of termites in the interior of the *Garbagruhaya* can be seen on its, northern wall. A large anthill built by termites on the base in the north-western corner in the exterior of the monument can be seen. If this process develops and goes on further it might lead to grave consequences.

Termites on the base - Picture 110

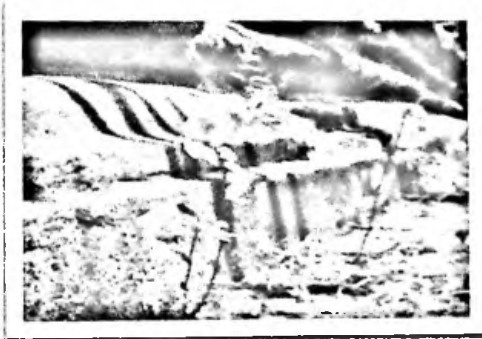
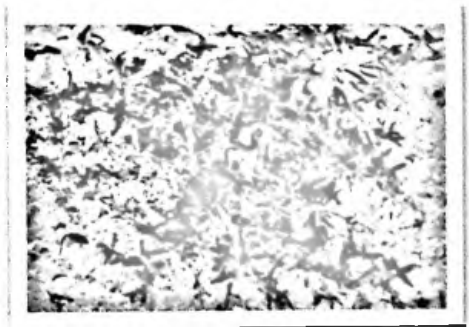
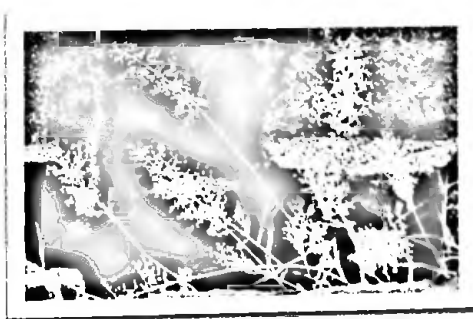
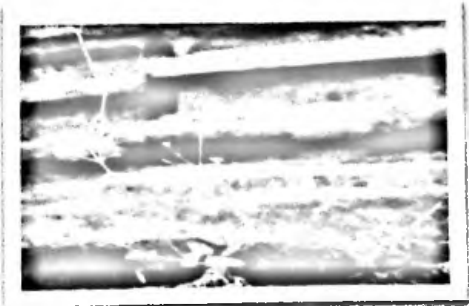
Various weeds such as grass, *val pathpadagam*, *kepumkiriya*, *valsarana*, grown on molding behind the monument have been seen.

Plants in Thuparama image house - Picture 114

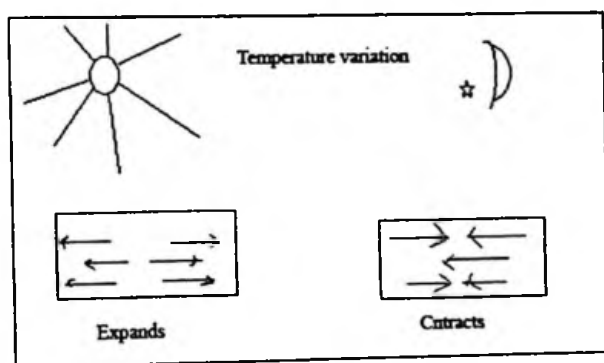
Picture - 115

Expansion and contraction damage caused

- Breaking away of large parts
- Peeling off the surface
- Minute cracks on the surface and interior parts
- Losing the attachment between the plaster and the bricks

- Loosening and splitting the attachment between the brick structure and the plaster.

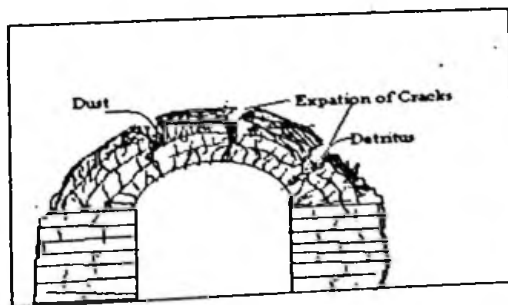
This kind of cracks grown can be seen vaulted roof in the Tuparama image house. When the thermal expansion which occurs on building material comes together, there will be stress on the raw materials and when scattered, it will cause harm to the monument. This resign also affect deterioration of brick roof in Thivanka, Lankathilaka and Thuparama Imaje houses. Stress is caused to the structure of the roof by the thermal expansion making it weak. This weakness results in collapsing the whole roof. Protected original lime plaster of vaulted roof in Thupareama imaje house was crack and destroyed the reason of this The stress caused by thermal expansion on the structure of the building, will cause the outer covering raw material like plaster to be destroyed. The plaster and the structure expand in two ways during thermal expansion. The edges do not expand in relation to the plaster. When the outer covering expands leaving out the edges, monuments will be deformed with cracks and parts jutting out. Those are the effective factors deterioration of brick roof.

Growth of cracks during heat expansion - Picture -116

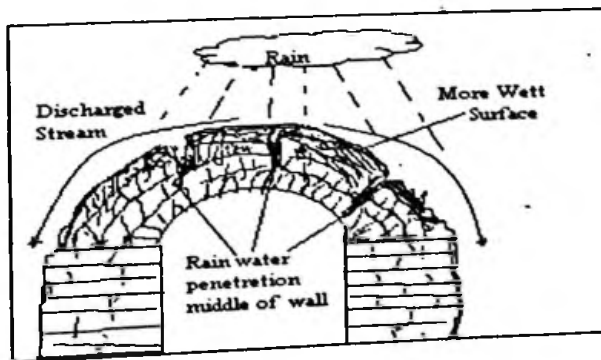
During rainy seasons, rain water directly falls on the brick built vaulted roof and thick layer of lime mortar is washed away. This layer already weakened by other deteriorative factors is easily worn out by this eroding process. As the roofs of Lankathilakaya, Thivanka and Parakramabahu palace are already collapsed ,the wall upper parts of these monuments and the interiors are feing washed away and water is being permeation of water in the into with each rainfall. In rainy season there serious two powerful damages due to the incessant heavy rain. The first is the heavy showers falling on the surface of monuments and washing away of it and cracking much water seepage in to brick walls and to brick works. Besides, excessive seepage of water may cause sliding or crashing down higher parts of brick roof. Unburned bricks may loosen and weaken the monument, due to erosion of clay mortar, time mortar, lime plaster etc.

Erosion caused on the surface - Picture - 117

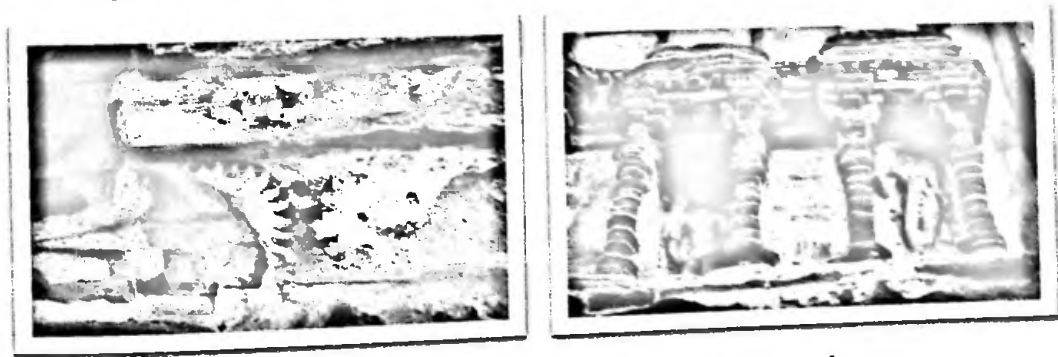
Picture- 118

Inner and outer walls of these monuments had their lime plasters colour painted and beautified with paintings. All these had been faded away owing to the long time exposure to sun light. Outside of the southern wall of Thivanka image house still keeps a place where colourings survive, owing to non respectoin of direct sunshine there still remain places with colourings where the sun light does not fall directly, as in the places covered by moldings in between the carvings of outside and arched shaped window sections.

Paintings - southern outer walls in Thivanka image house

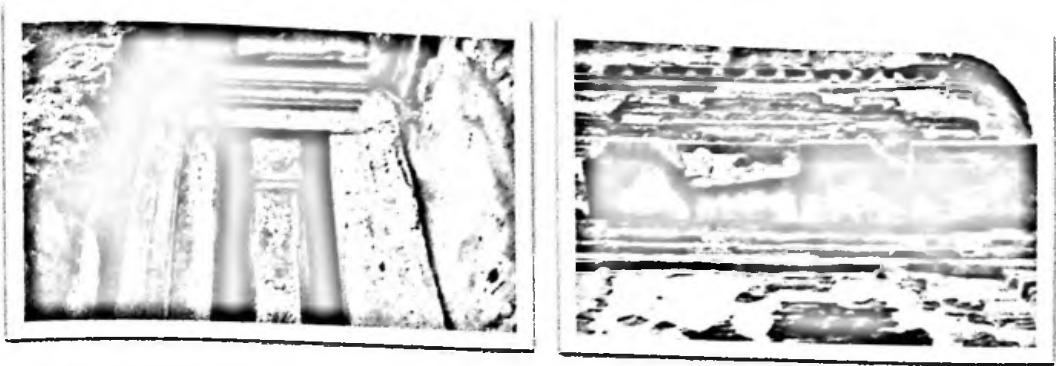
In outside walls of Lankathilaka image house there remain colored places above the arched windows etc. where sun light does not reach directly.

paintings - outer walls in Lankathilaka image house - Picture- 119

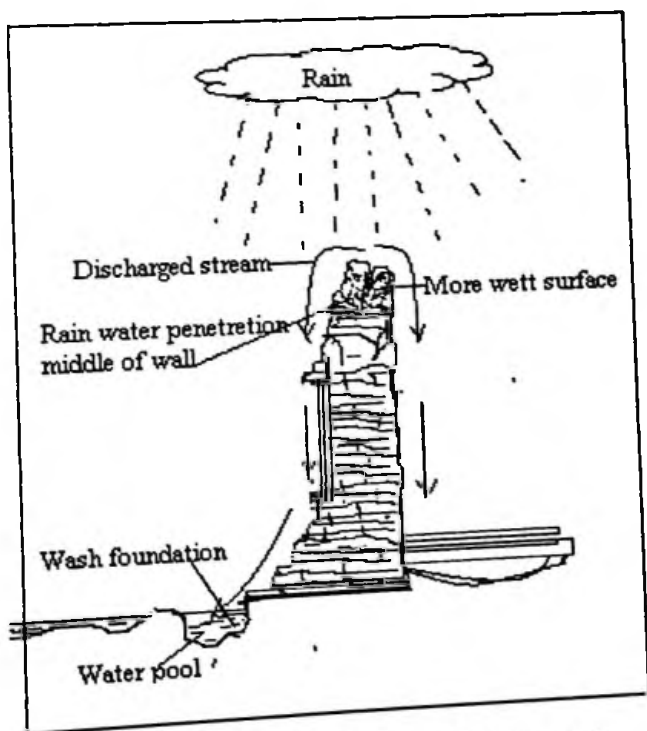
Picture-121

through the cavities in bricks, also the erosion caused by flowing water on the surrounding area of monument, sometimes the foundation washed away leaving the wall to crash down. Besides, excessive seepage of water may cause sliding or crashing down higher parts of walls. Unburned bricks may loosen and weaken the monument, due to erosion of lime mortar, lime plaster etc.

Erosion caused on the surface of monuments

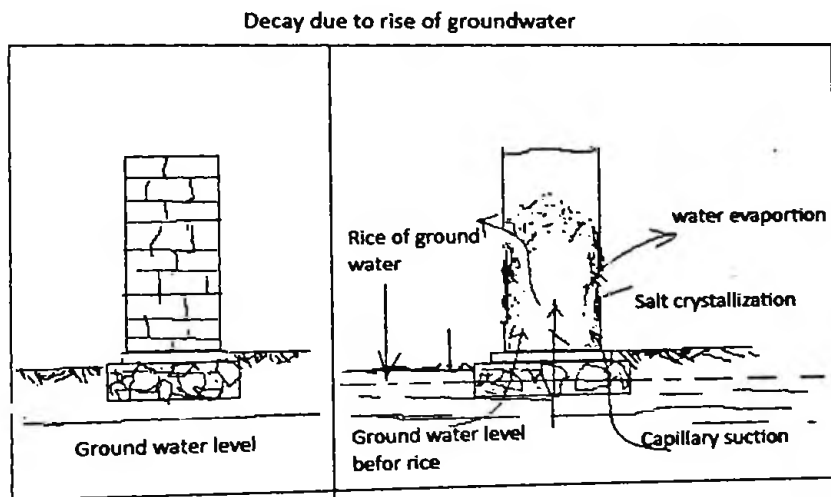
Picture-122

Whenever the water level of the monument premises goes up, any lime plaster and frescos etc. on both sides of interior and of the monument. Flakes like pants come out and environ with moisture originated bacteria, fungus algae lichens etc. will be formed. Bricks of the foundation due to water seepage and due to weight of the monument may vanish.

Decay due to rise of ground water

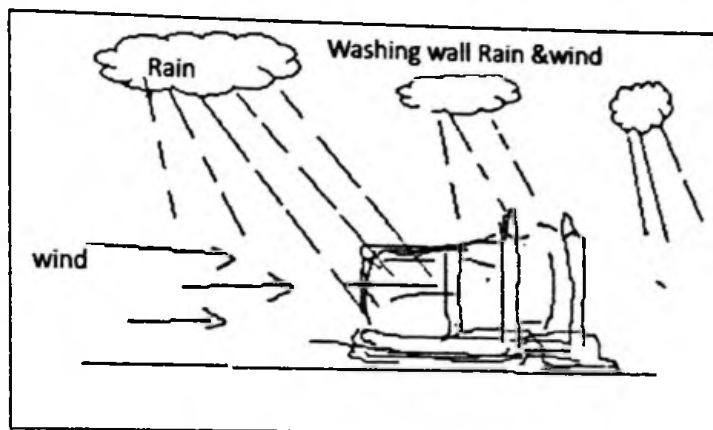
Picture - 125

Washing wall rain and wind
