**Study on Deterioration and Conservation of Brick
Monuments in Polonnaruwa.**

D. Chandrasiri Chithrananda
April, 2010.

Study on Deterioration and Conservation of Brick Monuments in Polonnaruwa

A thesis presented to the University of Moratuwa, for the Master of Science degree in the Architectural conservation of monuments and sites.

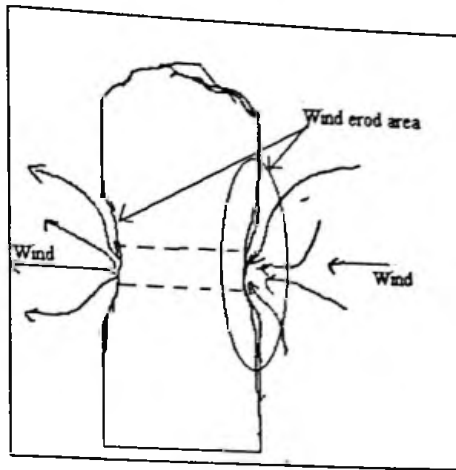
Picture -128

South wall of Lankathilaka Image House in Polonnaruwa too had been subjected to powerful wind erosion, Royal palace of king Parakramabahu had also suffered by the wind erosion. Its Royal interior walls have faced against the wind and the load it carried. Bricks decayed due to the salt crystallization by the ground water near the foundation are quickly eroded by wind action.

The large holes which were made to fix heavy wooden beam of upper floors of the palace have been enlarged by wind erosion. As the middle parts of walls appear feeble, while the upper parts are seen as giant mass.

Wind erosion cause on brick wall in Royal palace of king Parakramabahu

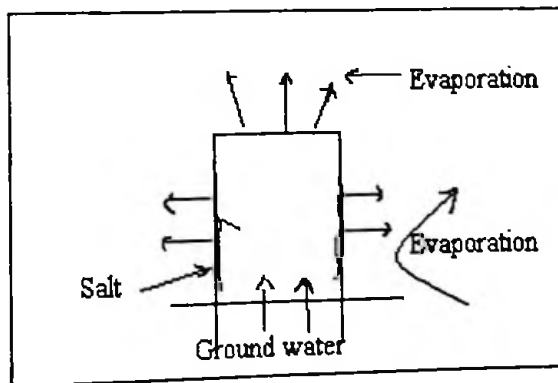
Picture - 129

Evaporation process quickened by wind also expedites the deterioration of building constructed with porous raw material. Water gained from rain, as well as from the ground is evaporated by wind, depositing salt contained in ground water on the walls and windward frontal parts in addition to the pores, holes and cavities in the building materials. Depositing salt on all fronts causes to weaken those fronts and to disintegrate and to make cavilities on them. Salt hasten to weaken the raw material and create deeper and large holes inside the bricks.

Salt weaken the raw material

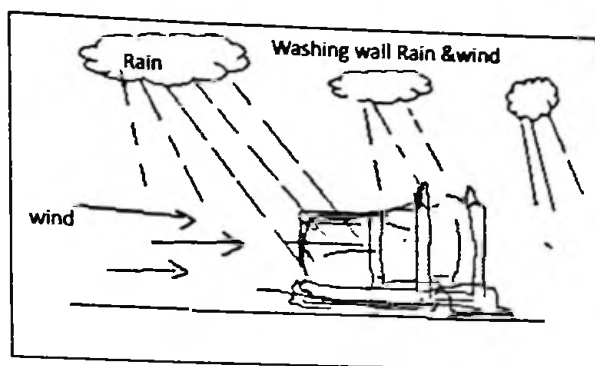
Picture - 130

Washing wall rain and wind

Deterioration of south walls and plasters in Lankathilaka image house, these reason is main Factor.

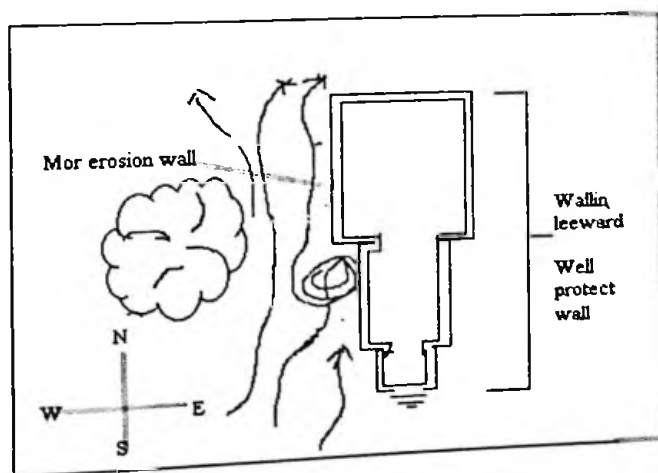
On the lee side of the building there occurs a low pressure zone and damages are in lessee's extent. Example north wall and a part of wall of Thivanka Image House are situated leeward and the damage by wind erosion in lesser here.

Walls in leeward Thivanka image house

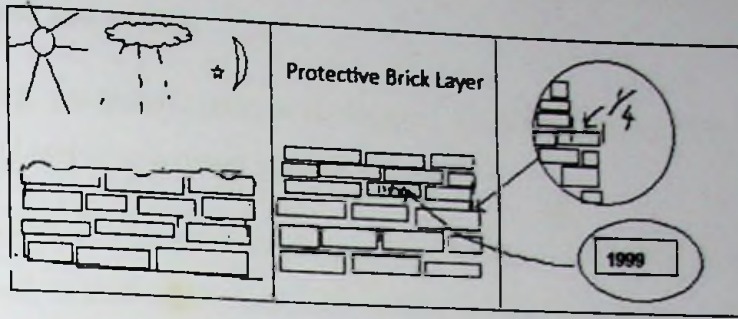
Picture- 132

Protective brick layer

Every part of a wall that is intact has to be protected with three lines of brick, laid down on the top of the ruined or exposed wall as a protective layer.

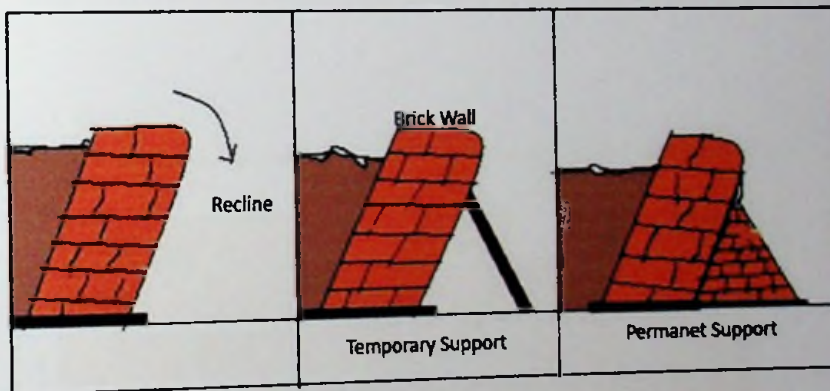
Picture-133

Supporting wall.

Wherever a brick wall is bulgy it has to be supported by posts or erecting supporting wall.

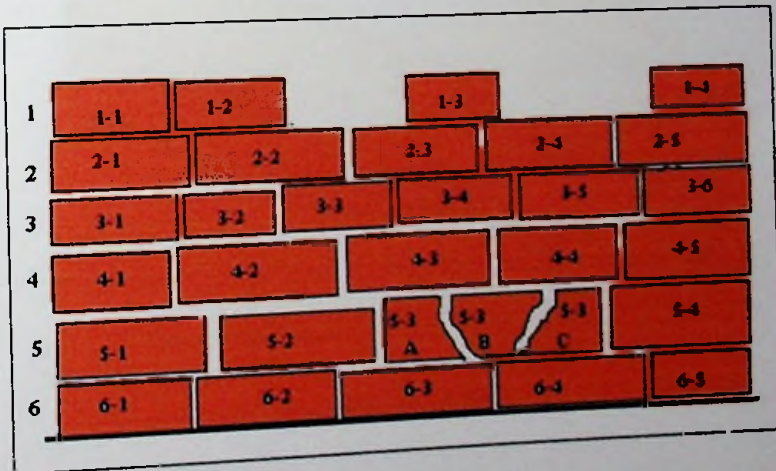
Picture - 134

Numbering brick walls

- Numbering to begin with upper layers of the brick wall and then towards lower layers consecutively.
- Numbering should begin from left side as the accepted way.
- Direction of "North" to be marked upon the plan.
- Numbering should be carried out disregarding any missing of bricks.

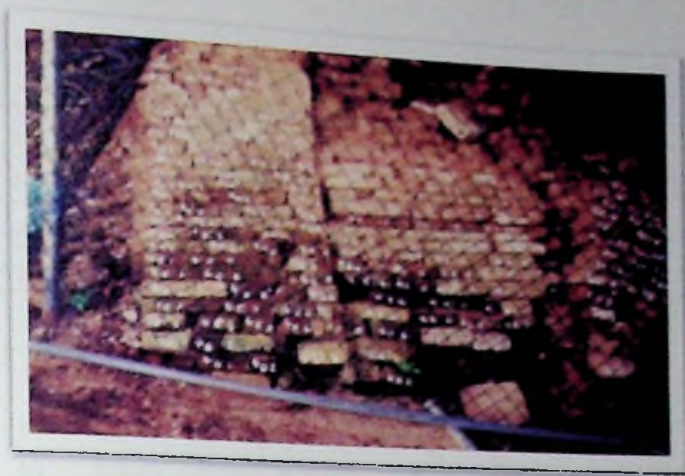
Picture - 135

Numbering bricks on the side wall Hathareskotuwa of Abhayagiri stupa, Anuradapura.

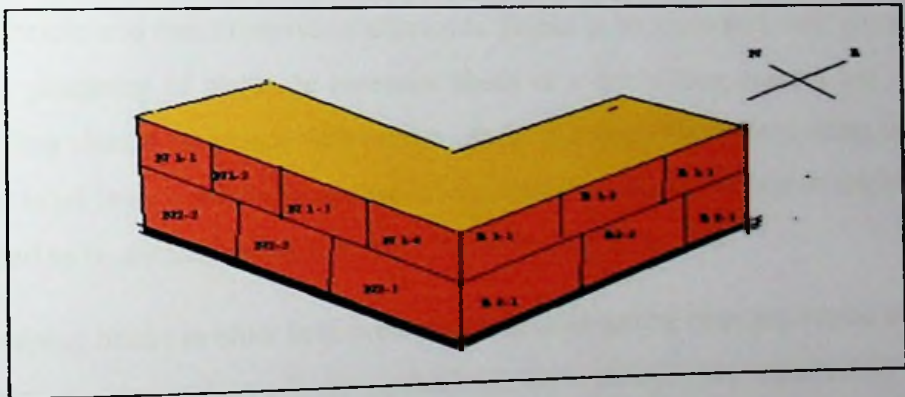
Picture - 136

Numbering brick walls with several directions

Numbering is done according to the direction as shown below.

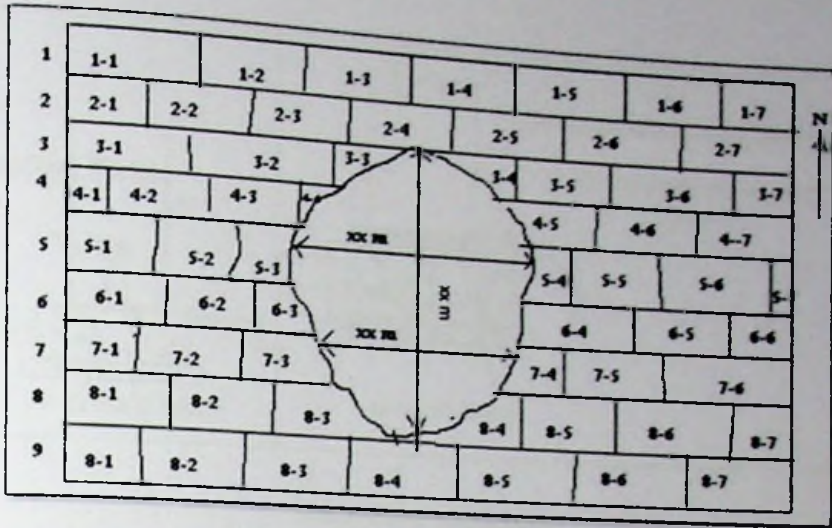
Picture – 137

Numbering upon scaled plan

Where there is a missing part exists on a brick wall, it is easy to re-build it by being numbered on a scaled plan.

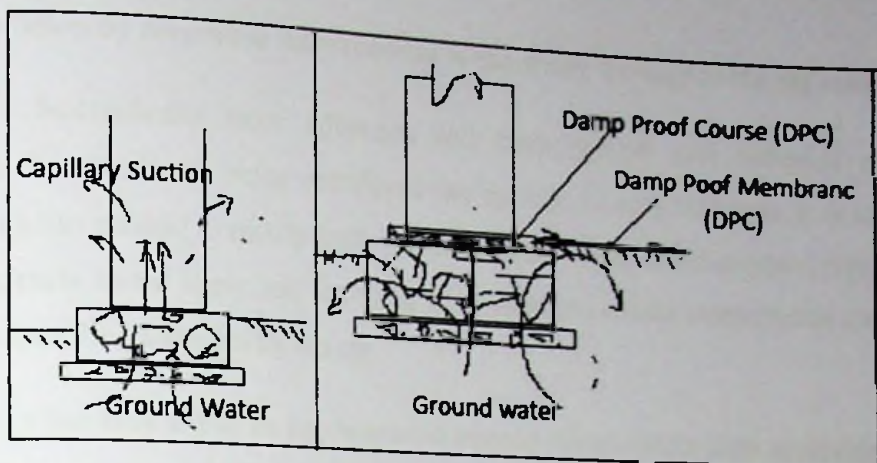
Picture- 138

Damp Proof course layer

After removing the wall, steps may be taken to find the cause that made the wall to crumble down. Such causes ought to be remedied. Weaknesses of the foundation should be strengthened. (In most cases concrete layers are introduced) Sometimes underground water seeps through the foundation and reach the wall making dampness therein. At such instances Damp Proof course or Damp Proof Membrane techniques should be used.

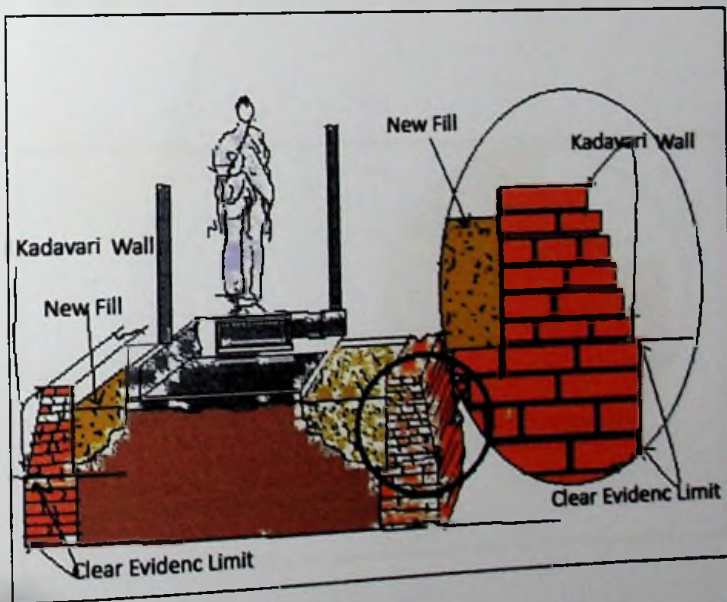
Picture - 139

Applying "Kadavari"

However, in order to preserve the monument beyond surface evidence (design, plastering, carving etc.) it requires applying "Kadavari" on brick surface.

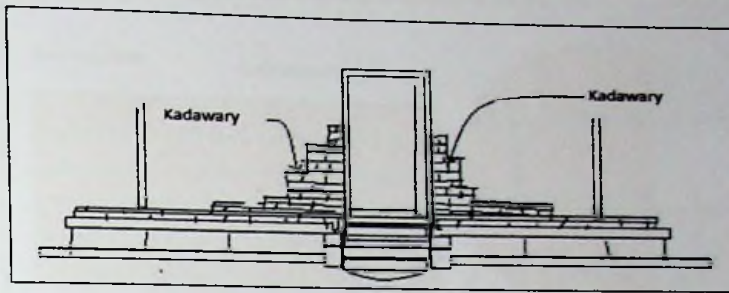
Picture - 140

Applying "Kadavari"

Where it is harmful to the existence of a monument, walls are raised beyond the level decided upon evidence available, in order to perpetuate its existence.

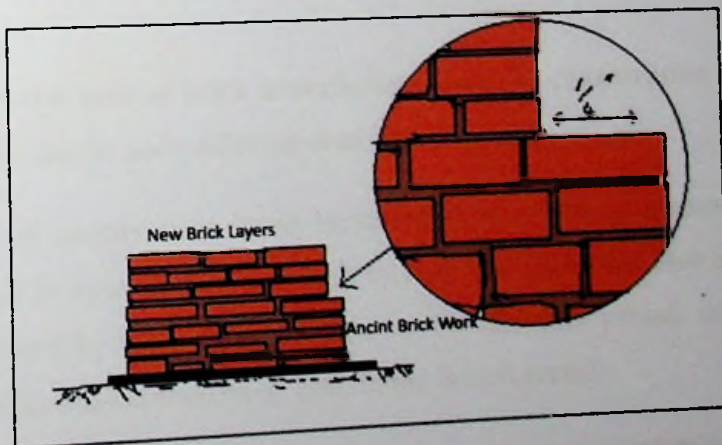
Picture - 141

Identification mark

Such additions should also be effected in order to preserve the importance of the monument. About $\frac{1}{4}$ of an inch backwards, laying and finishing of newly added surface, from the existing wall surface.

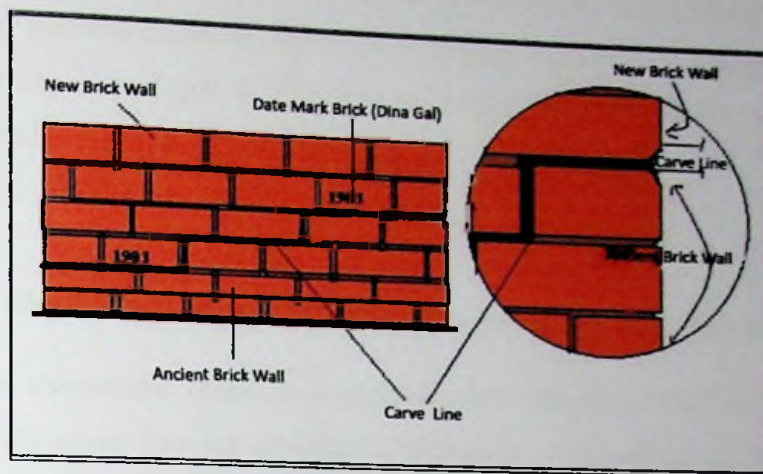
Picture -142

Identification mark

(A) To carve a line in between newly added part and the existing part and insert the put dated stones near to the joining.
