INSPECTION AND ASSESSMENT SYSTEM OF HIGHWAY BRIDGES IN SRI LANKA

Thesis submitted in partial fulfillment of the requirements for the
degree Master of Science in Structural Engineering Design

Department of Civil Engineering

University of Moratuwa

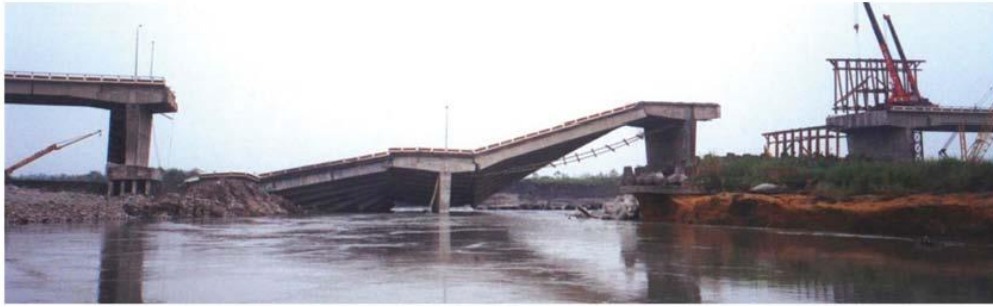
Figure 2-1: Collapse of Kao-Ping Bridge, Taiwan in year 2000 [5]

Chiou et al. [05] presents several highway bridge failures occurred in Taiwan and found out that most of those failed bridges have suffered exposure of pier foundation due to scour. After several flooding, foundation-bearing capacity had reduced due to scour and lead to damage or even collapses. In 2000, a pier of the Kao-Ping Bridge settled because its pile foundation was seriously exposed due to scour, leading adjacent decks to drop. Figure 2-1 presents collapsed decks of Kao-Ping Bridge. In 2008 a pier of the Hou-Fong Bridge tipped over because of the significant scour of its caisson foundation, also causing adjacent decks to collapse as illustrated in figure 2-2. In 2009 Shuang-Yuan Bridge experienced severe foundation scour and were destroyed during a major flood induced by the record-breaking rainfalls. Fourteen numbers of piers settled due to exposing piles as supporting soil was washed away, reducing load carrying capacity of piles. Figure 2-3 shows the remaining of the Shuang-Yuan Bridge after collapse of decks.

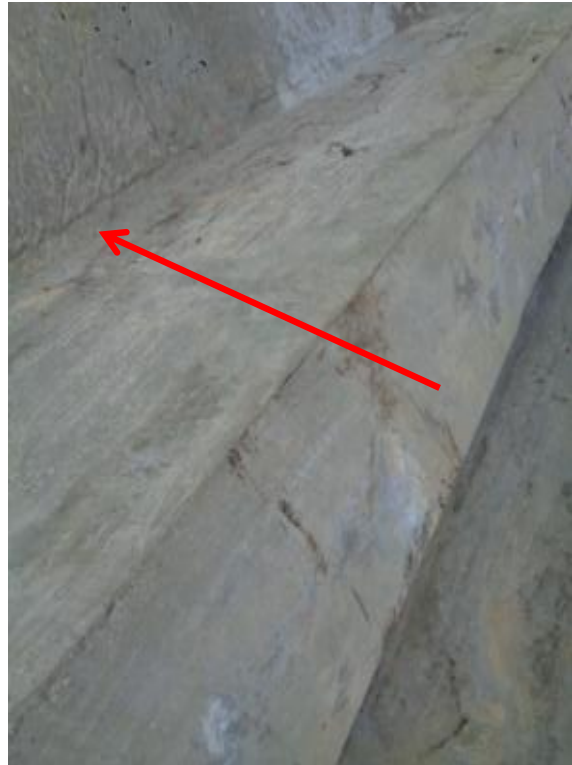
Deck slab - span 1

Deck slab	Corrosion of reinforcement due to depassivation	Spalling and reinforcement exposed	Rate of corrosion - Polarization resistance (kOhm-cm)	
			Spalling of concrete	0% Area
		No spalling of concrete	Risk of corrosion- Half cell potential (mV)	
			Concrete cover to reinforcement - cover meter (mm)	28
			Carbonation depth - Drill and phenolphthalein (mm)	21
		Delamination - hammer tap	50% Area	
		Stain marks of rust - potential to corrosion	5% Area	
		Good condition		
	Cracking	Cracks at mid-span (moment cracks)	Maximum crack width (mm)	
			Length of the crack (mm)	
Cracks closer to supports (shear cracks)		Maximum crack width (mm)	0.2	
		Length of the crack (mm)	2000	
Map cracking (thermal - shrinkage cracks)		Maximum crack width (mm)		
Vegetation on surface	Good condition			
	Several spots	Negligible impact		
		Considerable impact		
	Significant area covered	Negligible impact		
	No vegetation	Considerable impact

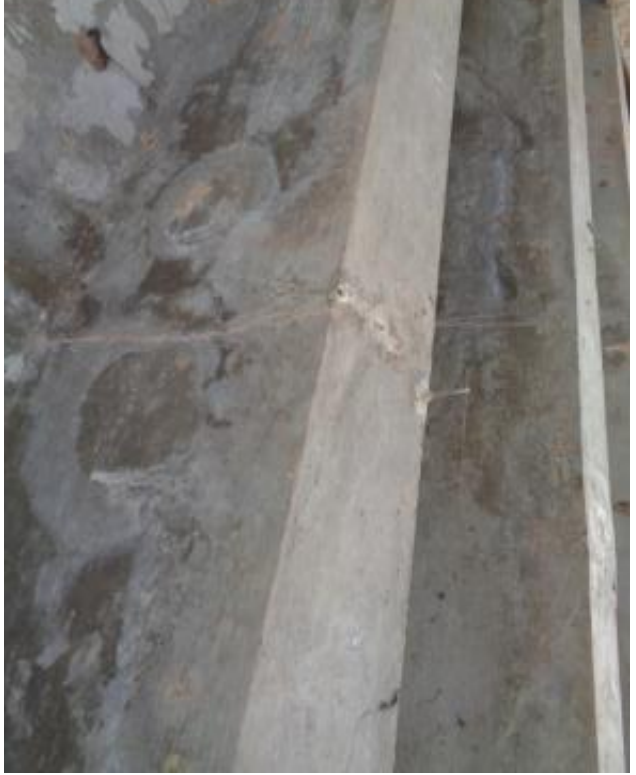
Girders - span 1

2- flexural crack

Girders	Corrosion of reinforcement due to depassivation	Spalling and reinforcement exposed	Rate of corrosion -Polarization resistance (kOhm-cm)	
		No spalling of concrete	Spalling of concrete	10 % Area
			Risk of corrosion- Half cell potential (mV)	
			Concrete cover to reinforcement - cover meter (mm)	
			Carbonation depth -Drill and phenolphthalein (mm)	
	Delamination - hammer tap	30% Area		
	Stain marks of rust - potential to corrosion	40% Area		
	Good condition			
	Cracking	Closely spaced cracks at mid-span (moment cracks)	Maximum crack width (mm)	0.2
			Length of the crack (mm)	1000
Single cracks at mid-span (shrinkage)		Maximum crack width (mm)		
		Length of the crack (mm)		
Cracks closer to supports (shear cracks)		Maximum crack width (mm)		
		Length of the crack (mm)		
Torsional cracks		Maximum crack width (mm)		
		Length of the crack (mm)		
Good condition				
Diaphragm malfunction	Relative displacement between girders	Hardly visible	Clearly visible	Severe

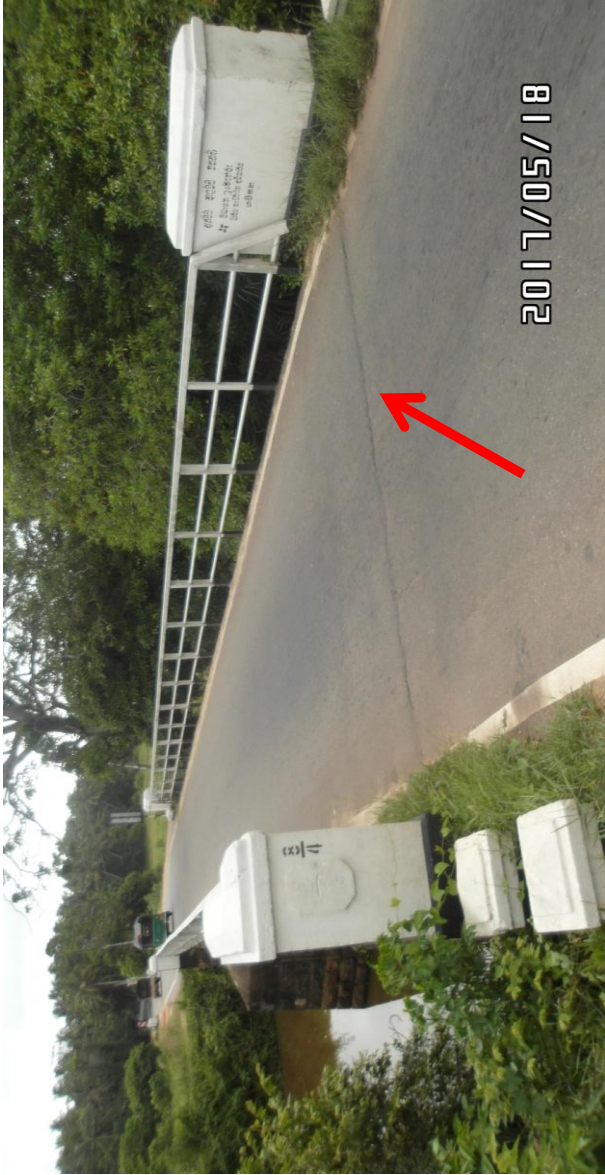
Wearing surface and other accessories of the bridge deck

Wearing surface	Cracking at expansion joint	Cracking	Maximum crack width (mm)		2	
	Pot holes, crocodile cracks and other damages	Good condition				
		Cracking and damages		Mild discomfort to users	Moderate discomfort to users	Severe discomfort to users
		Good condition				✓
	Flushing	Flushing		Mild discomfort to users	Moderate discomfort to users	Severe discomfort to users
Good condition					✓	
Leakage		No leakage	✓ Leakages, marks of leakages visible

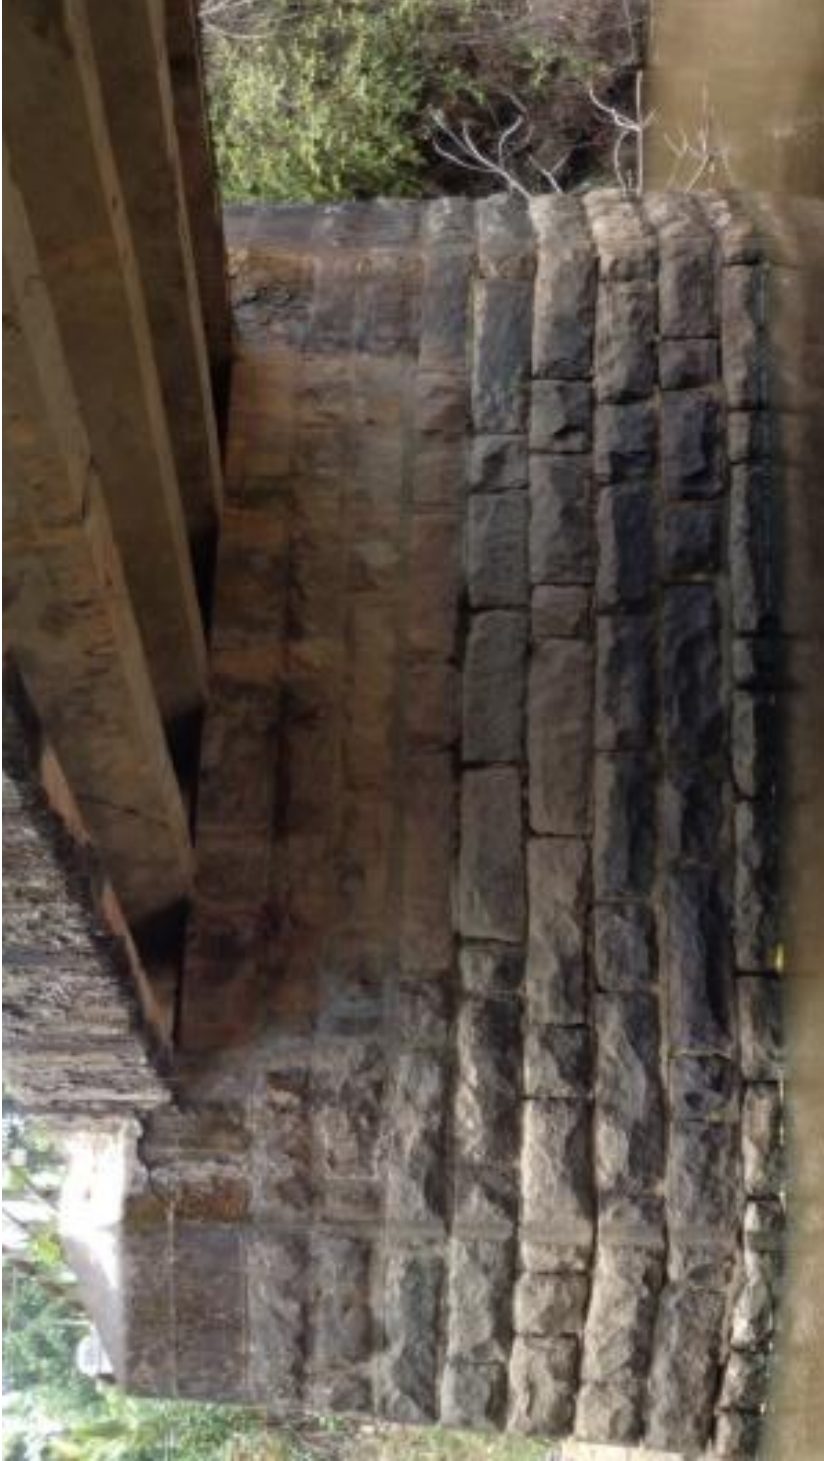
Pier capping beam and bridge bearing at pier - Crack mapping

No distinct capping beam

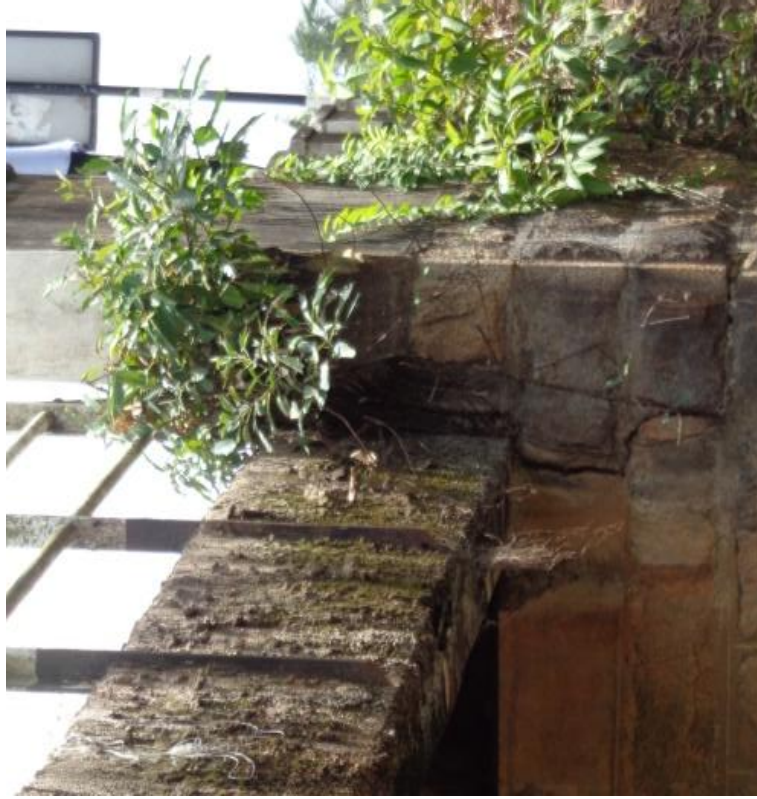
Wingwall - Random rubble masonry

1 - Crack due to lateral earth pressure

Mortar dislocation	Mortar dislocation allowing soil to pass through	10% Area	
	Minor mortar dislocations, but soil passing through is not possible	% Area	
	Good condition		
Cracking	Horizontal cracks indicating development of tensile stress	Maximum crack width (mm)	
		Length of the crack (mm)	
	Vertical cracks indicating settlement	Maximum crack width (mm)	
		Length of the crack (mm)	
Rubble Wing wall	Good condition		
	Movements and deformations	Lateral movement of abutment wall	✓ Moderate (Clearly visible)
		Vertical deformations	Mild (Hardly visible)
		Good condition	
	Vegetation on surface	Several spots	Negligible impact
		Significant area covered	✓ Considerable impact
		No vegetation	Negligible impact
			Considerable impact
			Severe (Dangerously deformed)
			Severe (Dangerously deformed)

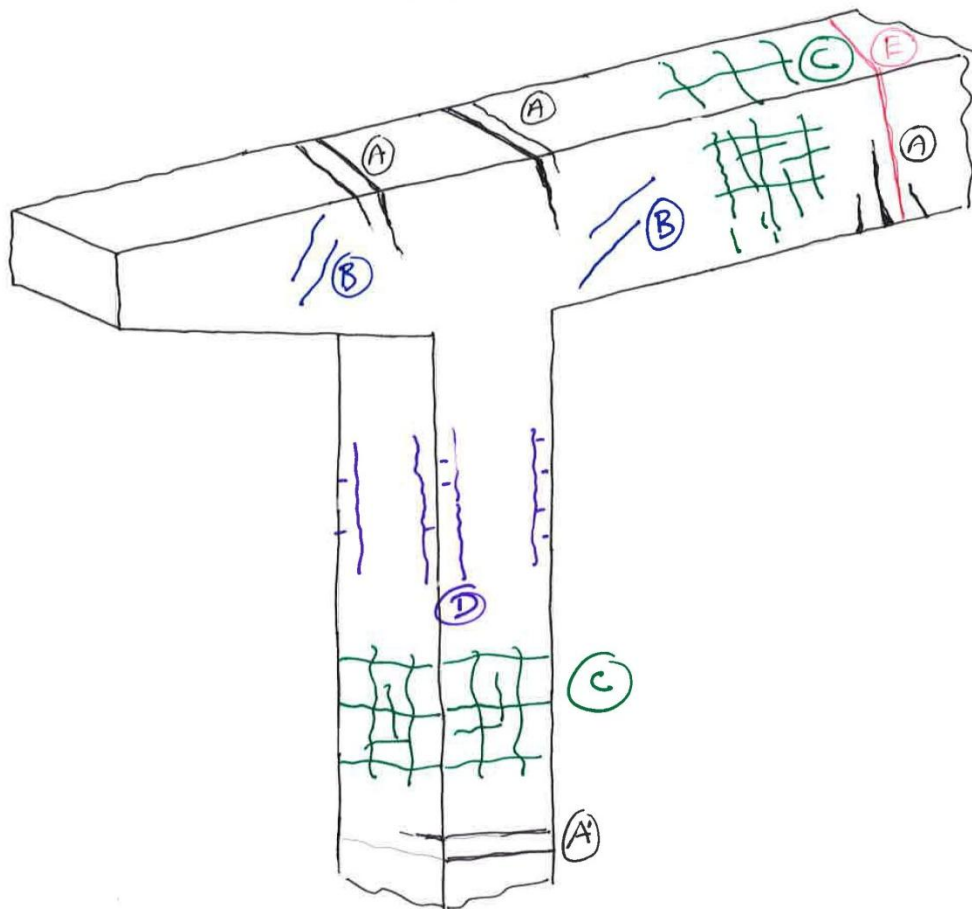
Basic crack patterns of a general pier and a capping beam

Type	Description
A	Cracks due to bending stresses induced mainly by vertical loads. Mainly possible at bottom face of spans and top face near supports. Could appear as a group of cracks in most cases. Crack width is maximum at faces.
A'	Cracks due to bending stresses induced mainly by lateral loads.
B	Shear cracks. Mainly possible near supports and around concentrated loads. Most likely 45 degrees to vertical plane.
C	Map cracking. There could be two possibilities. i) DEF, ii) Alkali Silica reaction. White colour deposits around cracks indicates the possibility of ASR.
D	Cracks parallel to edges. This is the early sign of spaling. At this stage, reinforcement must have started corrosion.
E	A single crack most likely at mid span of a beam indicates a possible cracking due to drying shrinkage. Most likely in thicker elements.

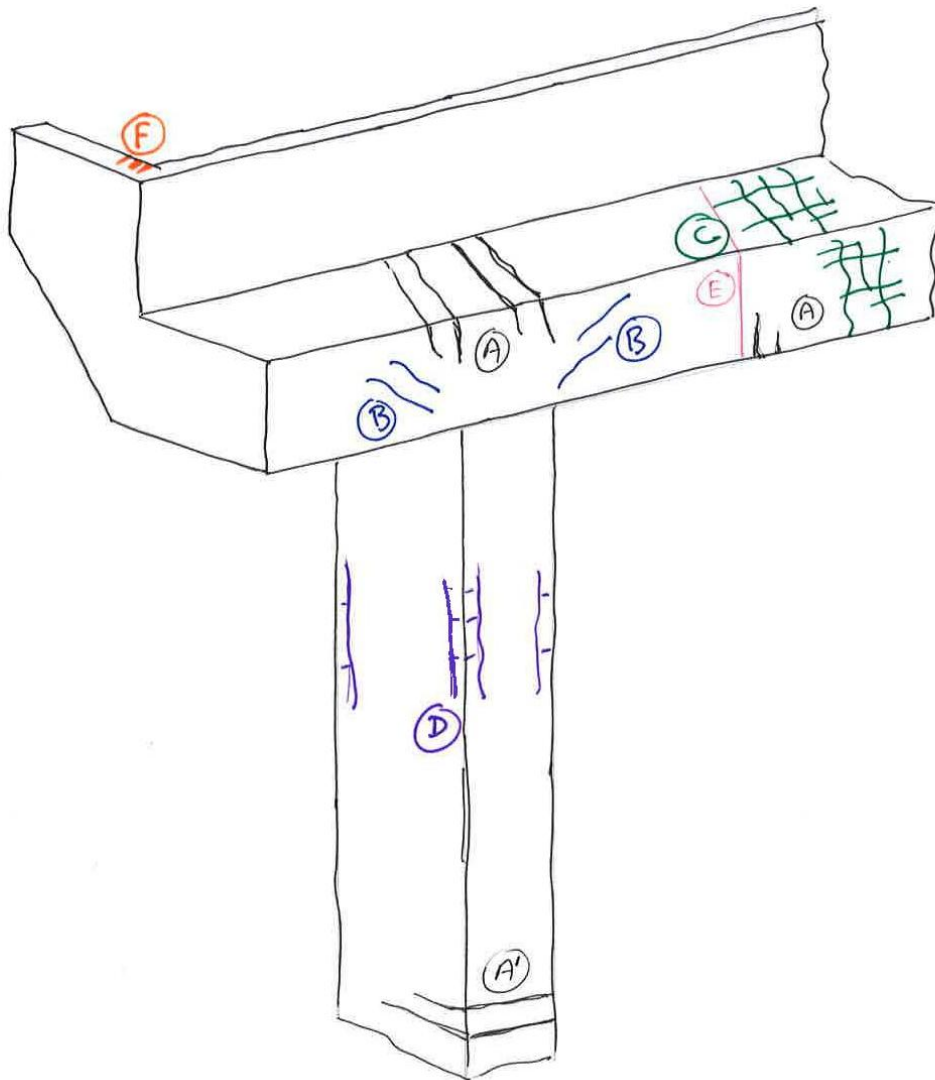
Basic crack patterns of a spill-through type abutment

Type	Description
A	Cracks due to bending stresses induced mainly by vertical loads. Mainly possible at bottom face of spans and top face near supports. Could appear as a group of cracks in most cases. Crack width is maximum at faces.
A'	Cracks due to bending stresses induced mainly by lateral loads.
B	Shear cracks. Mainly possible near supports and around concentrated loads. Most likely 45 degrees to vertical plane.
C	Map cracking. There could be two possibilities. i) DEF, ii) Alkali Silica reaction. White colour deposits around cracks indicates the possibility of ASR.
D	Cracks parallel to edges. This is the early sign of spalling. At this stage, reinforcement must have started corrosion.
E	A single crack most likely at mid span of a beam indicates a possible cracking due to drying shrinkage. Most likely in thicker elements.
F	Cracks due to bending stresses induced due to lateral earth pressure. These cracks develop mainly at soil side and hence leave unnoticed.

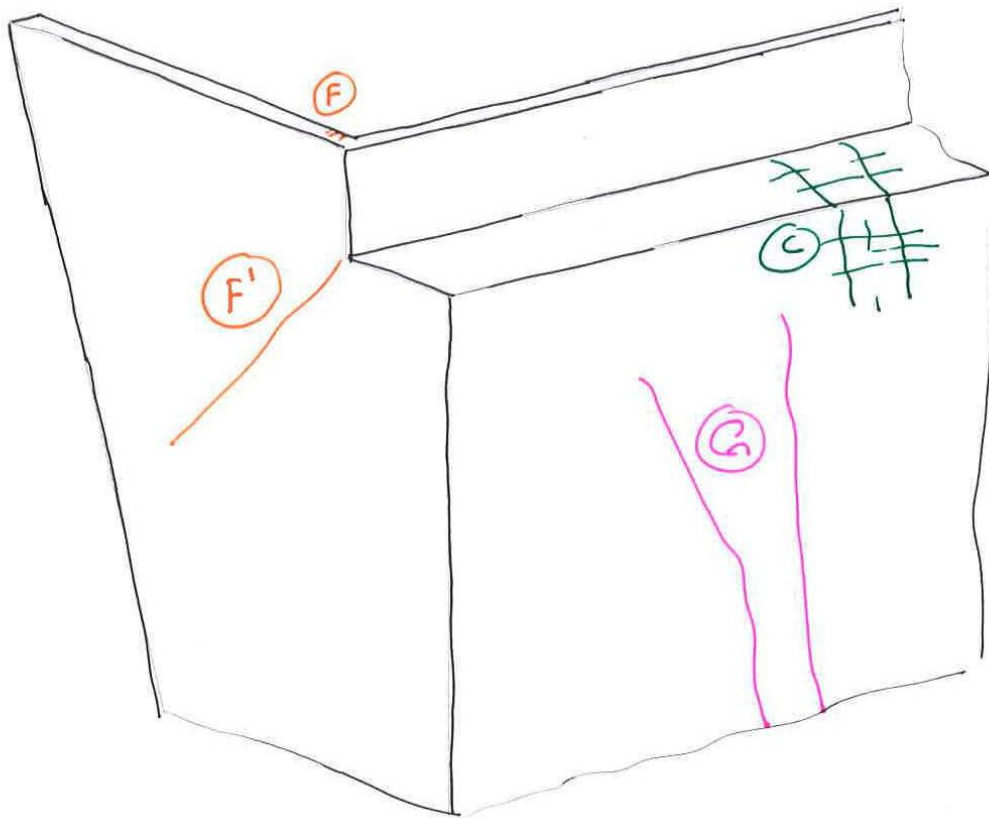
Basic crack patterns of general type of an abutment

Type	Description
C	Map cracking. There could be two possibilities. i) DEF, ii) Alkali Silica reaction. White colour deposits around cracks indicates the possibility of ASR.
F	Cracks due to bending stresses induced due to lateral earth pressure. These cracks develop mainly at soil side and hence leave unnoticed.
F'	Cracks due to bending stresses induced due to lateral earth pressure. Difference from type F is that these cracks mainly happens in mass concrete abutments and masonry abutments.
G	Vertical cracks due to differential settlements. These cracks mainly develop in mass concrete abutments and masonry abutments.

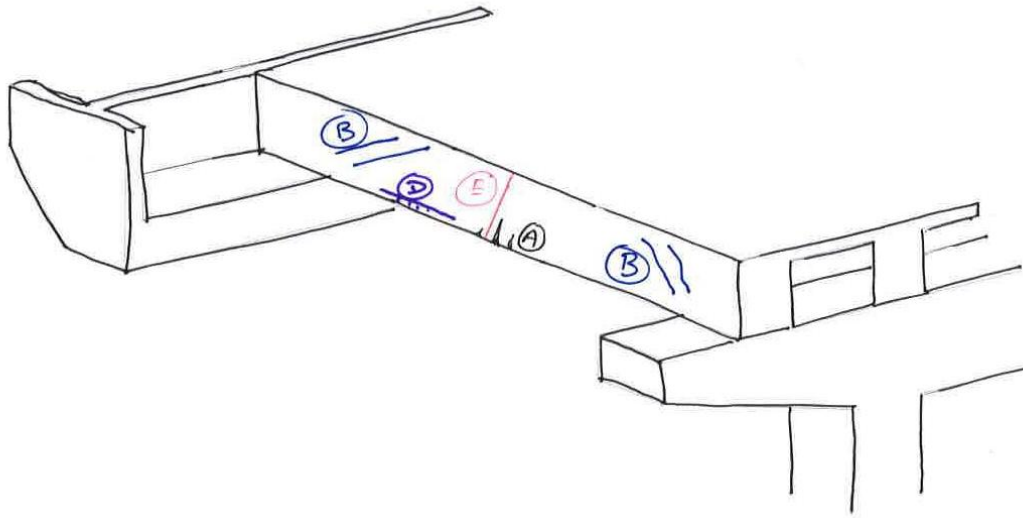
Basic crack patterns of a bridge beam

Type	Description
A	Cracks due to bending stresses induced mainly by vertical loads. Mainly possible at bottom face of spans and top face near supports. Could appear as a group of cracks in most cases. Crack width is maximum at faces.
B	Shear cracks. Mainly possible near supports and around concentrated loads. Most likely 45 degrees to vertical plane.
D	Cracks parallel to edges. This is the early sign of spaling. At this stage, reinforcement must have started corrosion.
E	A single crack most likely at mid span of a beam indicates a possible cracking due to drying shrinkage. Most likely in thicker elements.
