**ENHANCEMENT OF THE STABILITY AT THE SITE  
OF AN ANCIENT LANDSLIDE IN A ROAD CUTTING  
WITH DRAINAGE AND REINFORCEMENT – CASE  
HISTORY AT GINIGATHHENA**

Master of Engineering in Foundation Engineering and Earth Retaining  
Systems

Department of Civil Engineering  
University of Moratuwa  
Sri Lanka

August 2019

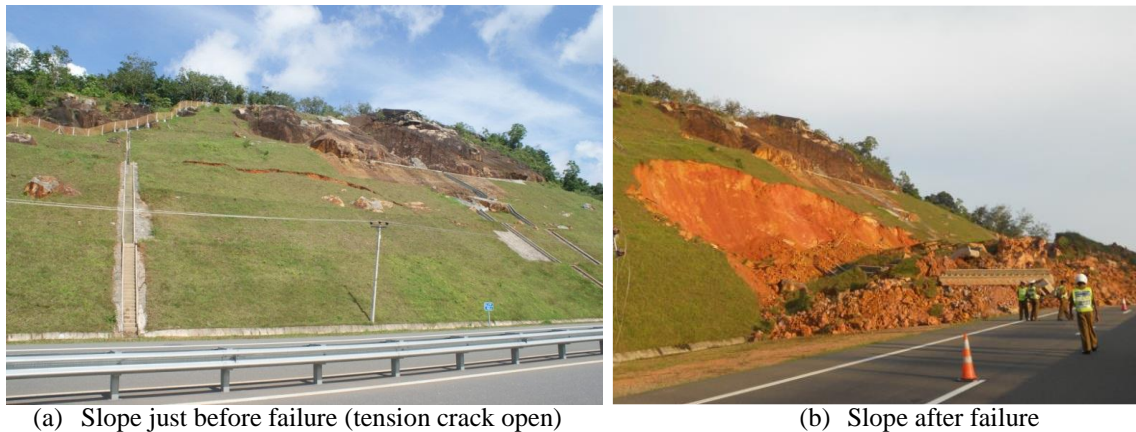
Figure 2.19 : Failure at Welipenna on Southern Expressway (*Idirimanna, 2016*)

This is a cut slope of height about 35 m and there were four berms. Berm drains and cascade drains were constructed with turfing as surface protection (Figure 2.19 (a)). Site geology was quite non uniform. There were rock outcrops and five different joint systems. Boudinage structures embedded in the soil mass were identified.

A failure occurred in the evening is illustrated in Figure 2.19 (b). The tension crack that showed up in the morning indicating the imminent failure can be seen in Figure 2.19 (a). The failure was back analyzed in the form of a parametric study considering possible scenarios of defective system of surface drains and the presence of relict joints. Identification of faults in the system of drains prompted this approach.

(a) Slope just before failure (tension crack open) (b) Slope after failure
