STRENGTH ASSESSMENT OF STEEL TOWERS

Department of Civil Engineering, University of Moratuwa

Abstract: In the recent past, considerable number of tower failures happened in telecommunication sector and power transmission sector in Sri Lanka. However, no lessons were learnt and there is still a vacuum in strength assessment of towers. The objectives of this research are conducting data survey on failed towers in Sri Lanka and identifying causes, analysing failed electric transmission towers using finite element analysis and finding the causes for the failures and developing simple methods to check tower capacity based on available simplified models. Four telecommunication towers and a transmission tower were considered to identify the failure reasons. Structural analysis of a transmission tower was done using a finite element analysis package, SAP2000. A manual method to analyse 3D trusses was developed by combining unit load method and tension coefficient method. To ensure the validity of proposed analysis methods, a simple tower model was erected, structural analysis was done using both SAP 2000 package and manual method, failure loads were predicted using SAP 2000 package, loadi

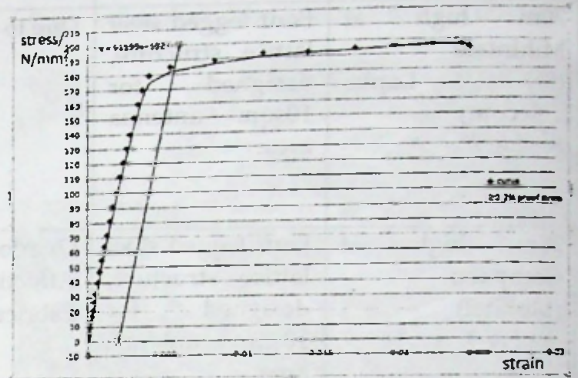
Fig 6 Stress-strain curve obtained from test

From the results (see Fig 6) tensile yield strength, ultimate tensile stress and Young's modulus were found as 183 N/mm², 195 N/mm² and 51.2 kN/mm², respectively. Using the obtained mechanical properties a model generated with appropriate dimensions.

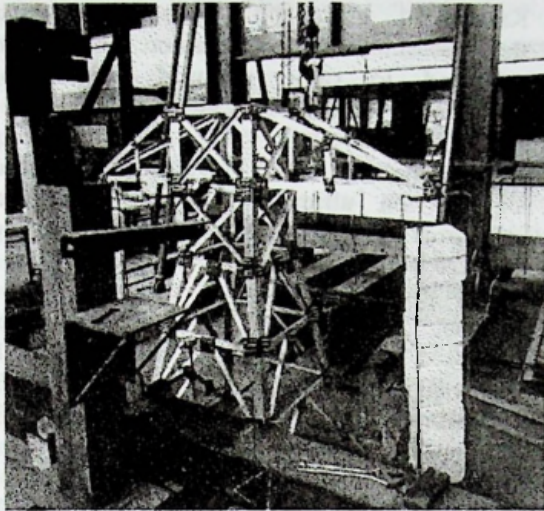
Fig 8 Loading arrangement

Tests resulted in completely different failures. When load on leg nodes are increased to 3.5 kN second panel horizontal member got bent (see Fig 10) and third panel leg member got bent (see Fig 9). Loading procedure continued and second panel tension member bolts failed at the same load i.e. 3.5 kN.
